Sargent Engineers, Inc.  
320 Ronlee Lane NW  
Olympia, Washington 98502-9241  
Tel 360 867-9284  
Fax 360 867-9318  
www.sargentengineers.com

April 5, 2005

**RE: Raft Island Bridge Condition Evaluation  
Project No.: A04208.00**

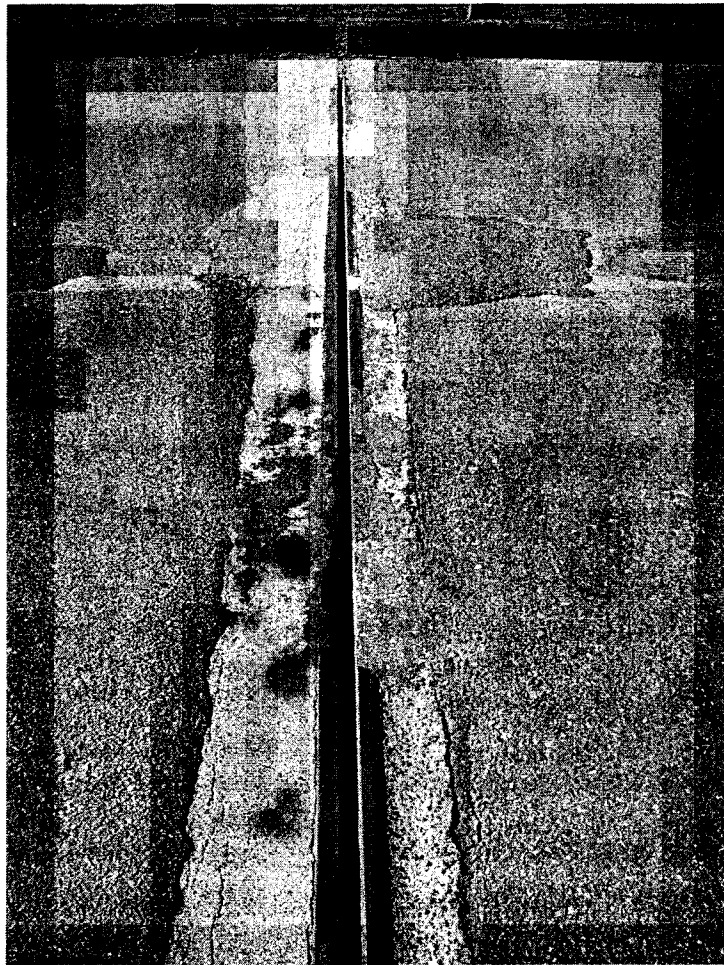
The asphalt surface is in fair condition with a majority of the defects occurring adjacent to the expansion joints. Some spalling of asphalt immediately adjacent to the compression seal joint has been repaired in the past and is breaking up again. Concrete headers at the joints have been patched and are beginning to show some distress again. The metal joint elements appear to be adequately anchored and are not showing any significant distress at this inspection.

Expansion Joint on Bridge with Asphalt Patches

6. Beam 5, Span 42 has a longitudinal crack at the center of the deck unit full length, this crack should be sealed by epoxy injection.
7. Deck surface – the asphalt surface adjacent to the expansion joints will continue to require periodic patching. It is important that these areas adjacent to the joints be maintained to minimize impact forces in the surrounding elements, i.e., steel joint elements, concrete deck units, etc.

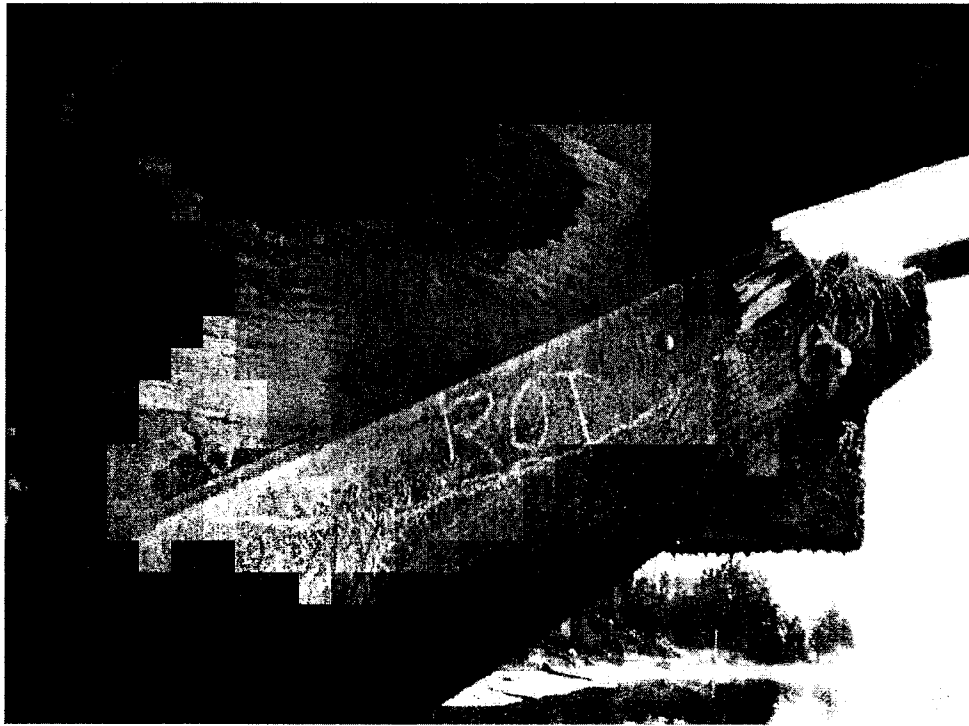
Many of the bracing members are splitting at the ends, typically extending through the bolt at the connection to the pile or beyond. Some have rot developing in these areas as well.

Cross Brace with Decayed End

Several of the cross-brace members are cracked or rotting to the extent that they provide little lateral restraint. These should be selectively replaced to restore lateral restraint at the bents.

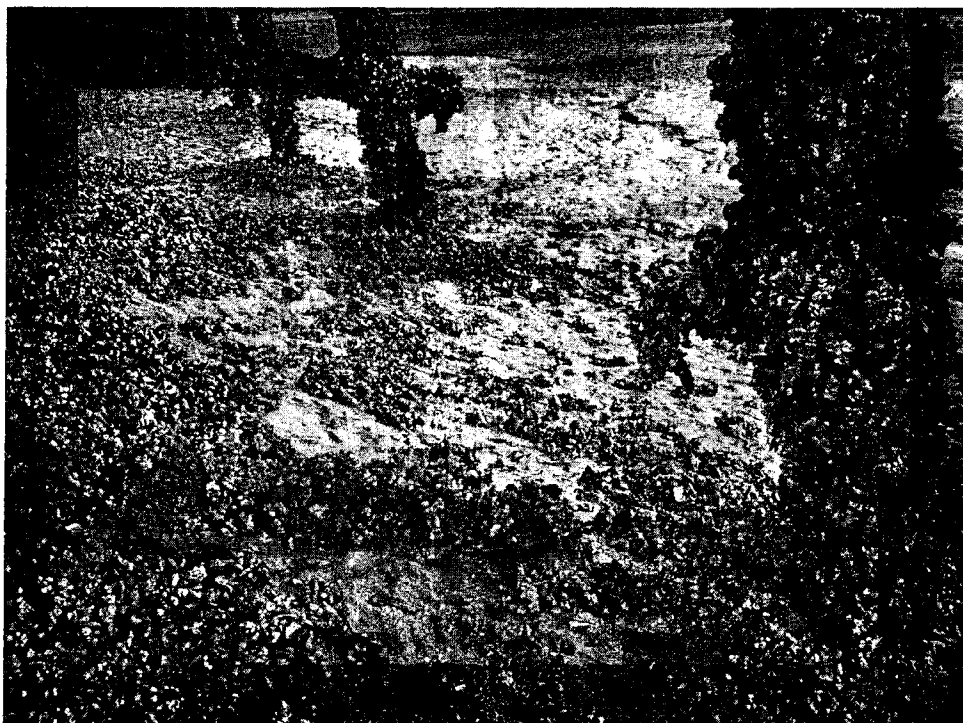
Bent with Missing Brace
