2007 Annual Bridge Inspection Report for Raft Island Bridge

July 2007

**Raft Island Improvement Association
Pierce County, Washington**

Exeltech Consulting, Inc.
2590 Willamette Drive NE, Suite 101
Lacey, Washington 98516

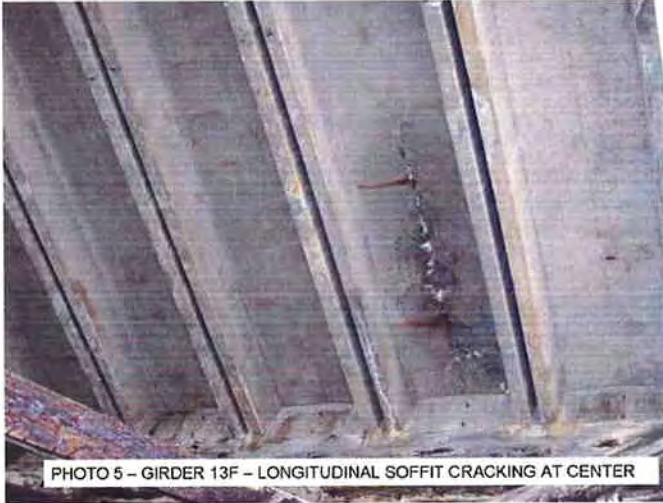
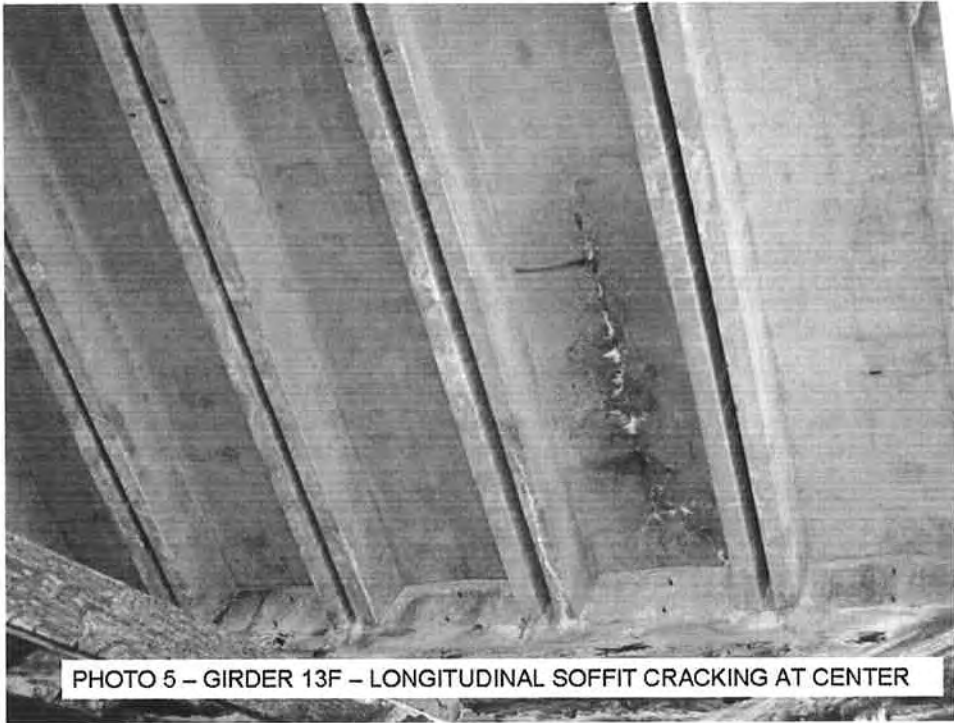
PHOTO 5 - GIRDER 13F - LONGITUDINAL SOFFIT CRACKING AT CENTER

PHOTO 5 – GIRDER 13F – LONGITUDINAL SOFFIT CRACKING AT CENTER

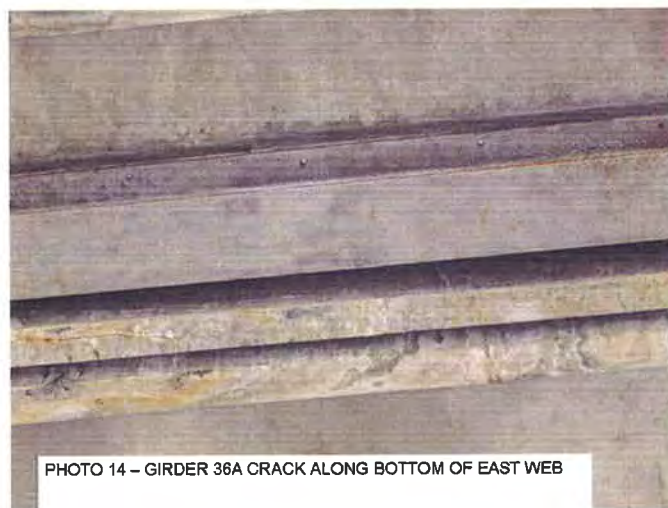
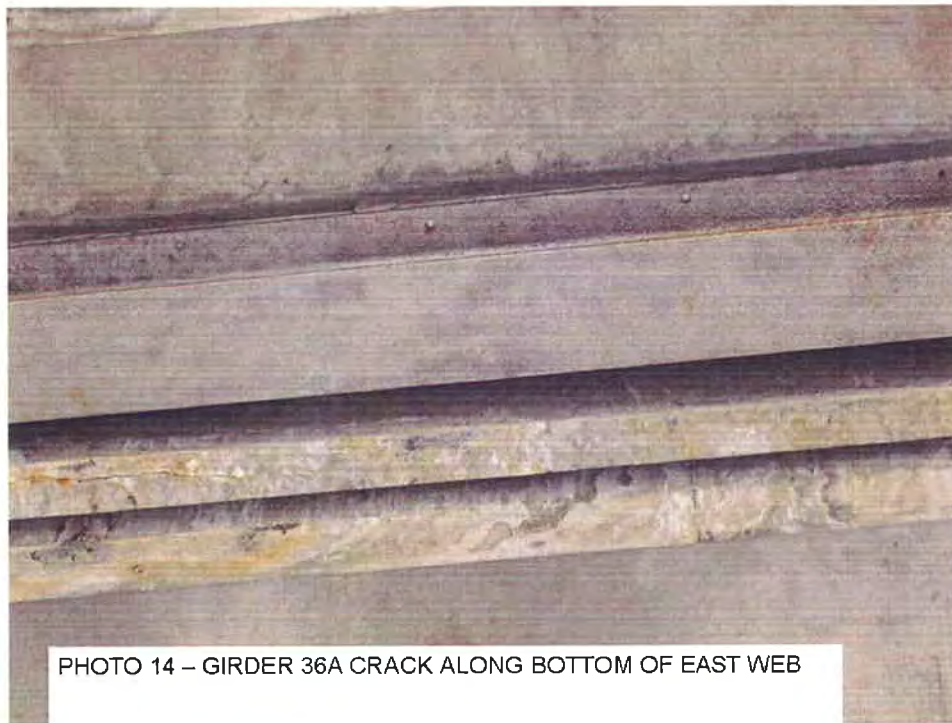
Span 36: Girder A – bottom of east web has 1' long rust stained crack – see Photo 14

PHOTO 14 - GIRDER 36A CRACK ALONG BOTTOM OF EAST WEB

PHOTO 14 – GIRDER 36A CRACK ALONG BOTTOM OF EAST WEB

Item	Description
Epoxy Crack Injection	Span 16: Girder G, 12" diagonal crack in east web (2007) Span 36: Girder A, 12" long crack in bottom of west web (2007)
Epoxy Patch Spalls	Span 6: Girder G soffit, two 4" diameter spalls with exposed rebar (2007) Span 16: Girder A soffit, three 3" diameter spalls with exposed rebar (2007) Span 22: Girder G east web, 8" long and 6" long spalls with exposed prestress (2007) Span 24: Girder A, one 3" diameter spall with exposed rebar (2006) Span 26: Girder A, one 3" diameter spall with exposed rebar (2005) Span 28: Girder A, one 3" diameter spall with exposed rebar and two delaminations (2006) Span 29: Girder A, one 3" diameter spall with exposed rebar (2007) Span 31: Girder A, three 3" to 4" diameter spalls with exposed rebar (2006) Span 44: Girder A, one 3" diameter spall with exposed rebar (2007)
Asphalt Overlay Patch and Crack Sealing at Expansion Joints	South abutment: Remove loose overlay, epoxy inject around anchor bolts, tighten expansion joint hold down bolts, patch with asphalt, and seal asphalt edges. Bent 32: Remove loose overlay, epoxy inject around anchor bolts, tighten expansion joint hold down bolts, patch with asphalt, and seal asphalt edges.

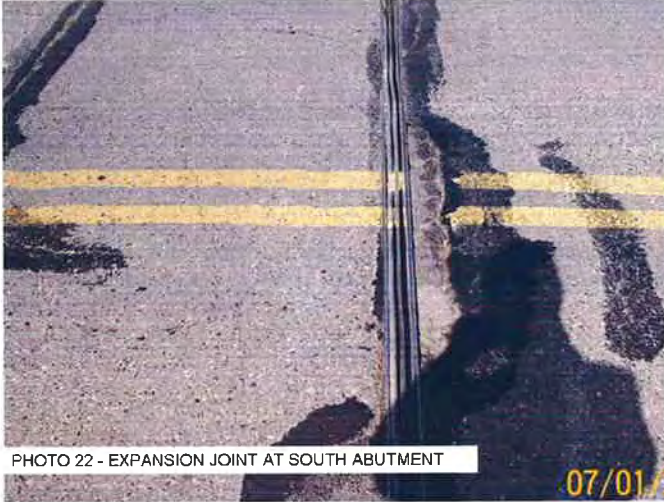
The asphalt depth is approximately 2 inches. The majority of the cracking and delamination is located near the expansion joints. Most of this distress consists of alligator cracks and visible signs of deterioration of the existing asphalt patches. At the expansion joint there is a “D” spall in the asphalt at the south abutment that is 4 feet 0 inches long by 3 inches wide by 2 inches deep. See Photo 22.

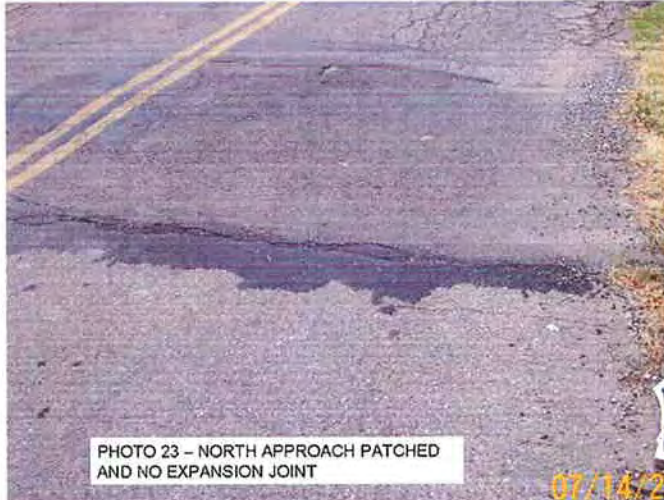
At Bent 32 there is “D” cracking in the asphalt 3 feet 0 inches long at the centerline that is starting to break up. At the north abutment there is cracking full width with some smaller “D” cracking. See Photo 23.

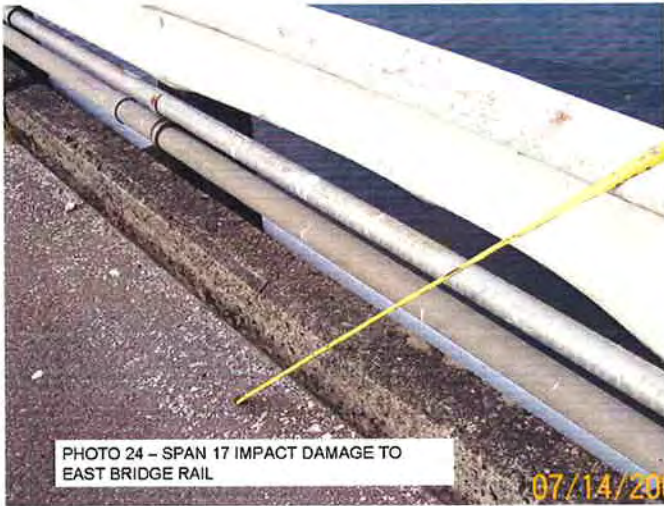
The rail on the structure is a W beam mounted on 8- by 8-inch timber posts. The top of the W beam is approximately 28 inches above the asphalt overlay. There is no approach rail. The east rail in Span 17 is bent out 2 inches over the 5-foot-8-inch post spacing due to traffic impact. See Photo 24.

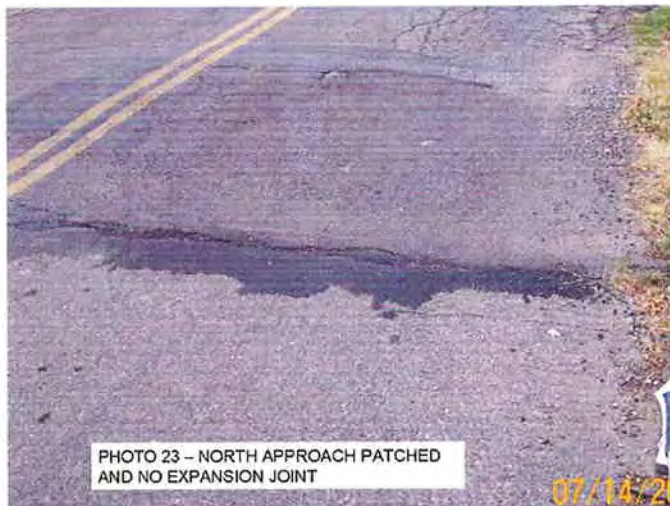
The south approach has several patches, but the patches are not impacting the bridge. The north approach has several large patches and is approximately ¾ inch higher than the bridge, which is causing moderate impact to the bridge. See Photo 23.

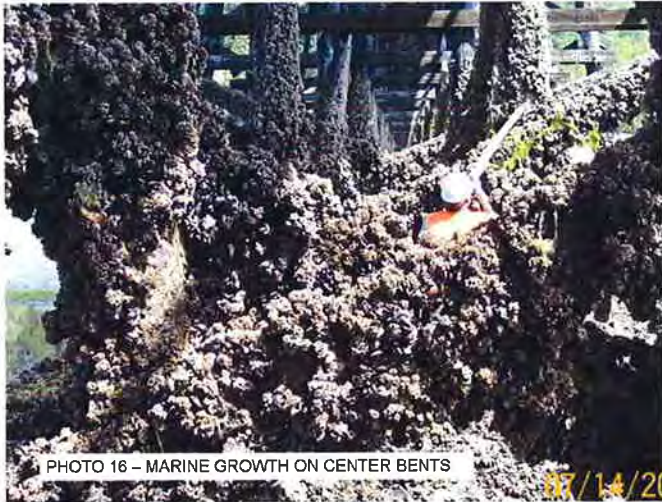
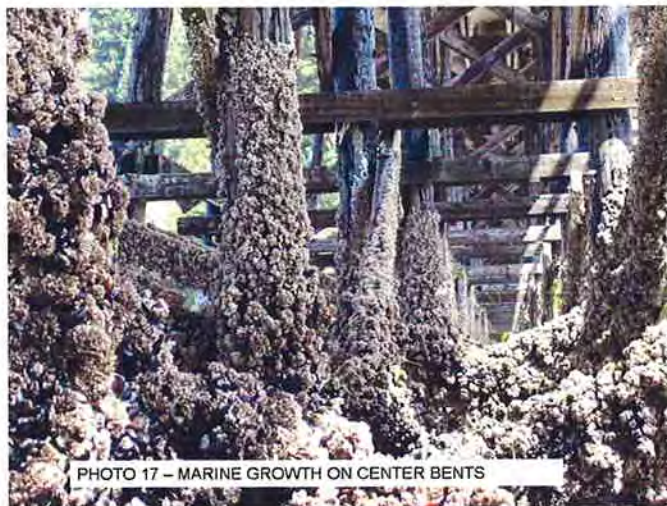
All of the piles that were near the center spans of the bridge were encased or buried in a heavy marine growth and silt buildup. The heavy marine growth was removed on two sides of each pile at three heights: ground line, 3 feet to 4 feet, and 6 feet to 7 feet, except at the shorter end bents. This provided access for soundings with a rock hammer and for visual inspection for marine borers. See Photos 16 and 17.

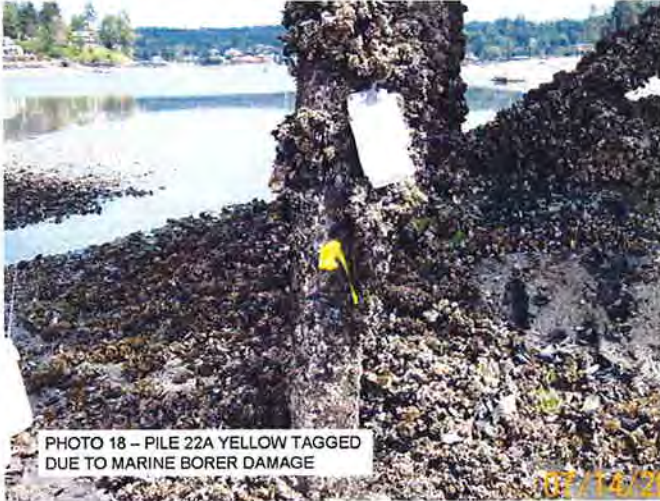
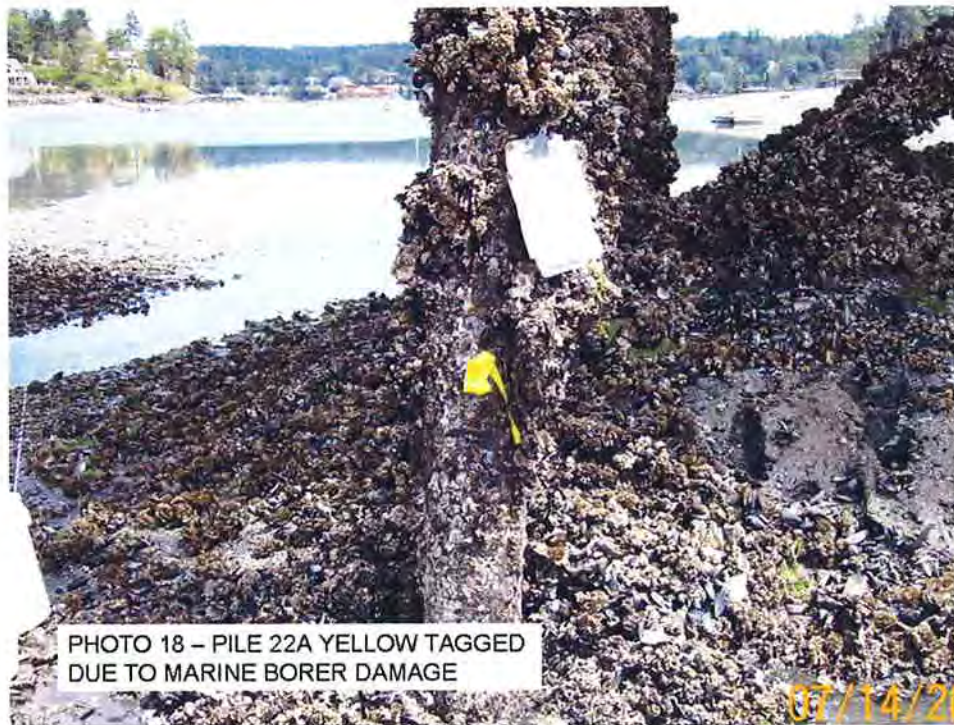
The sounding results indicated some audible signs of rot and marine borer damage at three piles. At piles 22A, 22D, and 27D, holes from marine borers were found. Pile 22D also has a surface rot pocket 12 inches high by 3 inches wide by 1 inch deep at the ground line and a small pocket of center rot. These piles were **YELLOW TAGGED** with flagging indicating that they should be **MONITORED** for additional damage during the next inspection. See Photos 18, 19, and 20.

PHOTO 18 – PILE 22A YELLOW TAGGED
DUE TO MARINE BORER DAMAGE

Future inspections should include cleaning all 188 pilings at the ground line and at several other locations and conducting a visual and sounding inspection. In particular, the **YELLOW TAGGED** Piles 22A, 22D, and 27D should be monitored for damage, and the bracing with rot should be monitored for damage.

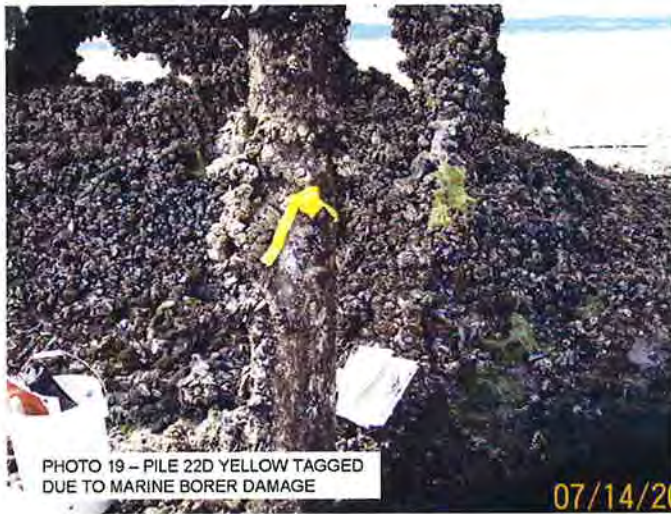
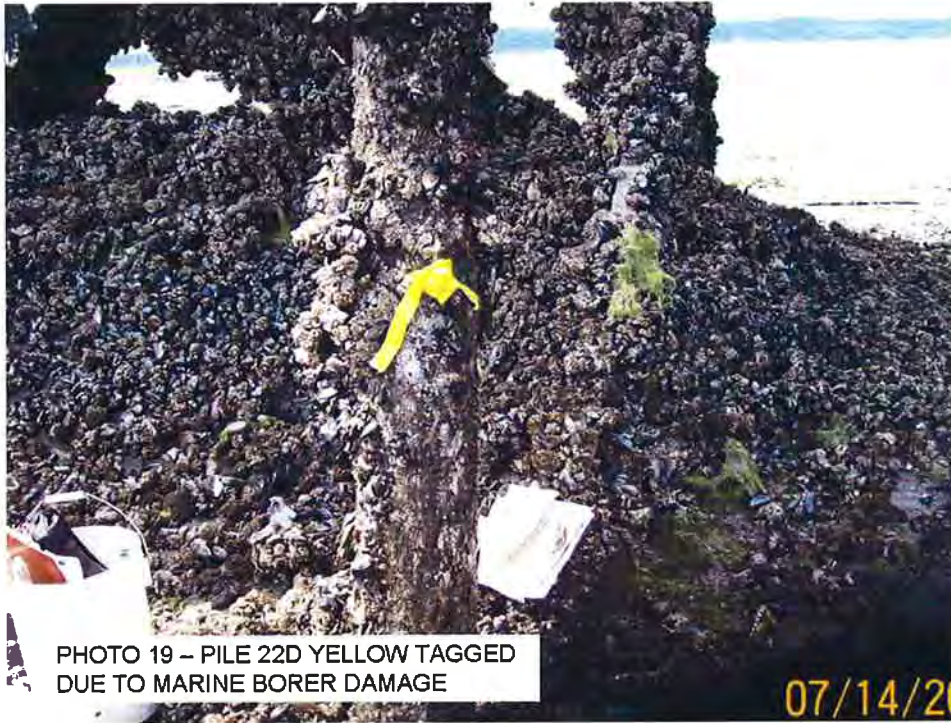
PHOTO 19 – PILE 22D YELLOW TAGGED
DUE TO MARINE BORER DAMAGE

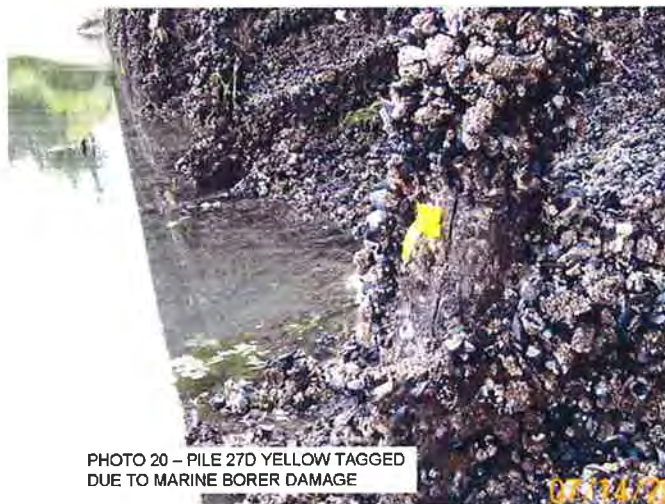
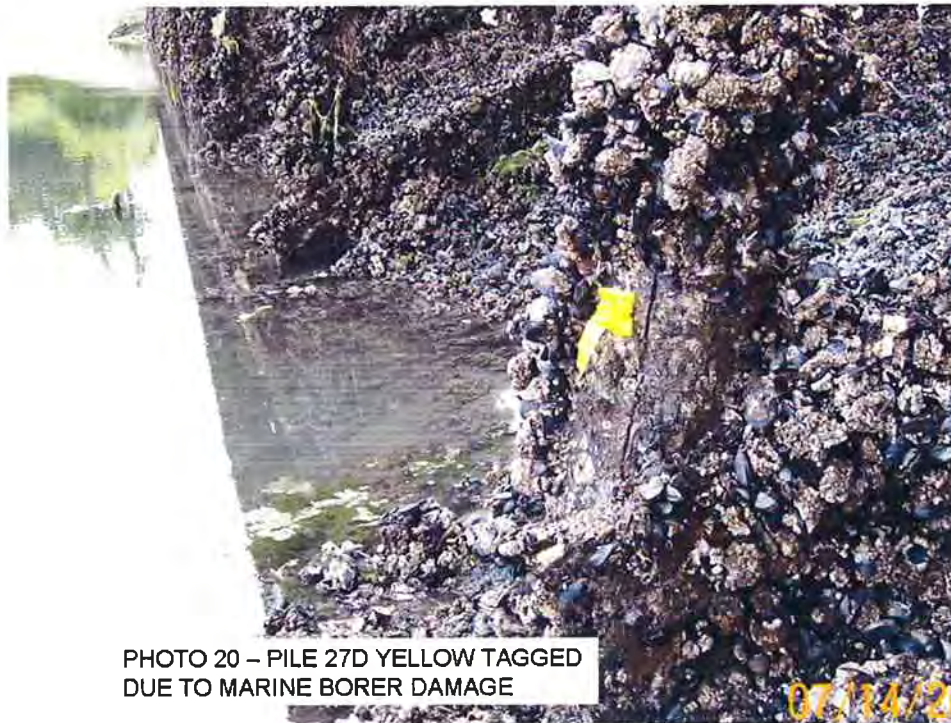
PHOTO 20 – PILE 27D YELLOW TAGGED
DUE TO MARINE BORER DAMAGE

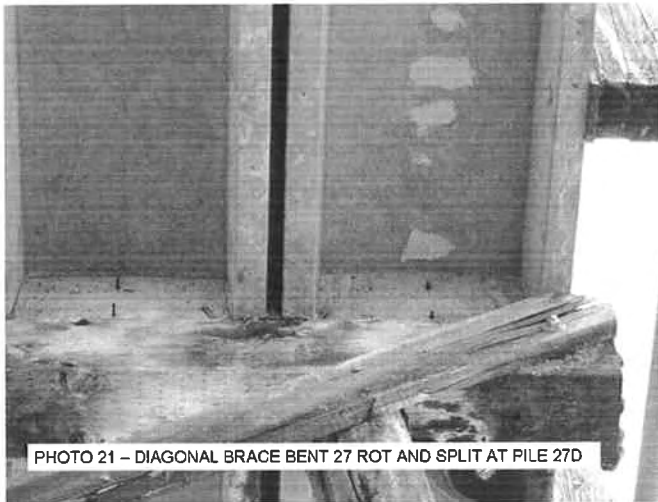
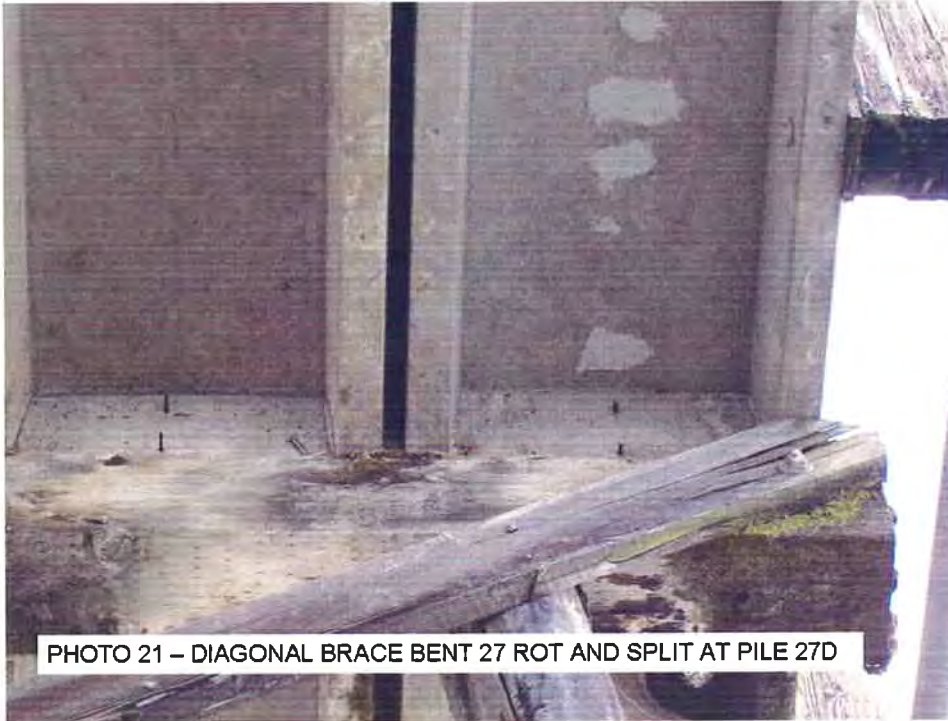
Most of the bracing members are in fair condition with a few members exhibiting varying degrees of rot at the ends of the members. This is particularly true at the upper ends of the diagonals. See Photo 21.

PHOTO 21 – DIAGONAL BRACE BENT 27 ROT AND SPLIT AT PILE 27D

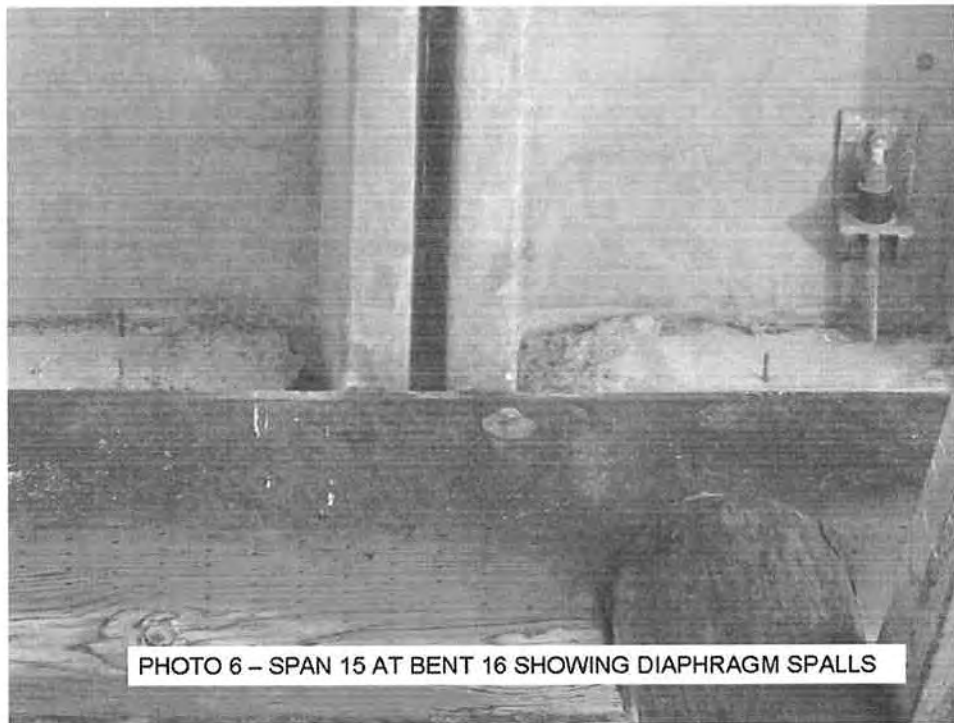
PHOTO 6 – SPAN 15 AT BENT 16 SHOWING DIAPHRAGM SPALLS

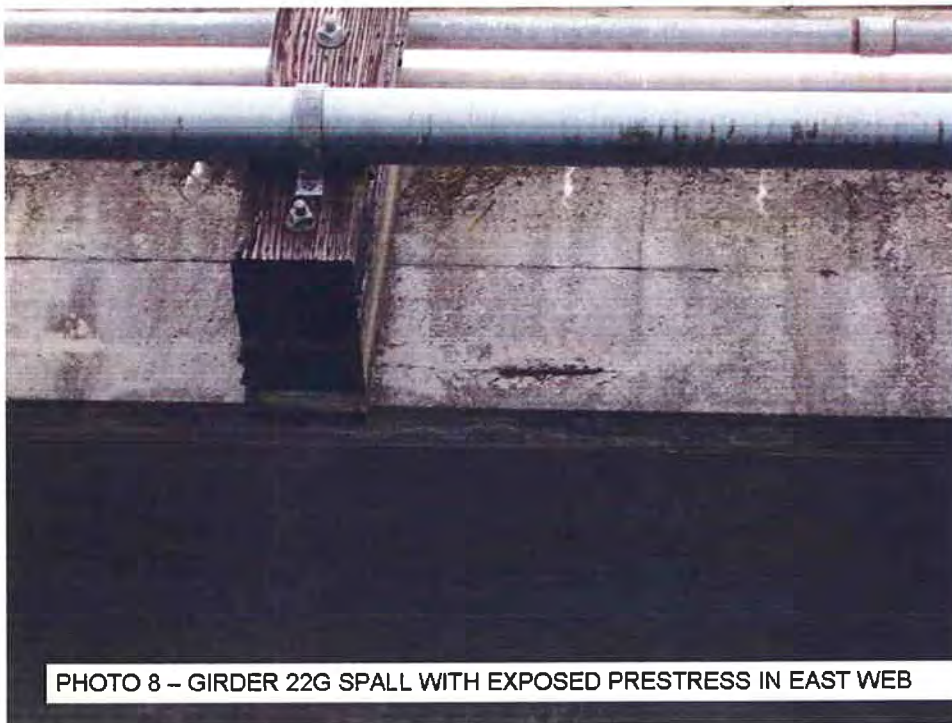
PHOTO 8 – GIRDER 22G SPALL WITH EXPOSED PRESTRESS IN EAST WEB

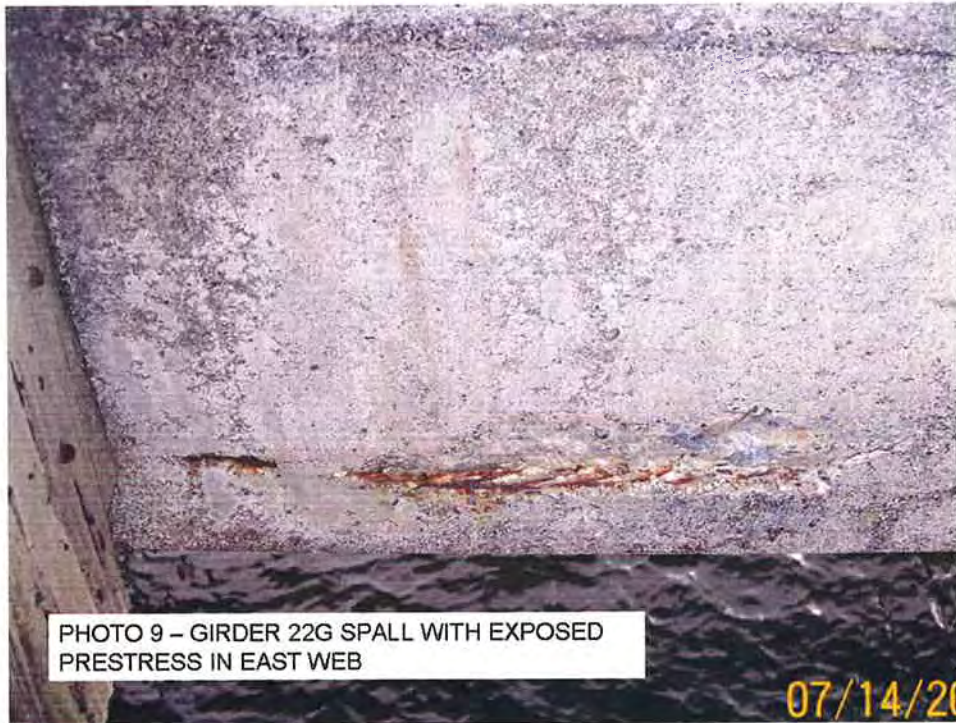
PHOTO 9 – GIRDER 22G SPALL WITH EXPOSED PRESTRESS IN EAST WEB

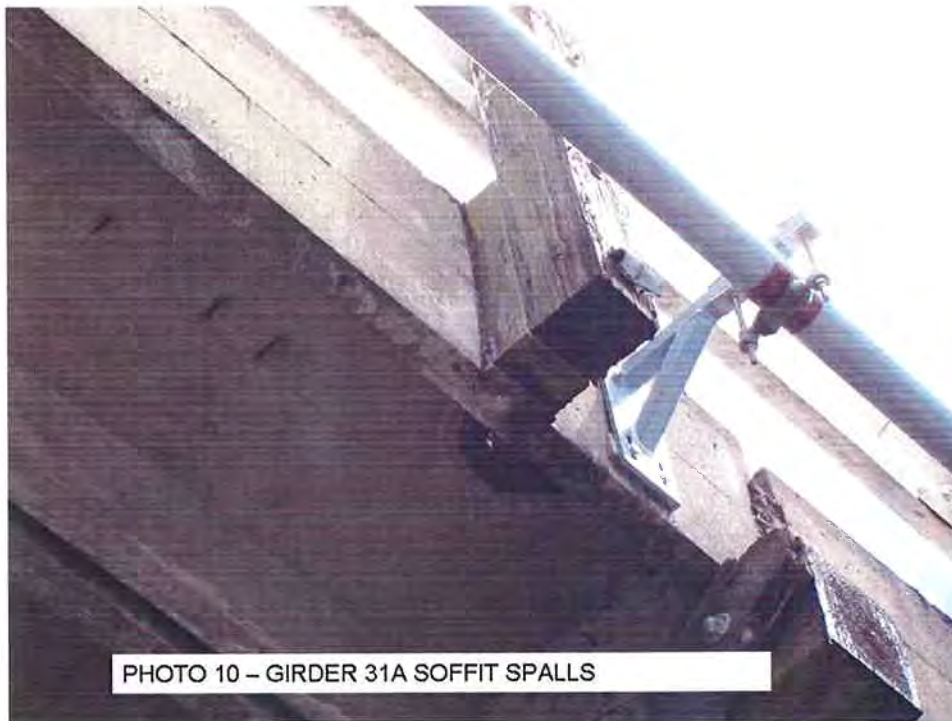
PHOTO 10 – GIRDER 31A SOFFIT SPALLS

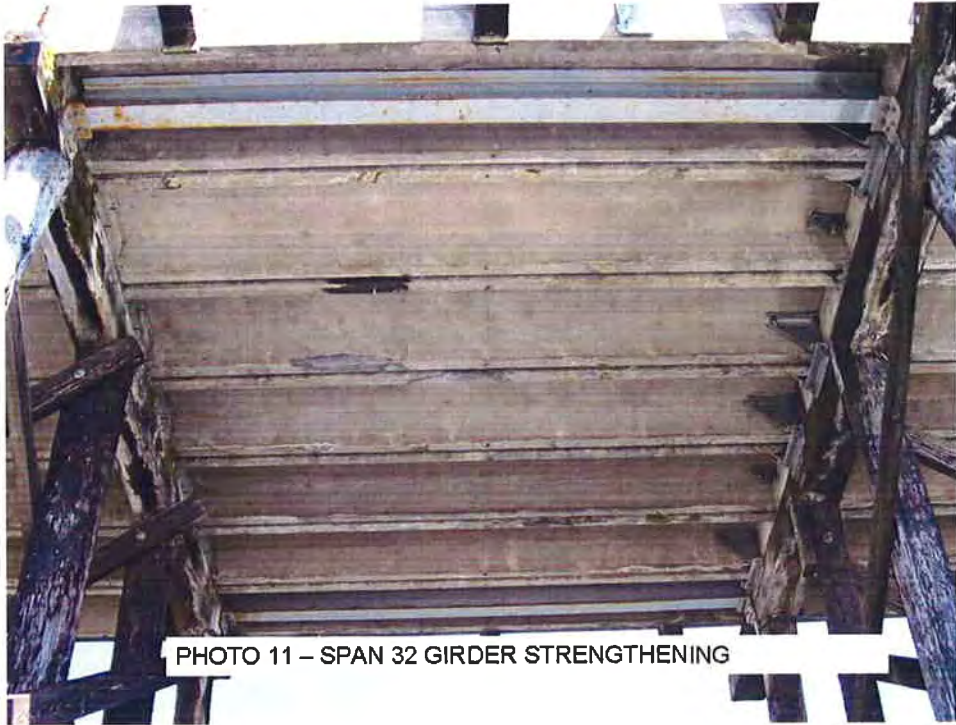
PHOTO 11 – SPAN 32 GIRDER STRENGTHENING

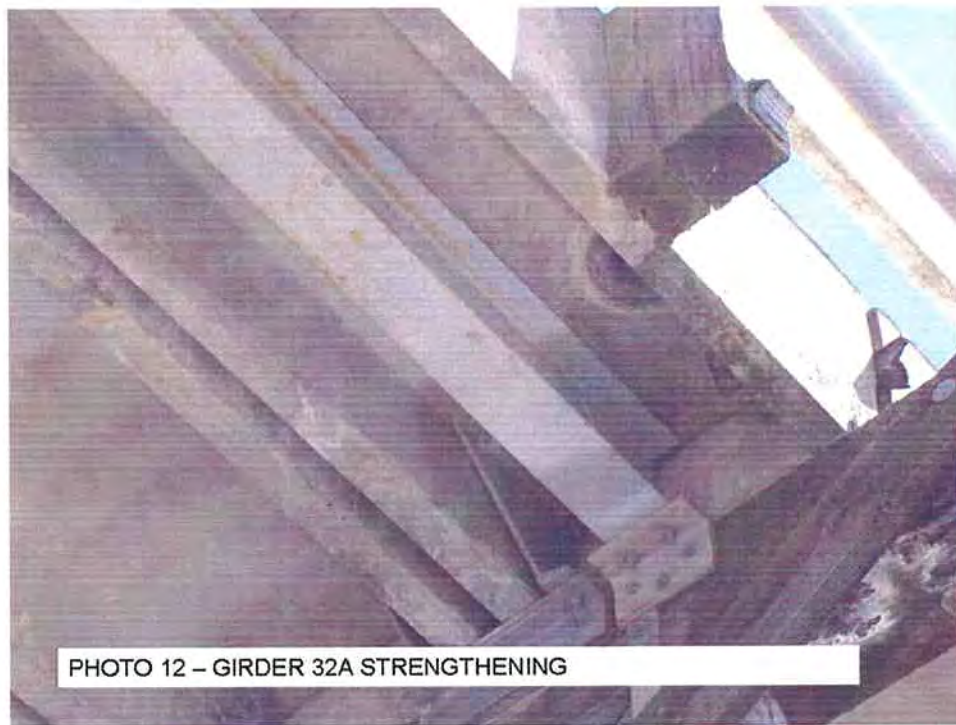
PHOTO 12 – GIRDER 32A STRENGTHENING

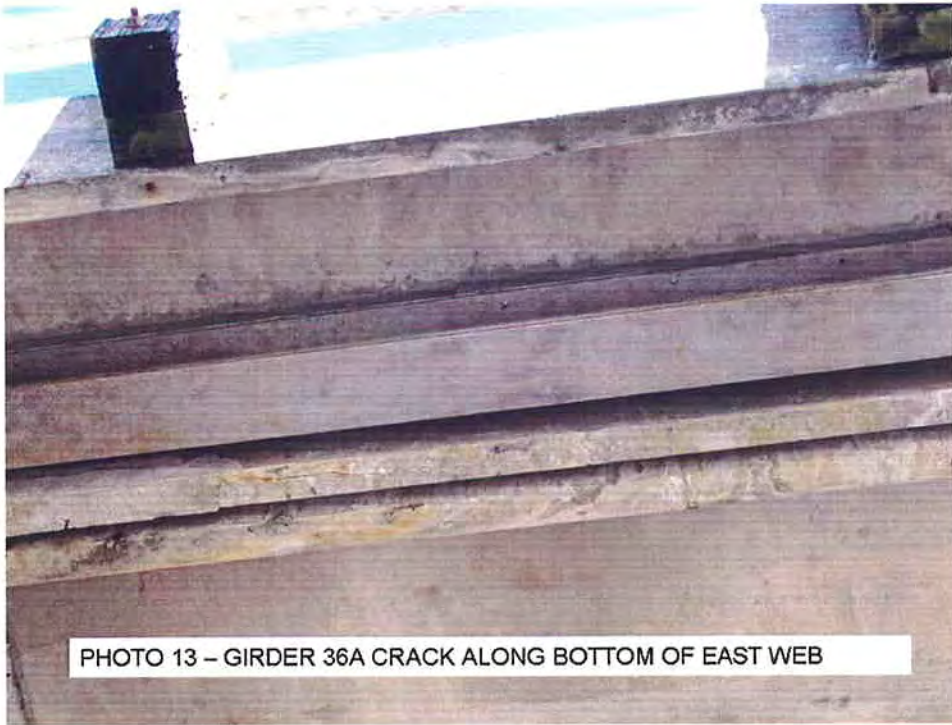
PHOTO 13 – GIRDER 36A CRACK ALONG BOTTOM OF EAST WEB

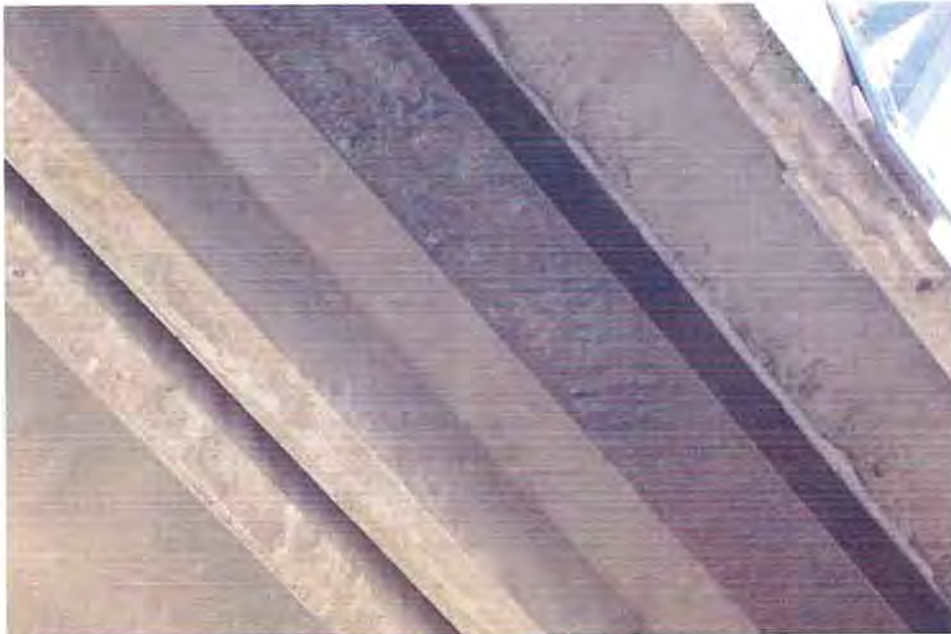
PHOTO 15 – GIRDER 42A RUST INHIBITOR PAINT ON STRENGTHENING BEAM

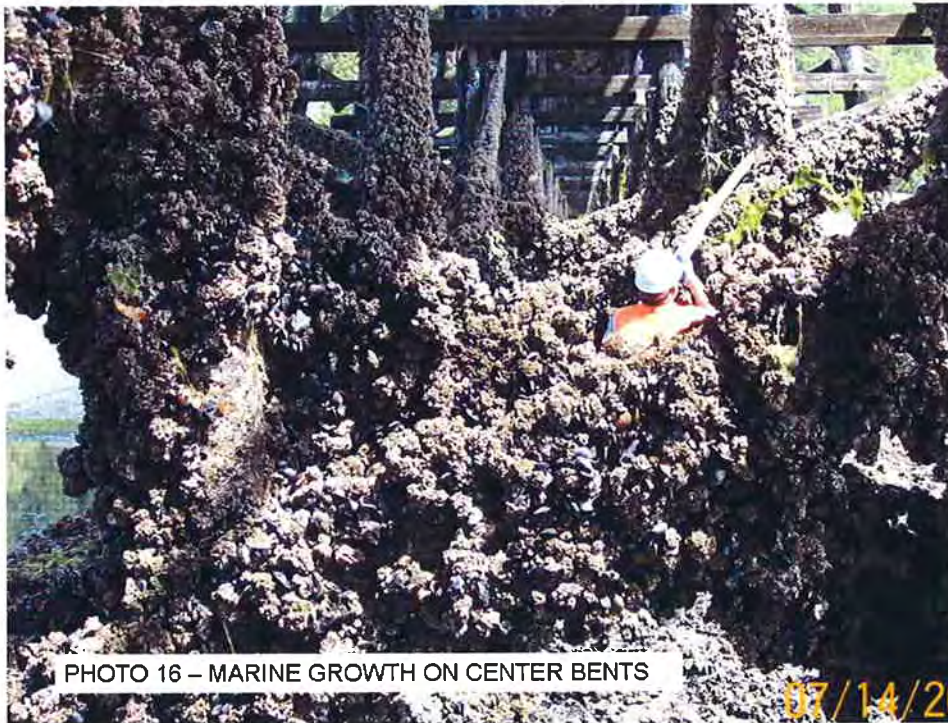
PHOTO 16 – MARINE GROWTH ON CENTER BENTS

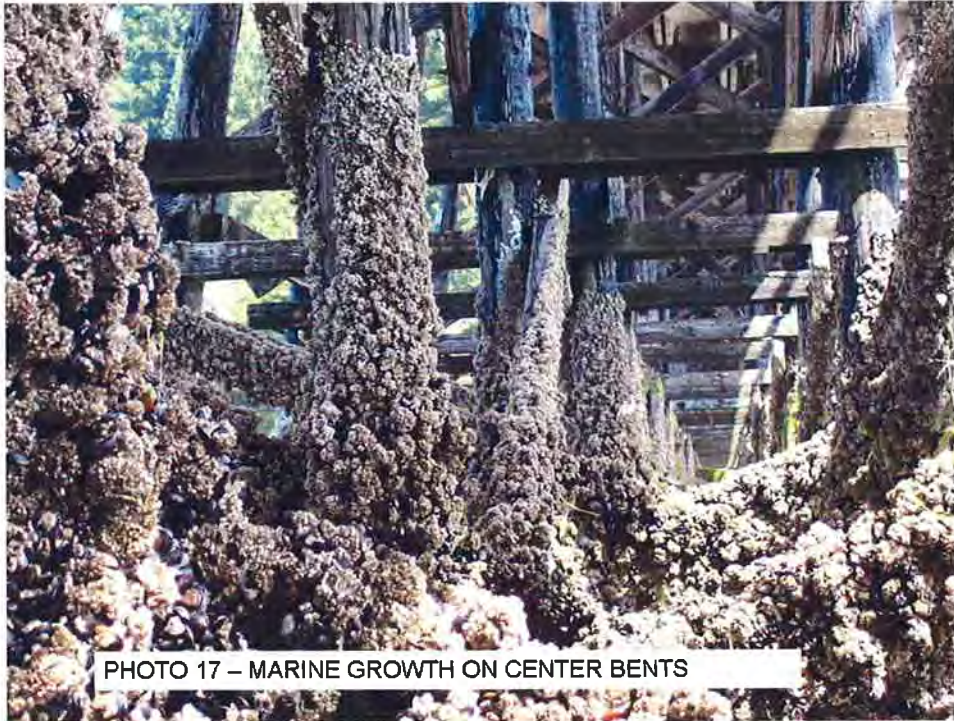
PHOTO 17 – MARINE GROWTH ON CENTER BENTS

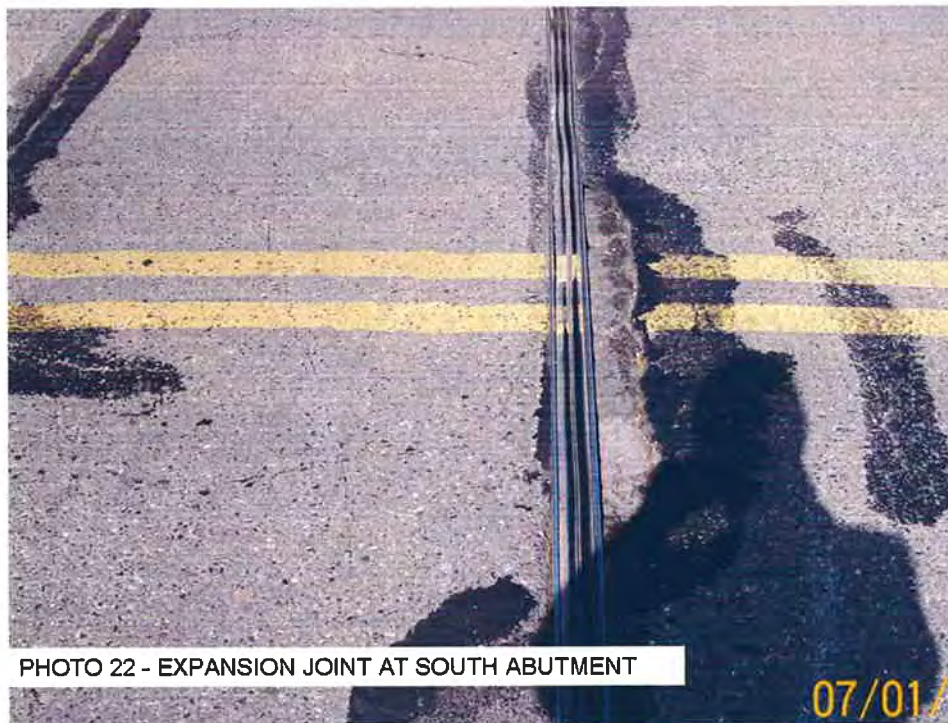
The asphalt overlay at the south abutment expansion joint has not been patched. This has resulted in continued loosening of the steel armor at the compression seal joint.

PHOTO 22 - EXPANSION JOINT AT SOUTH ABUTMENT

This is not a significant structural concern. However, the repair to the asphalt should be conducted within one year to avoid further damage to the joints, and the bracing should be monitored at the next inspection.
