Raft Island Improvement Association

**2008 ANNUAL BRIDGE INSPECTION
REPORT
FOR RAFT ISLAND BRIDGE**

Pierce County, Washington

September 2008

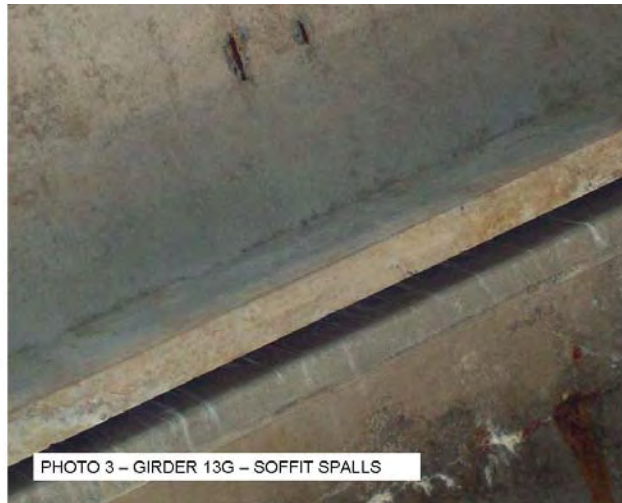
PHOTO 3 – GIRDER 13G – SOFFIT SPALLS

13	Girder A has two spalls with exposed rebar 4" and 2" long and two 4" delaminations (2008). Girder F has a 5' long rust stained leaching crack. Girder G has two spalls with exposed rebar 4" and 2" long and two 4" delaminations. Photo 3. (2008). Moisture, efflorescence and rust stains present at various locations along the bottom edge of the webs.
14	Girder F has hairline leaching cracking along soffit. Moisture and some efflorescence is present along the bottom edge of the webs at various locations.
15	The girder diaphragms at the North end over Bent 16 have poor concrete consolidation along the top and sides with some spalling. The diaphragms are cracked and displaced. This is not a new development as the condition existed in the photos from 2006. Longitudinal restrainers are present at this bent. Photo 4. (2008). Moisture, efflorescence and rust stains present at various locations along the bottom edge of the webs.

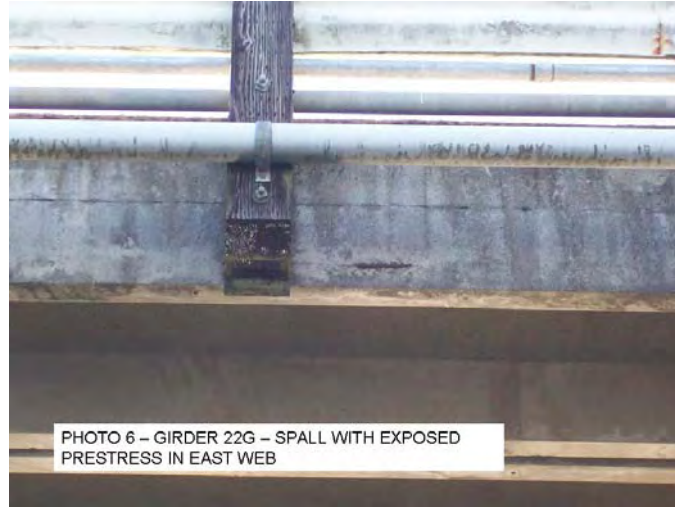
PHOTO 6 – GIRDER 22G – SPALL WITH EXPOSED PRESTRESS IN EAST WEB

21	Girder A has epoxy patches along soffit centerline. Efflorescence present at various locations along the bottom edge of the webs.
22	Girder A has epoxy patches along bottom west web. Girder G East web has two shallow spalls 8" long and 6" long with exposed prestress strands.(No change 2008). Photo 6. Efflorescence present at various locations along the bottom edge of the webs.

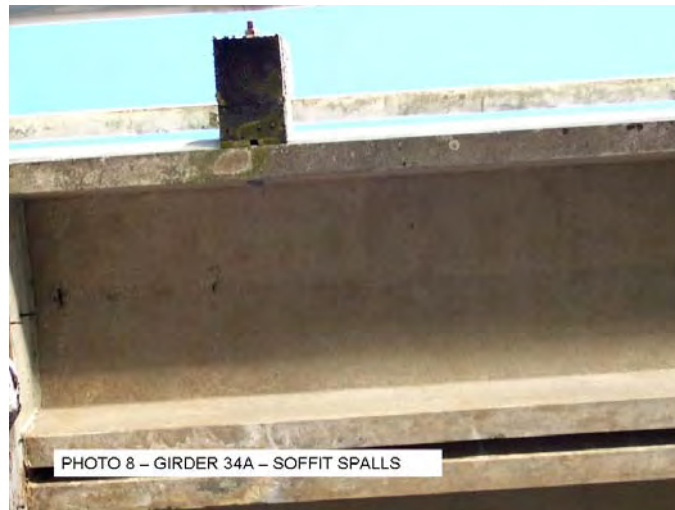
PHOTO 8 – GIRDER 34A – SOFFIT SPALLS

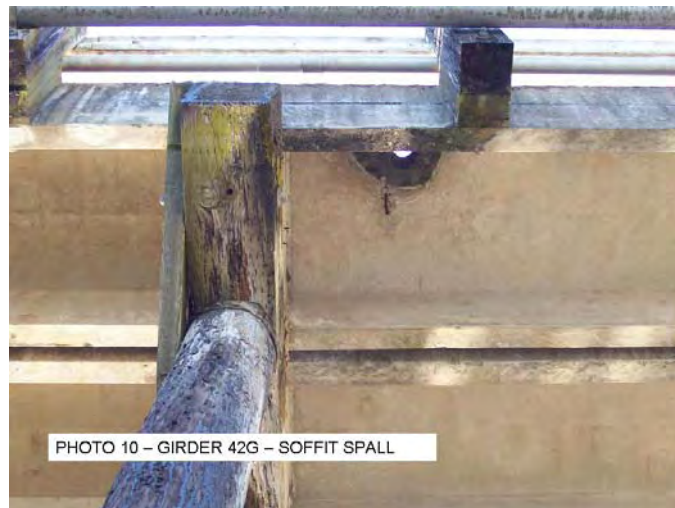
PHOTO 10 – GIRDER 42G – SOFFIT SPALL

42	The west web of Girder A has been patched. There is a steel girder under the soffit of Girder A to strengthen the girder. The girder appears to be coated with a rust inhibitor paint. Girder G has a spall in the soffit near the drain with 5" of exposed rebar. Photo 10 (2008). Moisture, efflorescence and rust stains present at various locations along the bottom edge of the webs.
43	Girder G west web has a 6" x 3" x 1" deep spall. Moisture, efflorescence and rust stains present at various locations along the bottom edge of the webs.
44	Girder A spalls identified in 2007 have been patched. (2008). Girder A has epoxy patches along soffit centerline. Moisture and some efflorescence is present along the bottom edge of the webs at various locations.
45	Girder A has epoxy patches along soffit centerline. The west web of Girder D has been patched. Moisture, efflorescence and rust stains present at various locations along the bottom edge of the webs.

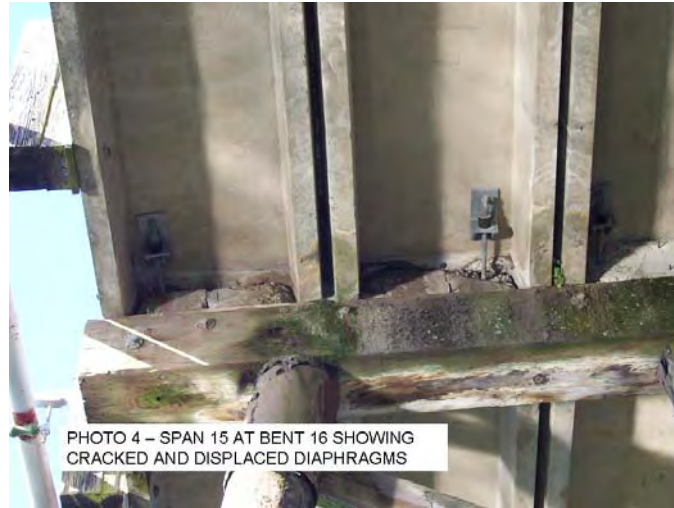
During the 2007 inspection it was noted that the diaphragms at the north end of span 15 at bent 16 were spalling with poor concrete consolidation along the top. In 2008 closer examination revealed that the diaphragms were cracked and displaced. **See photo 4 below.** The location is over an interior pier where there is an expansion joint and longitudinal restrainers. This prompted a closer inspection of pier 32 at the location of the other interior expansion joint. It was found that the diaphragms had been removed from the north end of span 31. **See photo 7 below.**

PHOTO 4 – SPAN 15 AT BENT 16 SHOWING
CRACKED AND DISPLACED DIAPHRAGMS

During the 2007 inspection it was noted that the diaphragms at the north end of span 15 at bent 16 were spalling. In 2008 closer examination revealed that the diaphragms were cracked and displaced. The location is at an interior pier where there is an expansion joint and longitudinal restrainers. This prompted a closer inspection of pier 32 at the location of the other interior expansion joint. It was found that the diaphragms had been removed from the north end of span 31. These diaphragms act as edge support for the deck under the expansion joints. The damaged and missing diaphragms could be part of the cause of the loose expansion joints at these locations.

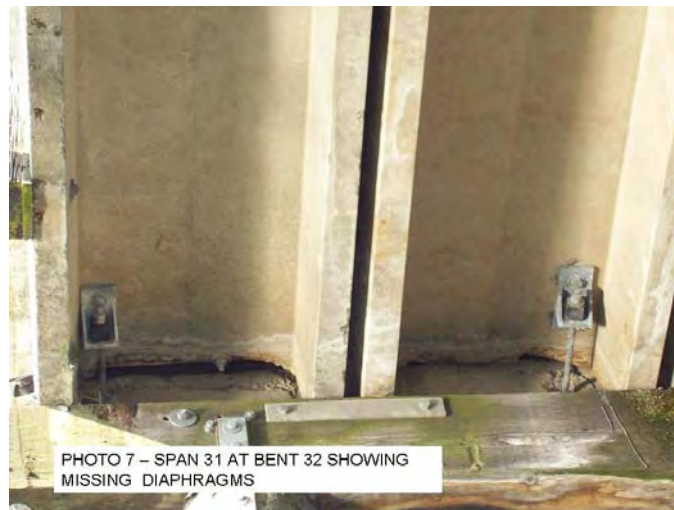
PHOTO 7 – SPAN 31 AT BENT 32 SHOWING
MISSING DIAPHRAGMS

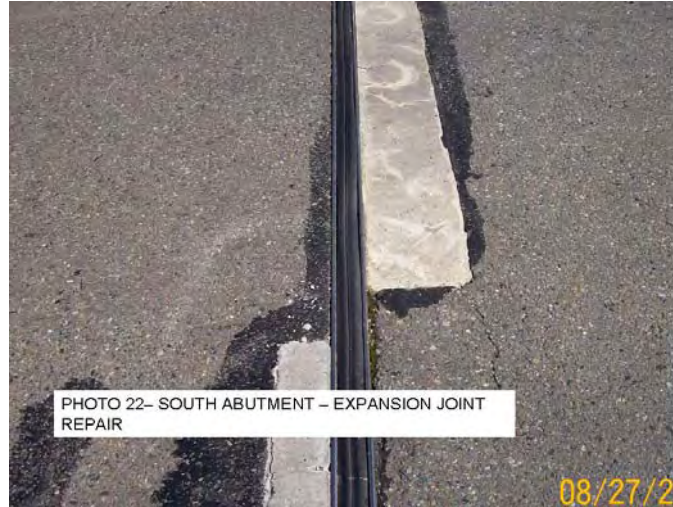
The expansion joint at the south abutment is an armored compression seal. The opening measured 2¼” between the steel armor at a temperature of 80 degrees. There are new concrete repair patches at centerline and in the northbound lane. The patch at centerline measures 4” wide x 52” long and is cracked and loose. **See photo 22 below.**

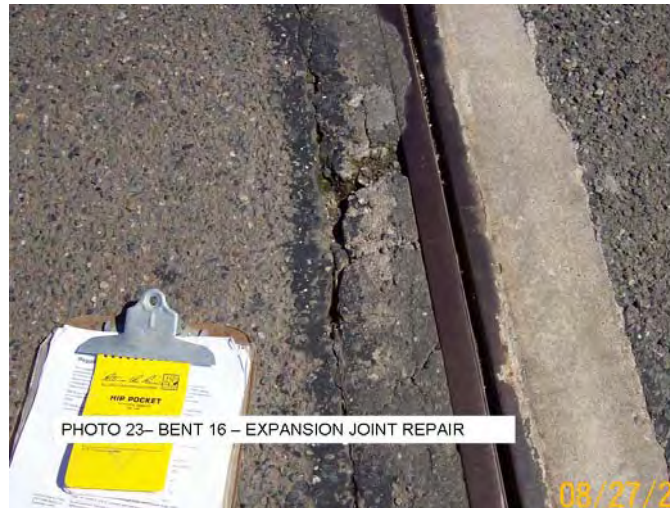
The expansion joints at bents 16 and 32 are strip seals with a measured opening of approximately $\frac{1}{2}$ " between the steel extrusions at a temperature of 80 degrees. At bent 16 there is a new concrete repair patch on the south side of the joint. **See photo 23 below.**

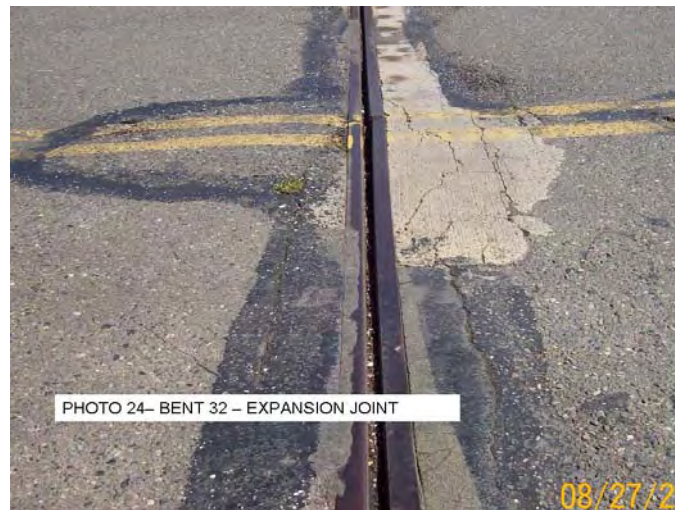
At bent 32 there is an old concrete patch at centerline that is cracked and starting to break up. **See photo 24 below.**

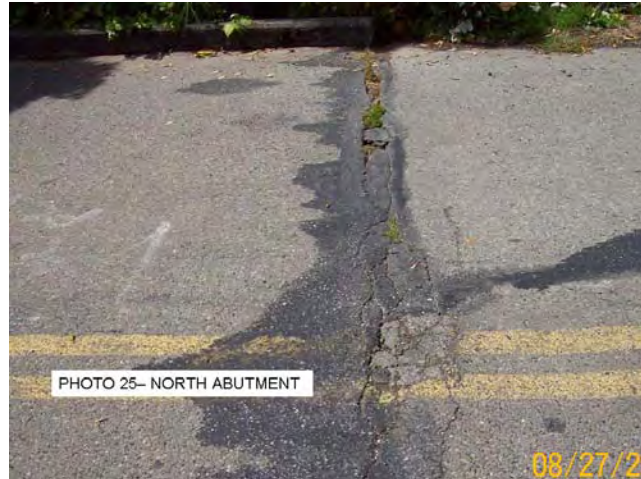
At the north abutment there is cracking full width with some smaller “D” cracking. **See photo 25 below.** It is anticipated that this cracking will worsen as the rotten timber cap deteriorates.

The south approach has several patches but is not causing traffic to impact the bridge. The north approach has several large patches and is approximately $\frac{3}{4}$ ” higher than the bridge, which is causing moderate impact to the bridge. **See photo 25 below.**

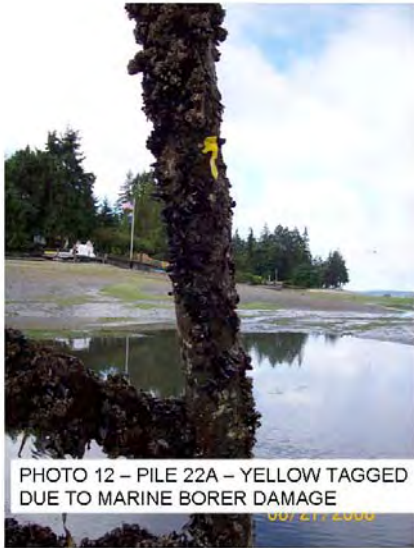
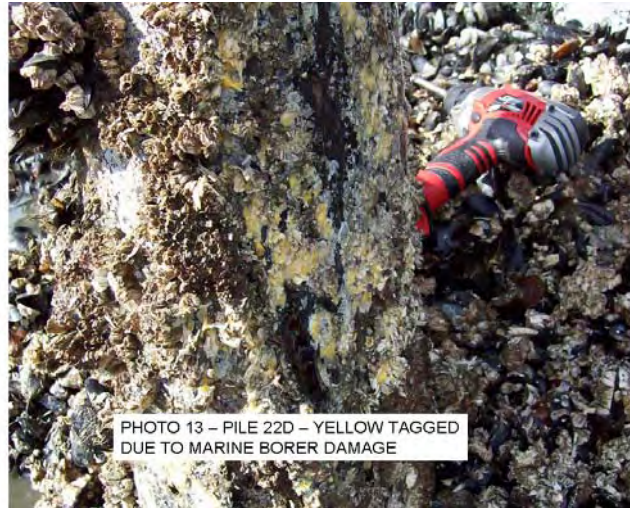
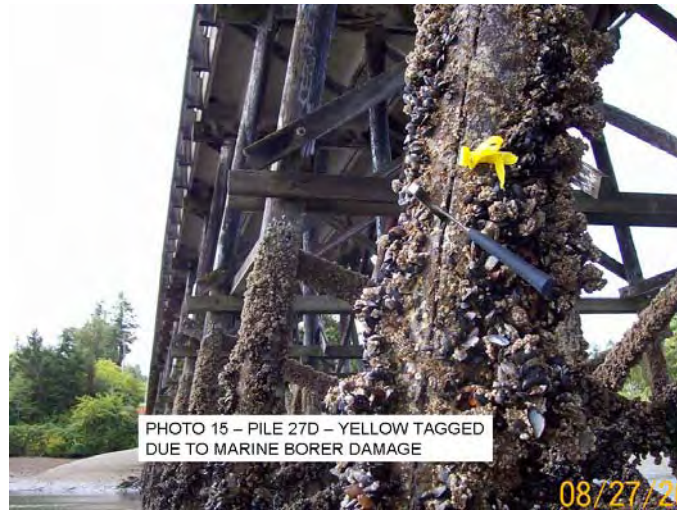
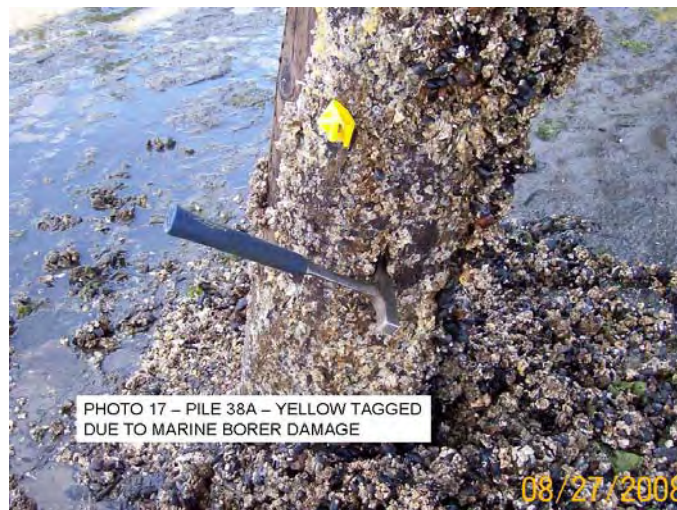
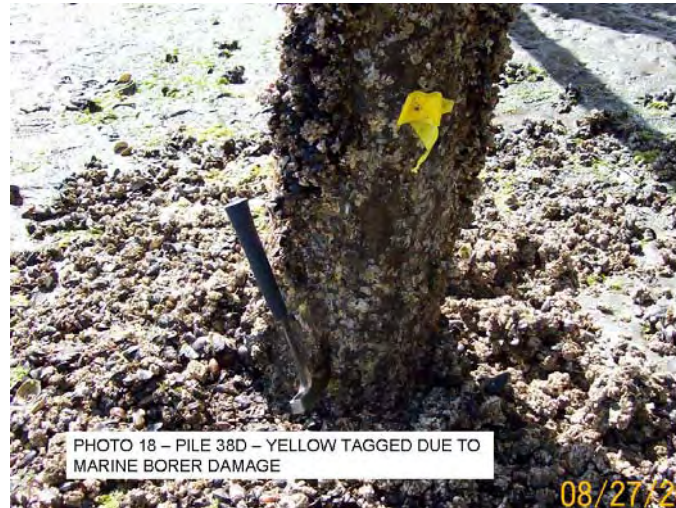
The sounding results indicated some audible signs of rot and marine borer damage at six piles. At piles 8D, 22A, 22D, 27D, 38A and 38D, holes from marine borers were found. Pile 22D also has a surface rot pocket 12" high x 3" wide x 1" deep at the ground line and a small pocket of center rot. These piles were YELLOW TAGGED with flagging indicating that they should be MONITORED for additional damage during the next inspection. **See photos 12, 13, 15, 17 and 18 below.**

Future inspections should include cleaning each piling at the ground line and conducting a visual and sounding inspection. In particular the YELLOW TAGGED piles 8D, 22A, 22D, 27D, 38A and 38D should be monitored for damage. Also the YELLOW TAGGED timber cap at the north abutment should be monitored for damage. The bracing with rot should also be monitored for damage.

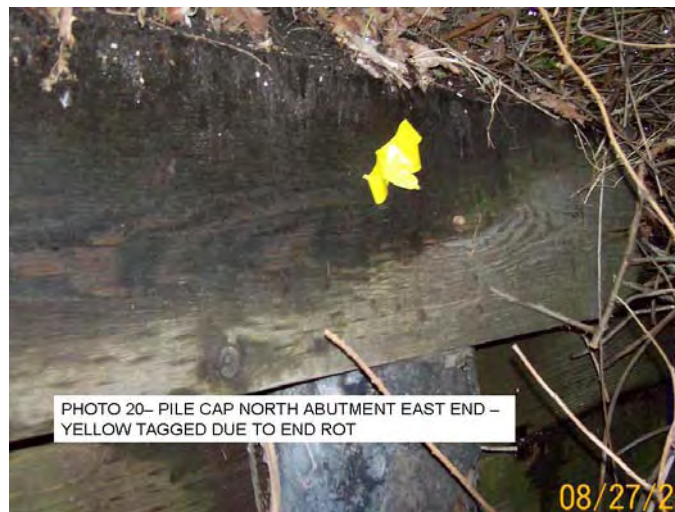
Pile caps were sounded at end bents and a few of the interior bents where timber checks indicated the possibility of rot. The north abutment cap has end rot at the east end. There is a 5" shell over pile 47E and a 2" shell near the end. **See photo 20 below.**

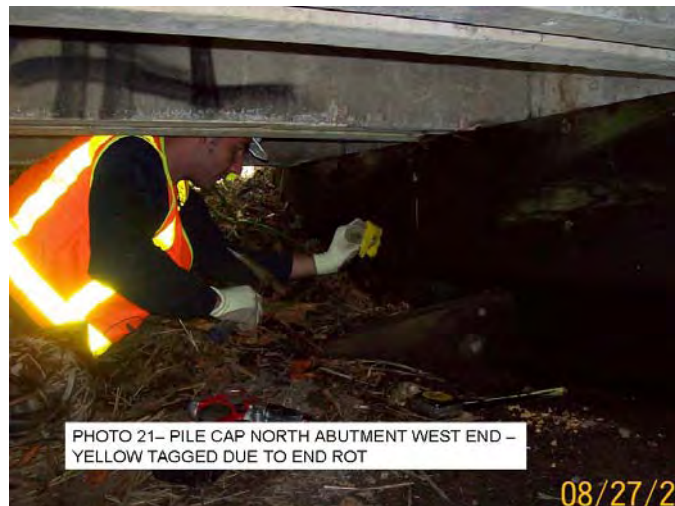
The west end had similar rot with a 5" shell over pile 47A. **See photo 21 below.** The cap was YELLOW TAGGED indicating it should be MONITORED for additional damage during the next inspection.

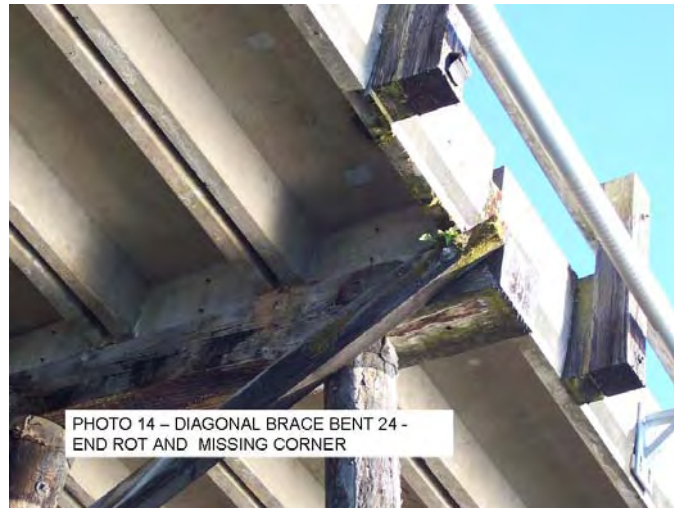
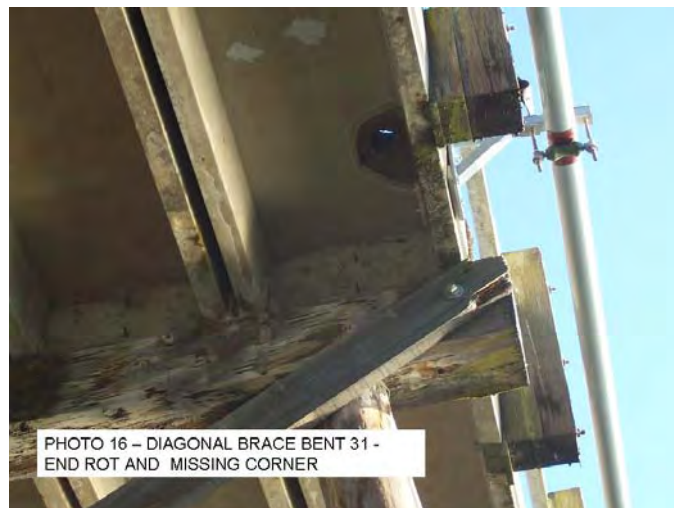
In addition to the timber pile repairs, some lateral bracing had been replaced over the years. Most of the bracing members are in fair condition with a few members exhibiting varying degrees of rot at the ends of the members. This is particularly true at the upper ends of the diagonals. **See photos 14 and 16 below.**

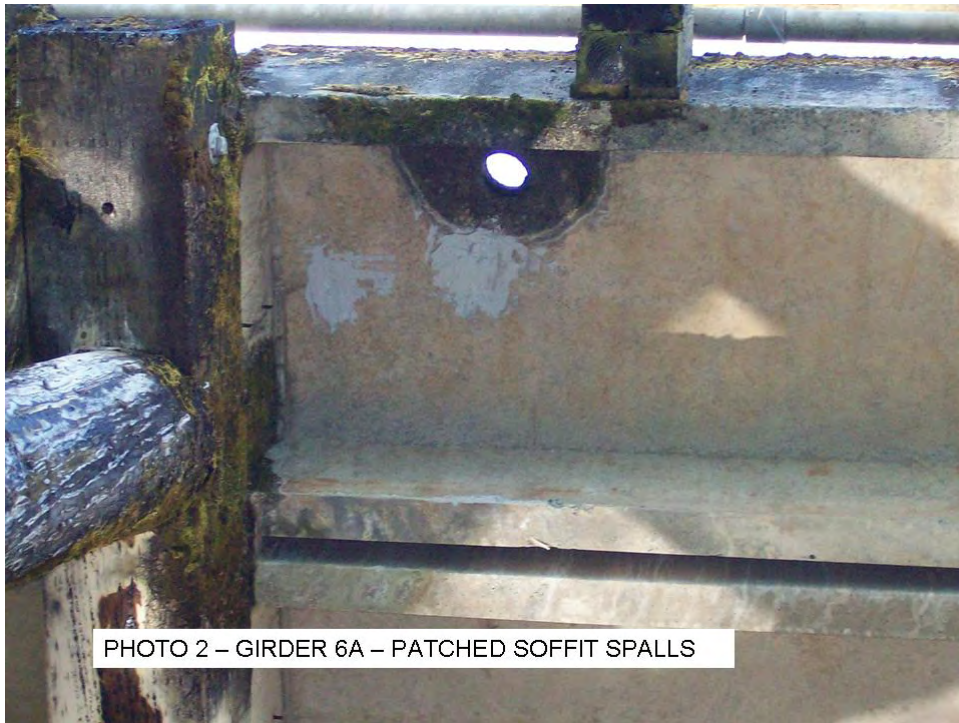
PHOTO 2 – GIRDER 6A – PATCHED SOFFIT SPALLS

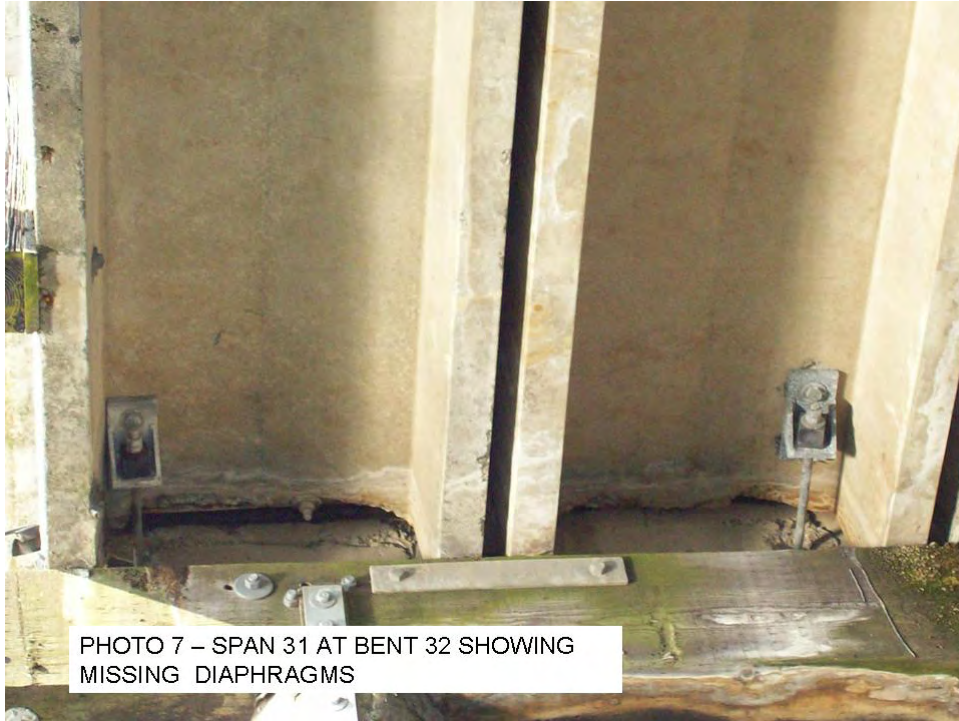
PHOTO 7 – SPAN 31 AT BENT 32 SHOWING MISSING DIAPHRAGMS

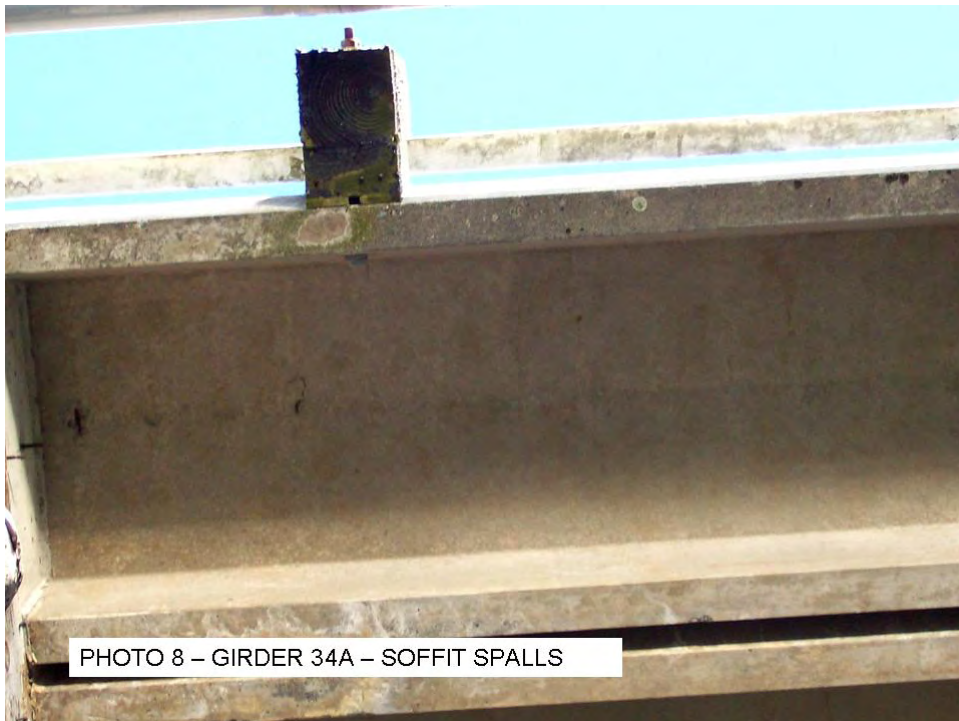
PHOTO 8 – GIRDER 34A – SOFFIT SPALLS

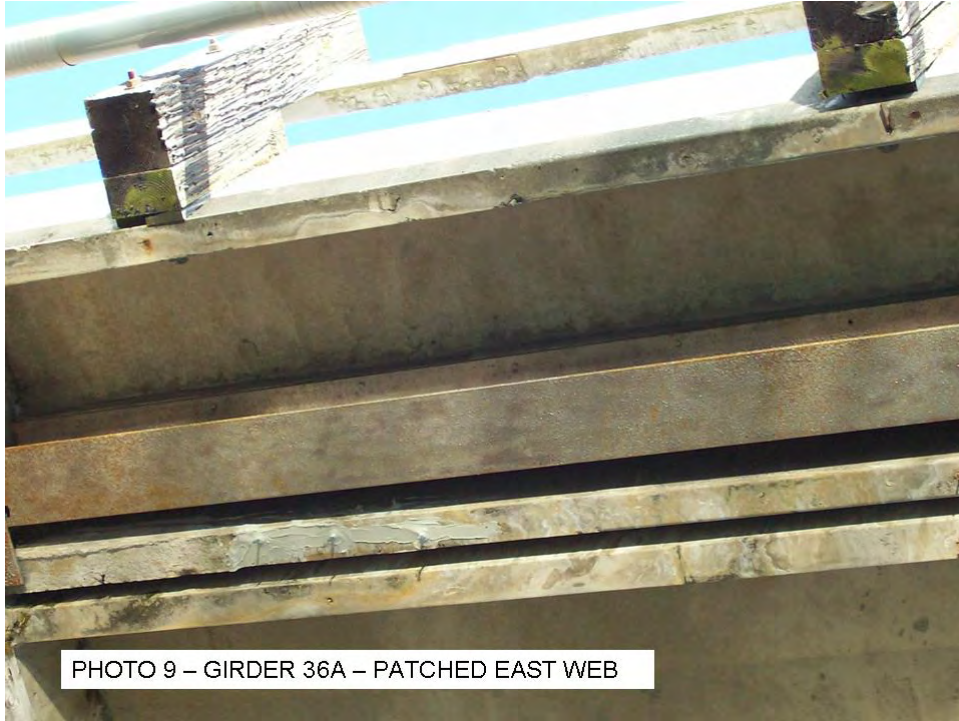
PHOTO 9 – GIRDER 36A – PATCHED EAST WEB

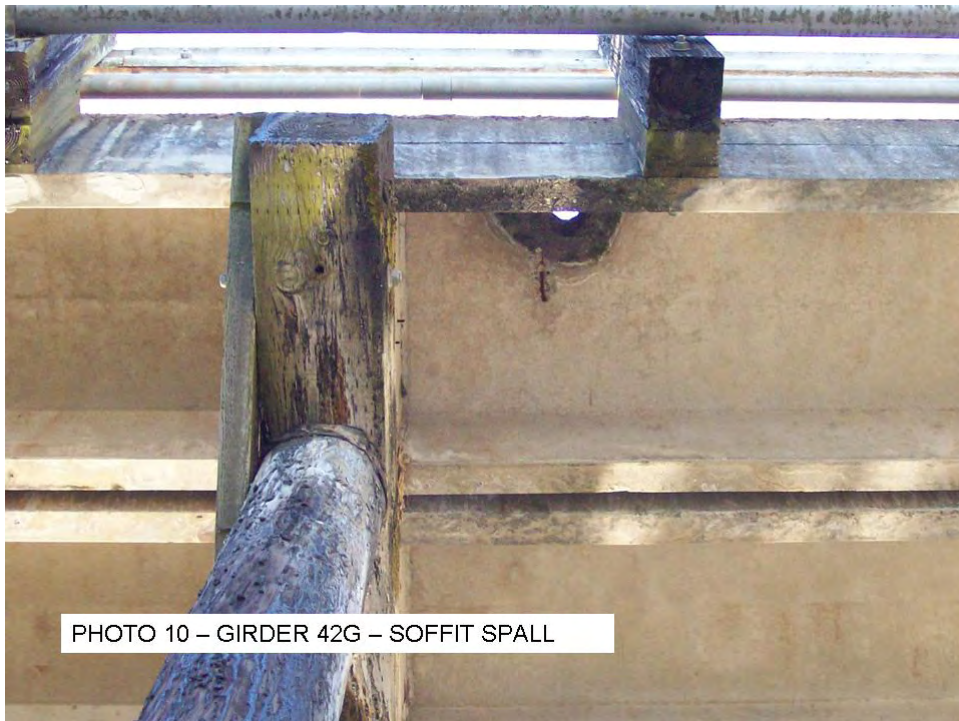
PHOTO 10 – GIRDER 42G – SOFFIT SPALL

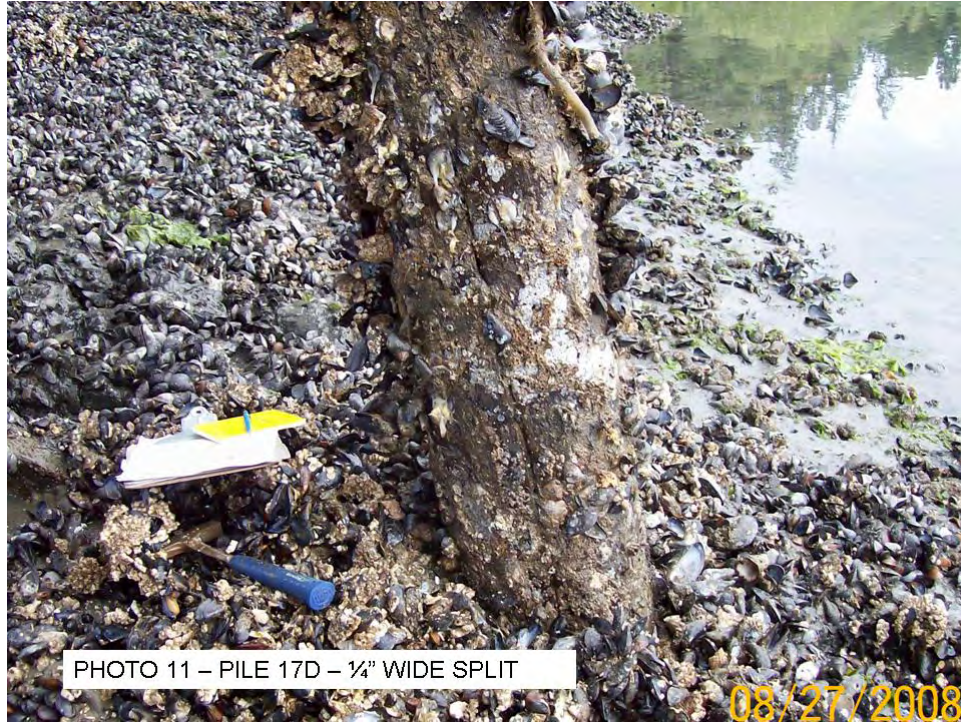
#16	Pile 16A has steel collar at cap connection.
#17	Pile 17D has 1/4" wide split from ground 10' long. No rot found. Photo 11.
#18	Pile 18C has metal strap at cap indicating pile is a replacement.

PHOTO 11 – PILE 17D – ¼" WIDE SPLIT

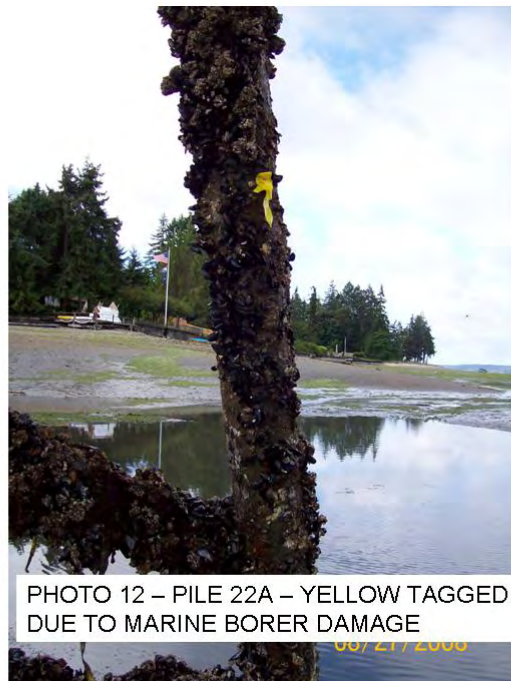
#21	Pile 21A has concrete filled splice at ground line.
#22	Pile 22A has marine borer damage at groundline. Pile was YELLOW TAGGED (2007). Photo 12.
#22	Pile 22D has marine borer damage at groundline. Also surface rot 12" x 3" x 1" deep and minor center rot, less than 1" rot pocket, and a 3" shell. Pile was YELLOW TAGGED (2007). Photo 13.

PHOTO 12 – PILE 22A – YELLOW TAGGED
DUE TO MARINE BORER DAMAGE

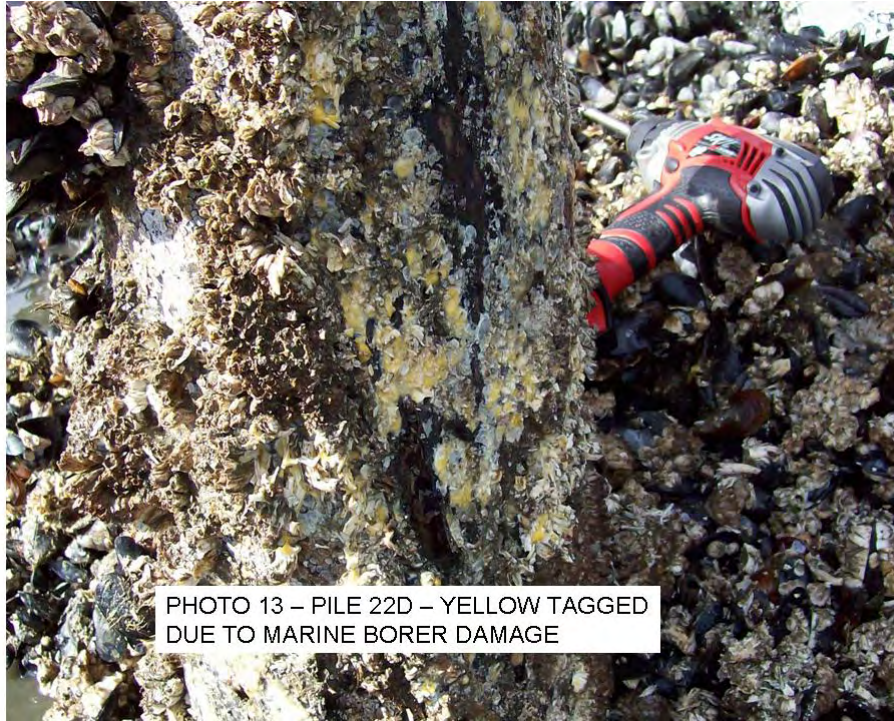
PHOTO 13 – PILE 22D – YELLOW TAGGED
DUE TO MARINE BORER DAMAGE

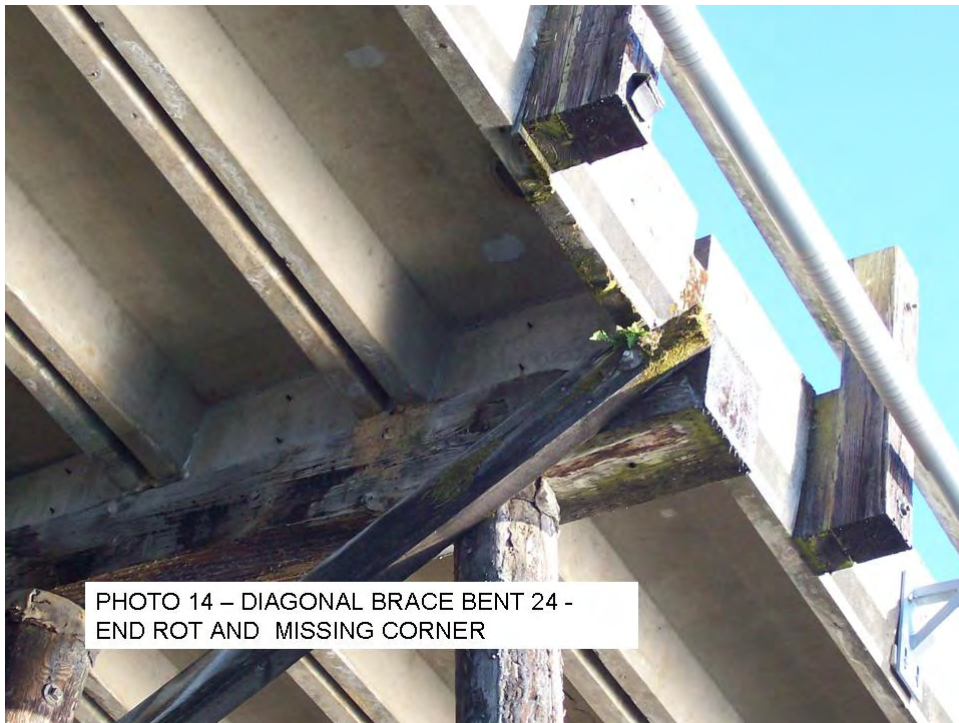
#23	Pile 23A has concrete filled splice at ground line with metal straps at cap.
#24	Pile 24C has 3/16" wide split from ground 15' long. No rot found.
#24	Diagonal brace at top west end has end rot and corner is missing. Photo 14.

PHOTO 14 – DIAGONAL BRACE BENT 24 -
END ROT AND MISSING CORNER

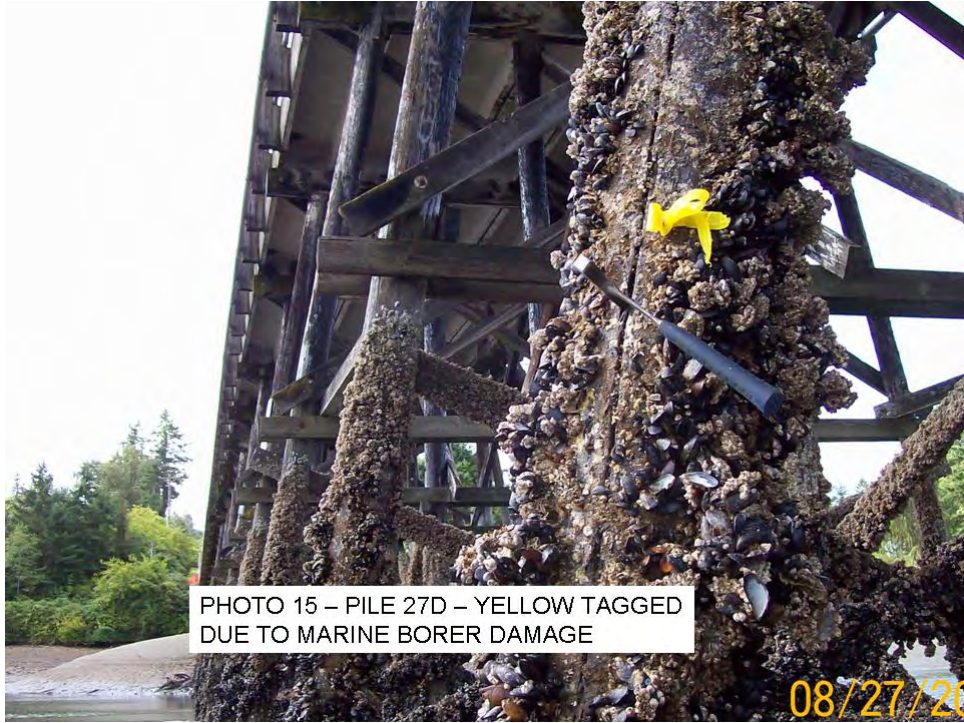
#27	Pile 27D has full height 1/2" wide check. Photo 15. There is marine borer damage at groundline. Pile was YELLOW TAGGED (2007).
#27	Diagonal brace at top east end is split with rot.

PHOTO 15 – PILE 27D – YELLOW TAGGED
DUE TO MARINE BORER DAMAGE

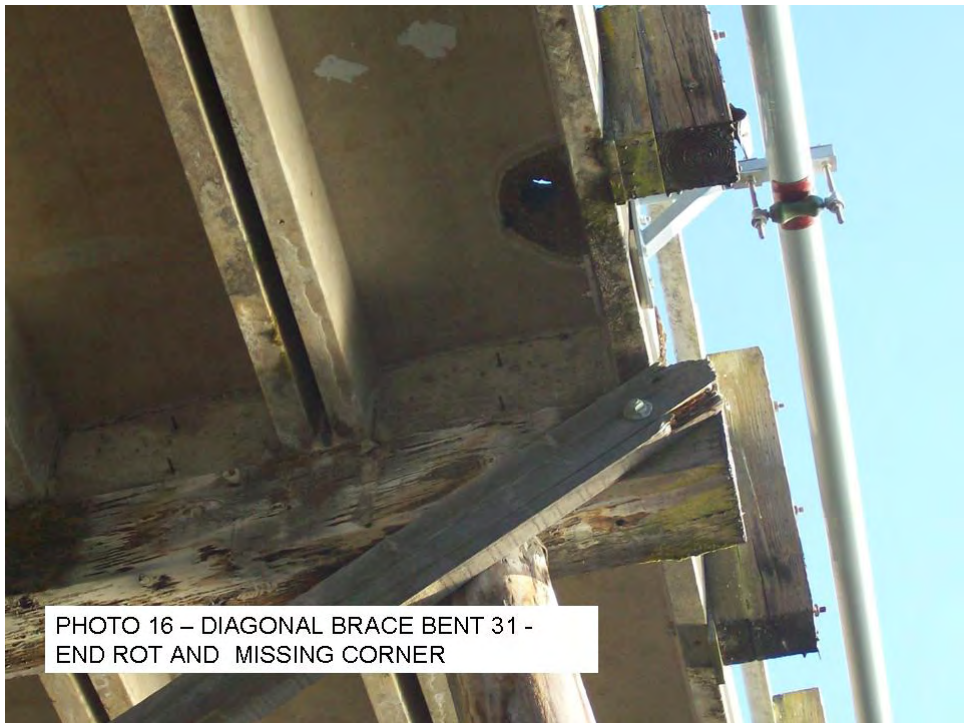
#31	Diagonal brace at top west end has rot. Photo 16.
#32	Pile 32A has metal strap at cap indicating pile is a replacement.
#32	Pile 32B has metal strap at cap indicating pile is a replacement.

PHOTO 16 – DIAGONAL BRACE BENT 31 -
END ROT AND MISSING CORNER

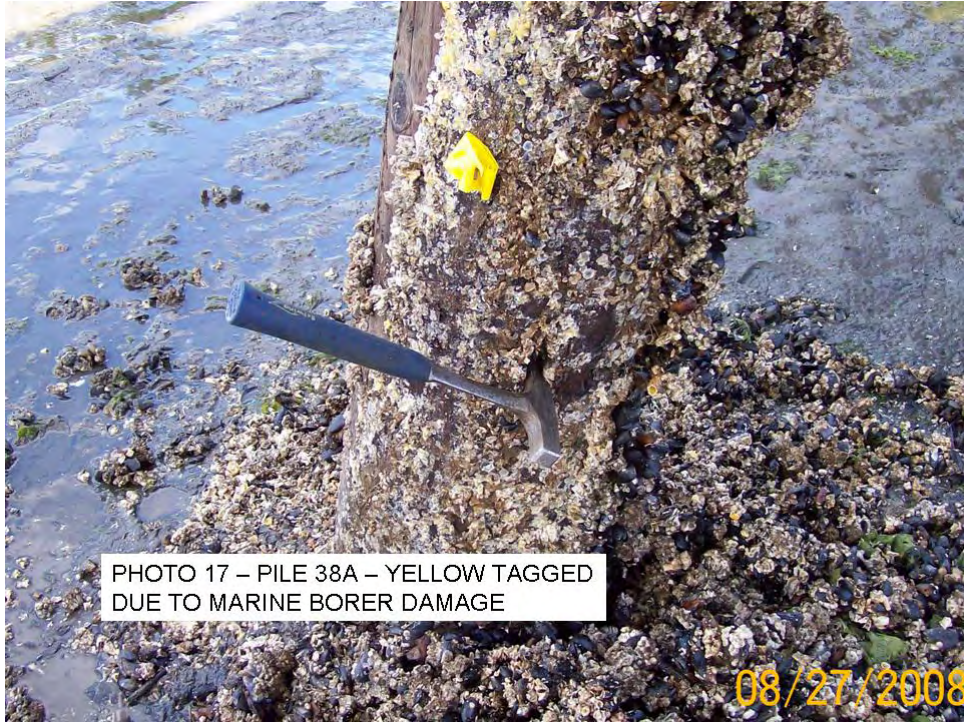
#38	Pile 38A has marine borer damage at groundline. There is a 3" x 1" hole and there is center rot with a 4" shell. Pile was YELLOW TAGGED (2008). Photo 17.

PHOTO 17 – PILE 38A – YELLOW TAGGED DUE TO MARINE BORER DAMAGE

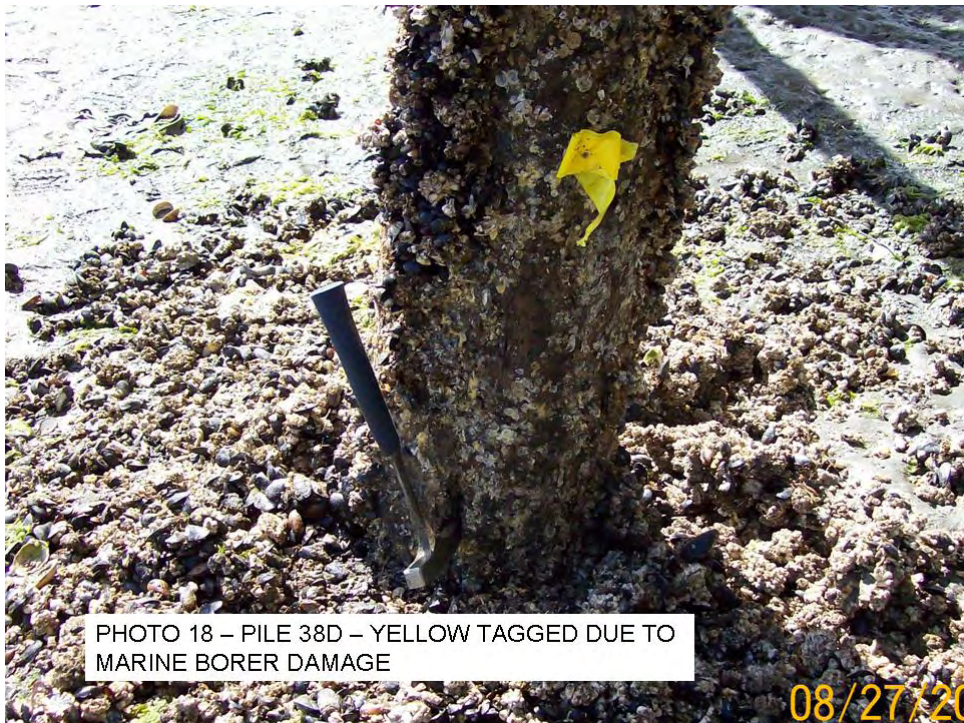
#38	Pile 38D has marine borer damage at groundline. There is a 3" x 1" hole. No rot was found. Pile was YELLOW TAGGED (2008). Photo 18.
#38	Diagonal brace at top west end has end rot.

PHOTO 18 – PILE 38D – YELLOW TAGGED DUE TO MARINE BORER DAMAGE

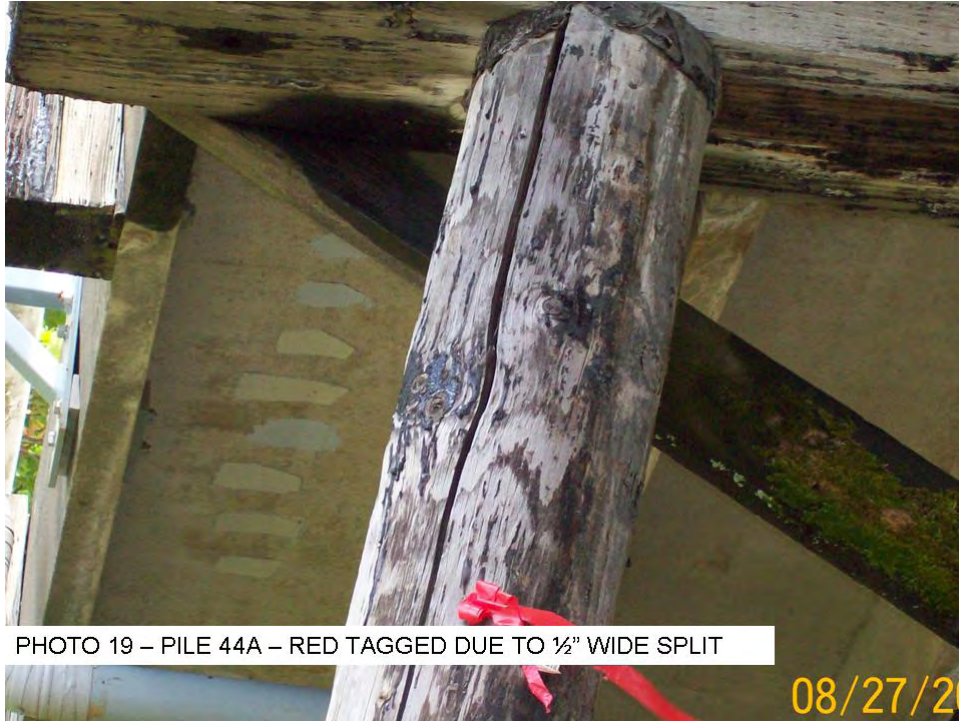
PHOTO 19 – PILE 44A – RED TAGGED DUE TO 1/2" WIDE SPLIT

Raft Island Bridge Repair Recommendations	
Item	Description
Timber pile banding	Bent 44: Pile 44A has a ½" wide split starting at the top extending down 2/3 of the pile length. The split is through the full diameter at the top. A metal band should be installed at the top.
Epoxy Patch Spalls	Span 13: Girder A soffit, two spalls 4" and 2" with exposed rebar Span 13: Girder G soffit, two spalls 4" and 2" with exposed rebar Span 16: Girder A soffit, three 3" diameter spalls with exposed rebar (2007) Span 22: Girder G East web, 8" long and 6" long spalls with exposed prestress (2007) Span 23: Girder B soffit, 12" long shallow spall and delamination along centerline Span 34: Girder A, two spalls with 2" long exposed rebar
Replace Damaged and Missing Concrete Diaphragms	Bent 16 Span 15 Girders: Remove and replace the diaphragms which are cracked and displaced. Bent 32 Span 31 Girders: Replace the missing diaphragms at the bent.

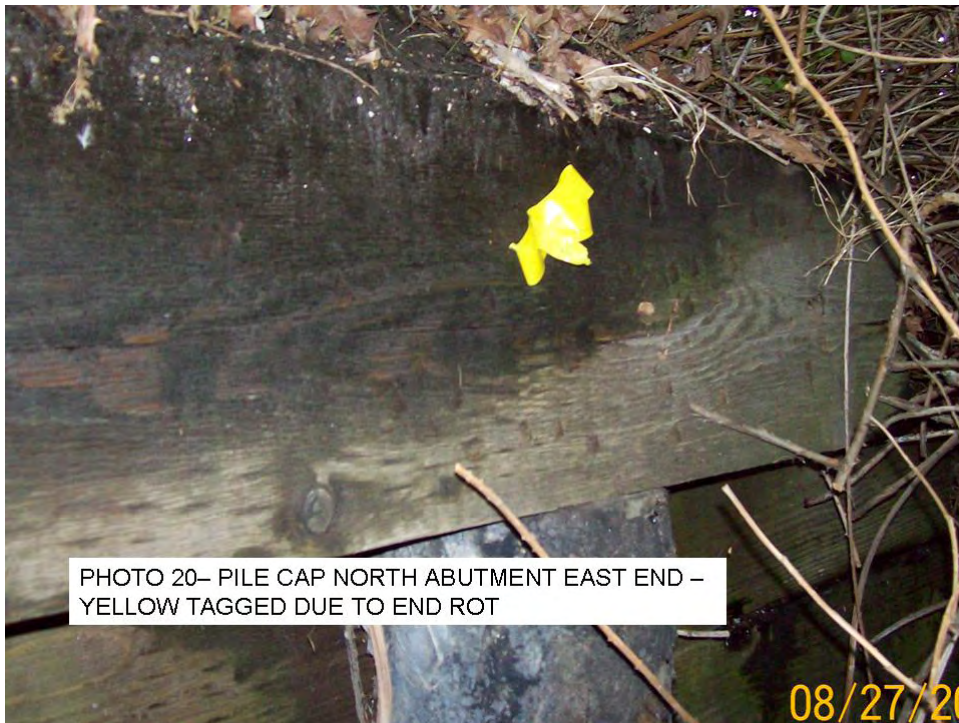
North abutment cap has end rot at east end. There is a 5" shell over Pile 47E and a 2" shell near the end. Photo 20. The west end had similar rot with a 5" shell over Pile 47A. Photo 21. Cap was YELLOW TAGGED (2008).

PHOTO 20– PILE CAP NORTH ABUTMENT EAST END – YELLOW TAGGED DUE TO END ROT

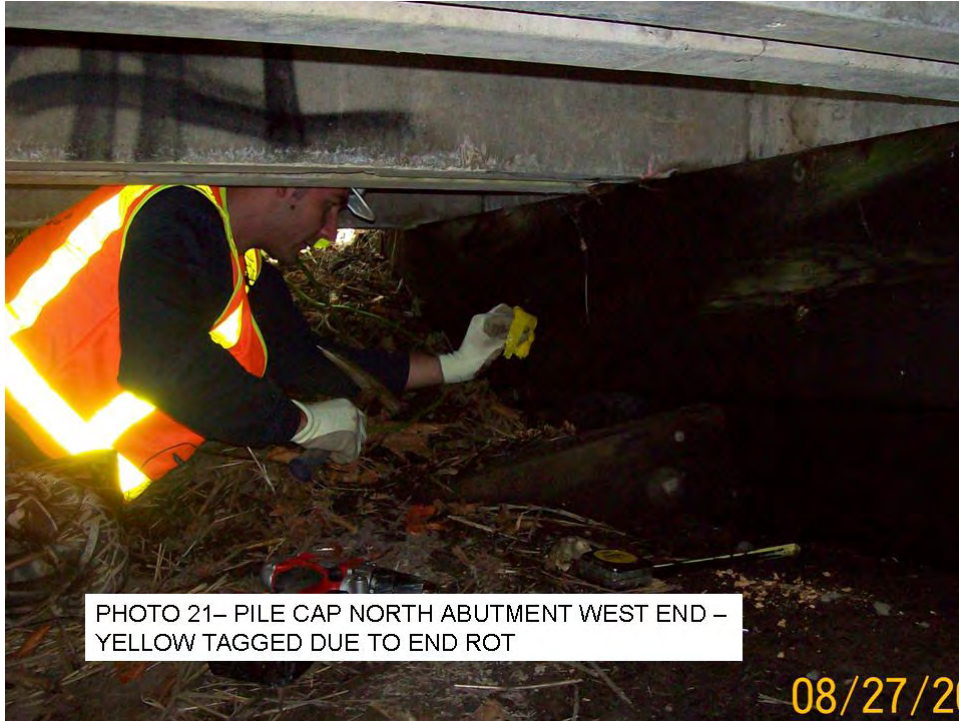
PHOTO 21- PILE CAP NORTH ABUTMENT WEST END - YELLOW TAGGED DUE TO END ROT

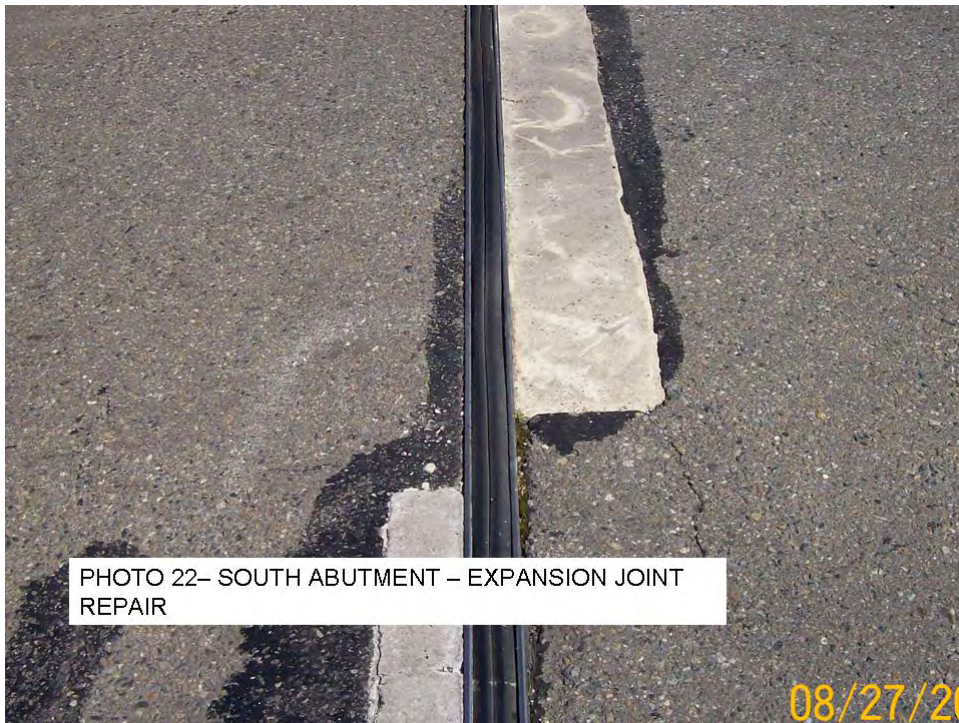
PHOTO 22- SOUTH ABUTMENT - EXPANSION JOINT REPAIR

406 The compression seal header at the south abutment has been repaired. There is new concrete Set 45 at centerline and in the northbound lane on the south side of the joint. The new header at the centerline is cracked and loose.

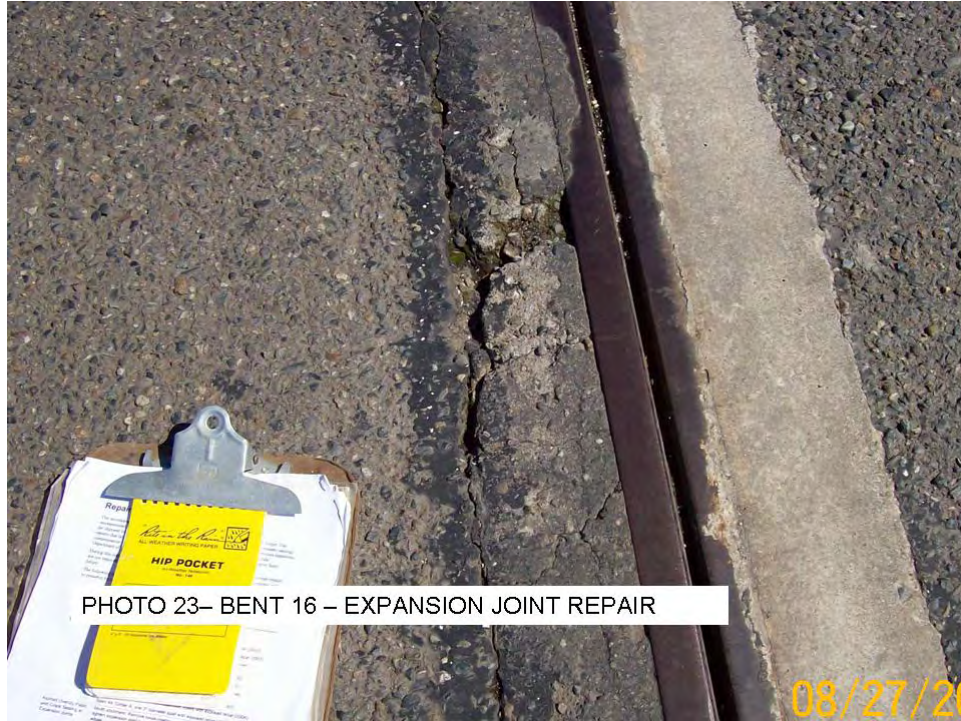
PHOTO 23- BENT 16 - EXPANSION JOINT REPAIR

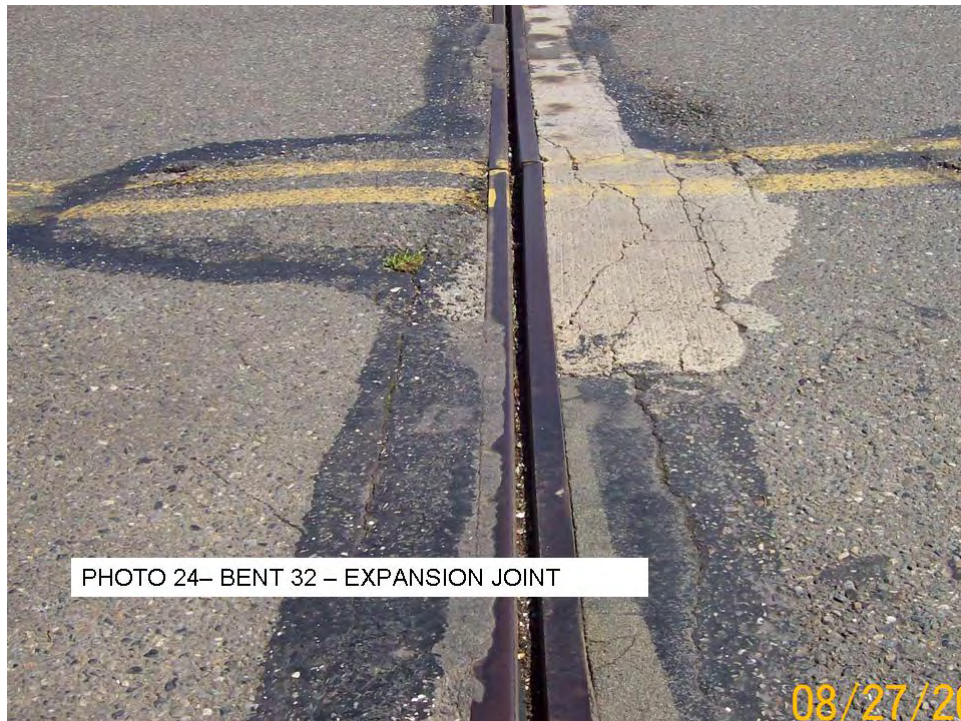
PHOTO 24- BENT 32 - EXPANSION JOINT

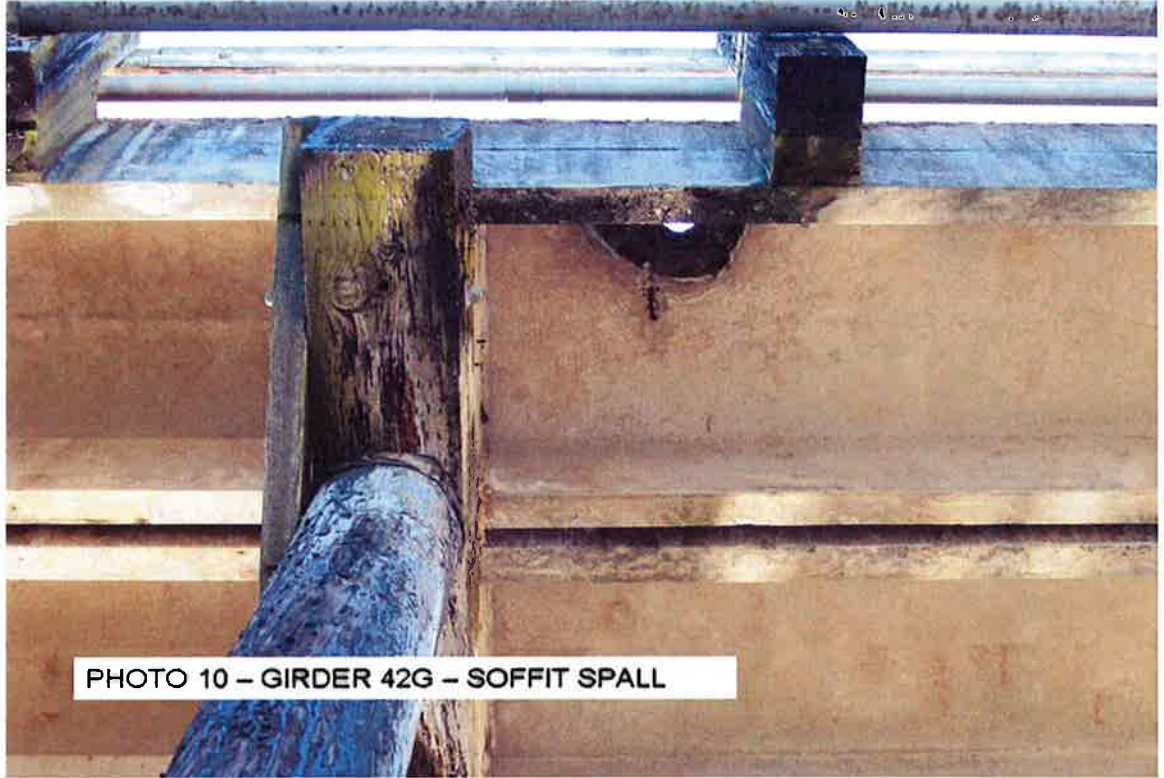
2008
Photo type: R - Repair
Orientation: UP
Dates: 9/9/2008
Repairs: 1
GIRDER 42G SOFFIT
SPALL

PHOTO 10 - GIRDER 42G - SOFFIT SPALL
