Raft Island Improvement Association

**2008 ANNUAL BRIDGE INSPECTION
REPORT
FOR RAFT ISLAND BRIDGE**

Pierce County, Washington

September 2008

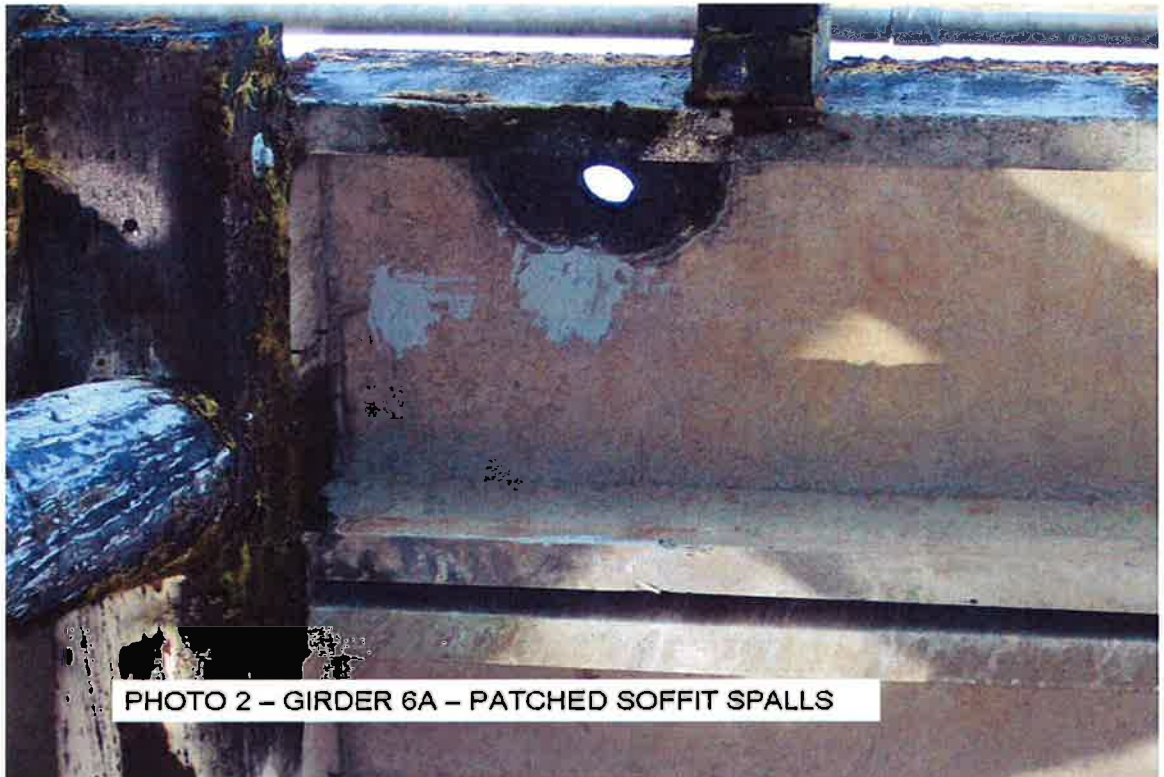
2008
Photo type: R - Repair
Orientation: UP
Dates: 9/9/2008
Repairs: 1
GIRDER 6A PATCHED
SOFFIT SPALLS

PHOTO 2 - GIRDER 6A - PATCHED SOFFIT SPALLS

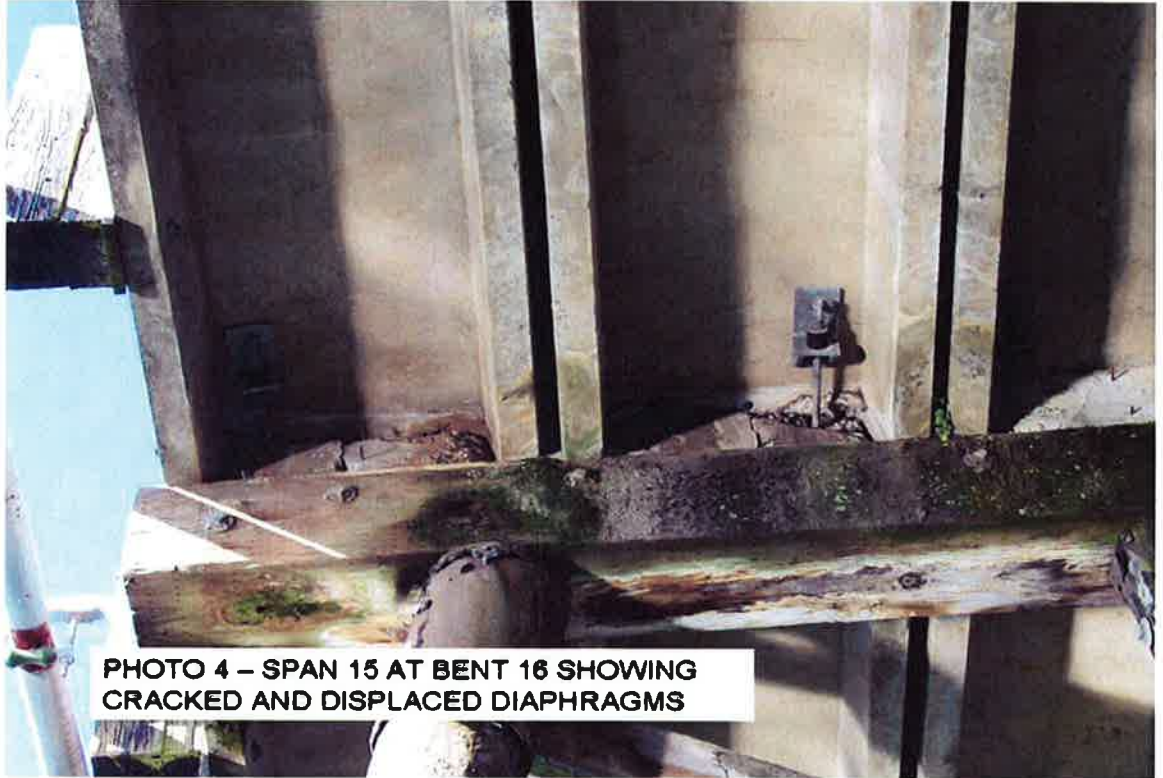
2008
Photo type: R - Repair
Orientation: N
Dates: 9/9/2008
Repairs: 1
DIAPHRAGMS BENT 16

PHOTO 4 – SPAN 15 AT BENT 16 SHOWING
CRACKED AND DISPLACED DIAPHRAGMS

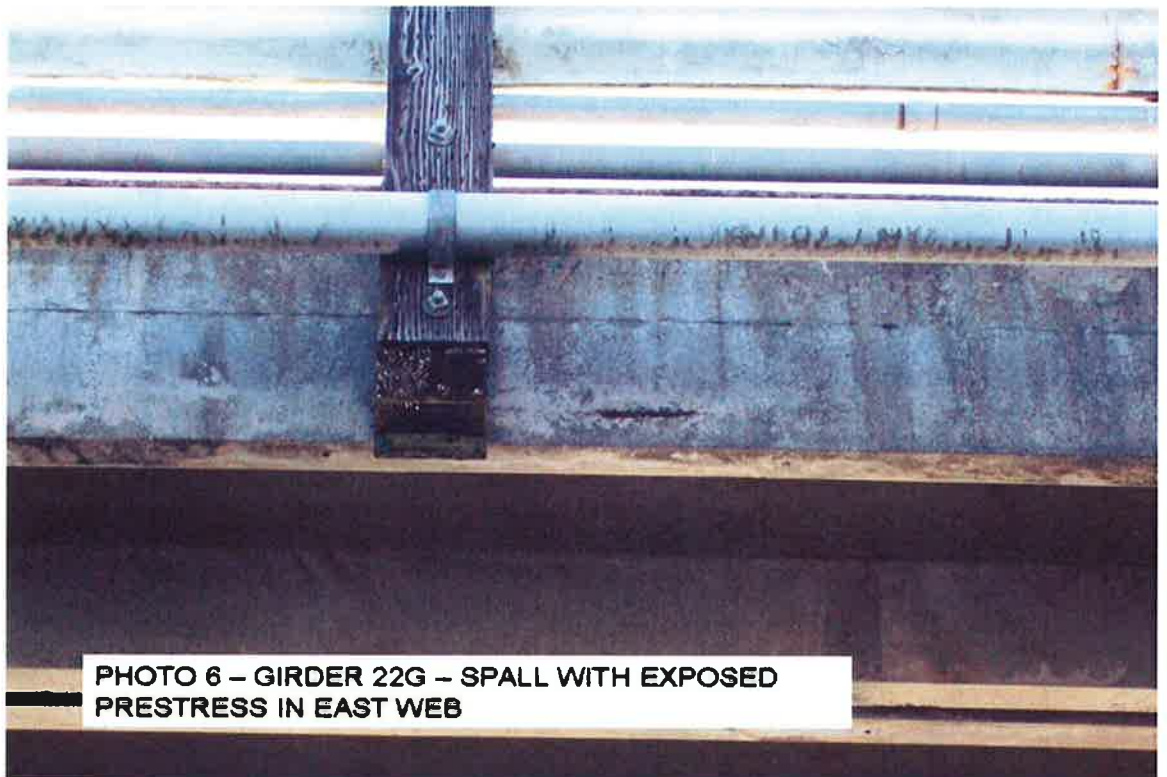
2008
Photo type: R - Repair
Orientation: W
Dates: 9/9/2008
Repairs: 0
GIRDER 22G EXPOSED
PRESTRESS STRANDS

PHOTO 6 – GIRDER 22G – SPALL WITH EXPOSED
PRESTRESS IN EAST WEB

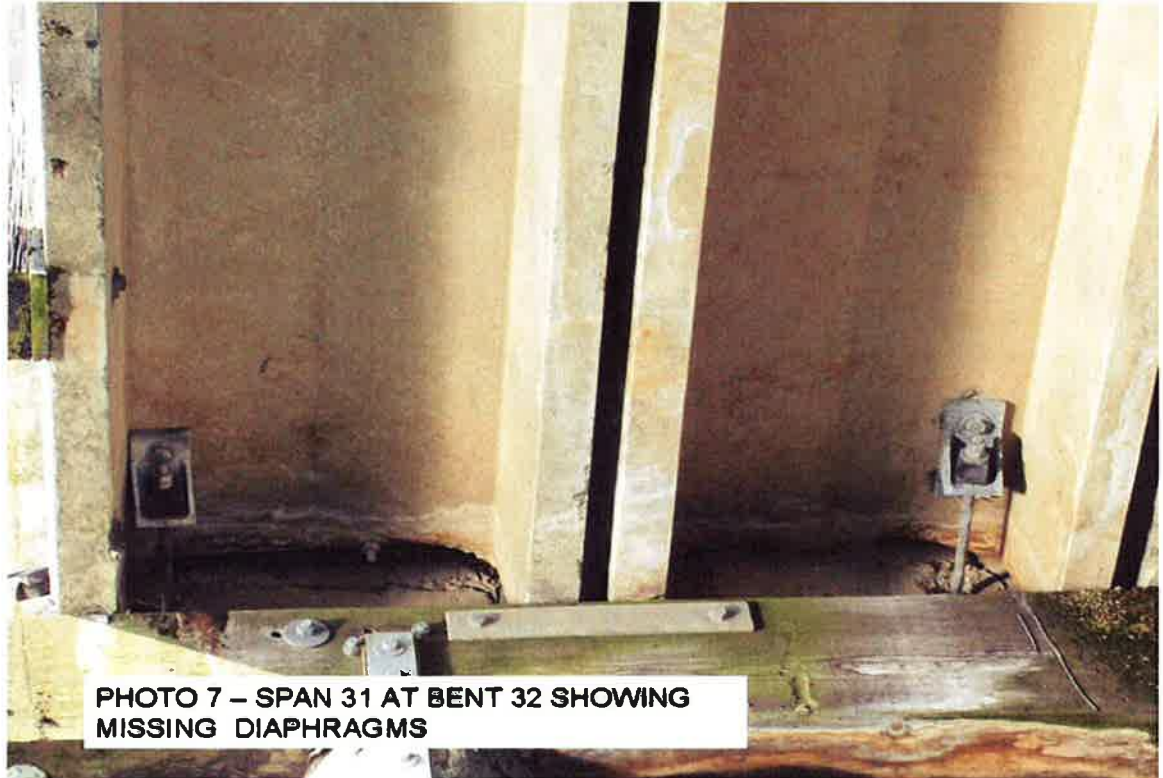
2008
Photo type: R - Repair
Orientation: N
Dates: 9/9/2008
Repairs: 1
DIAPHRAGMS BENT 32

PHOTO 7 - SPAN 31 AT BENT 32 SHOWING MISSING DIAPHRAGMS

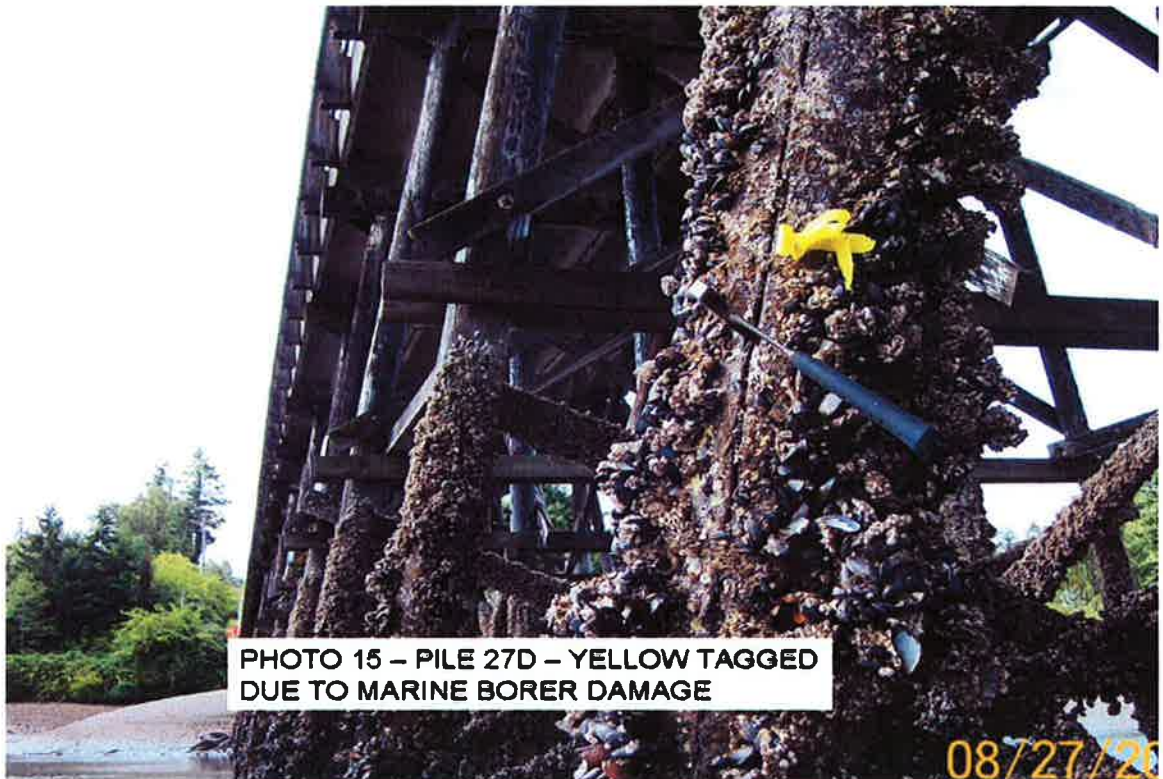
2008
Photo type: M - Monitor
Orientation: SW
Dates: 8/27/2008
Repairs: 1
PILE 27D MARINE BORER DAMAGE

PHOTO 15 - PILE 27D - YELLOW TAGGED DUE TO MARINE BORER DAMAGE

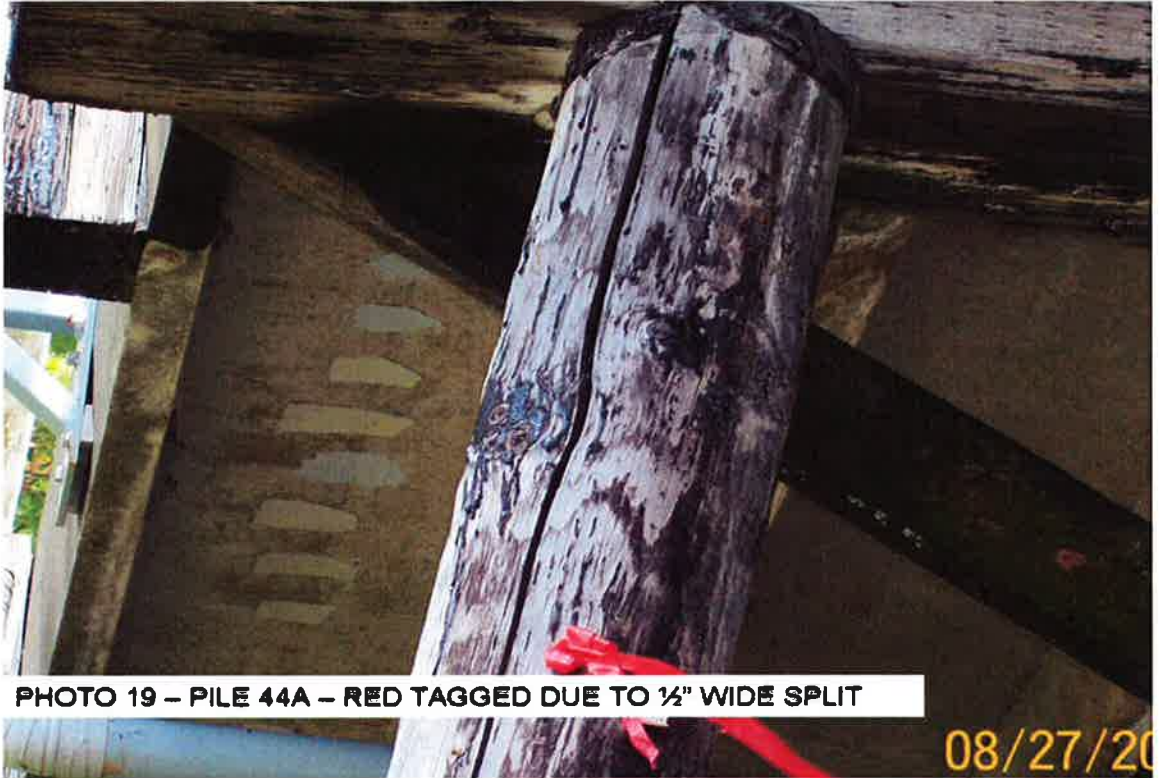
2008
Photo type: R - Repair
Orientation: N
Dates: 8/27/2008
Repairs: 1
PILE 44A

PHOTO 19 - PILE 44A - RED TAGGED DUE TO 1/2" WIDE SPLIT

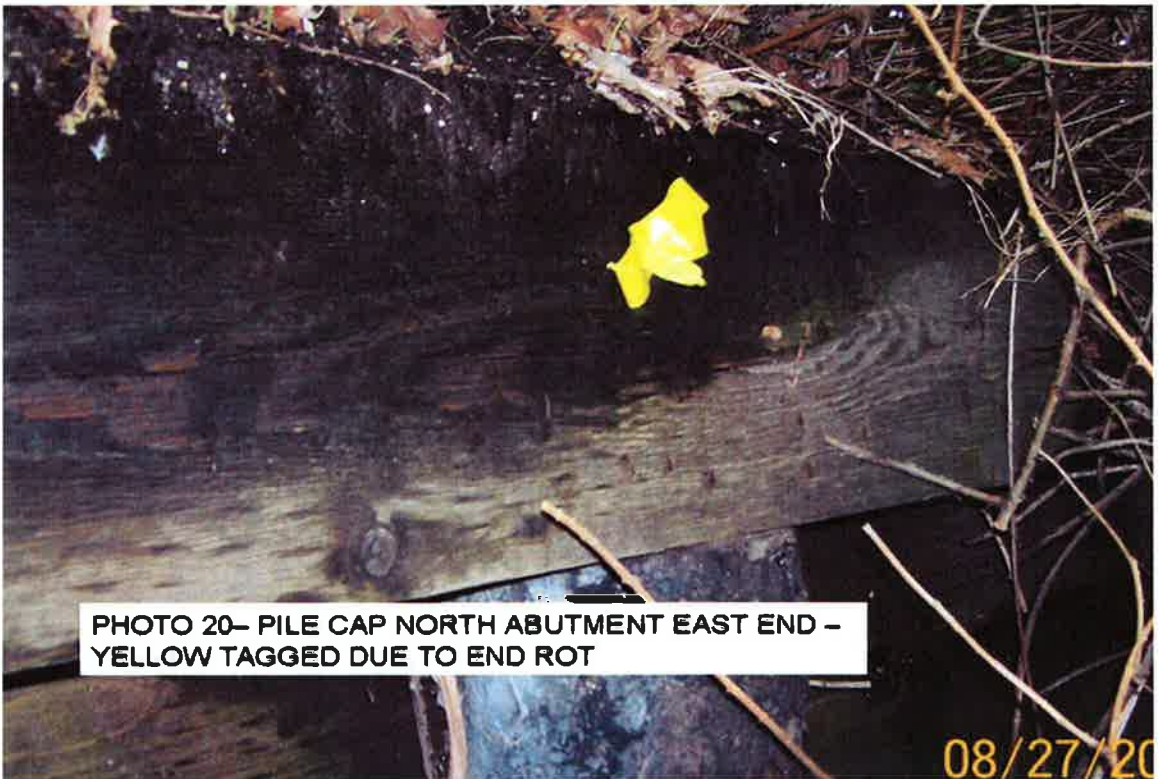
2008
Photo type: M - Monitor
Orientation: NE
Dates: 8/27/2008
Repairs: 1
PILE CAP AT NORTH
ABUTMENT

PHOTO 20- PILE CAP NORTH ABUTMENT EAST END -
YELLOW TAGGED DUE TO END ROT
