BRIDGE INSPECTION REPORT

Bridge Name RAFT ISLAND BRIDGE

Structure ID 08800700

Intersecting CARR INLET

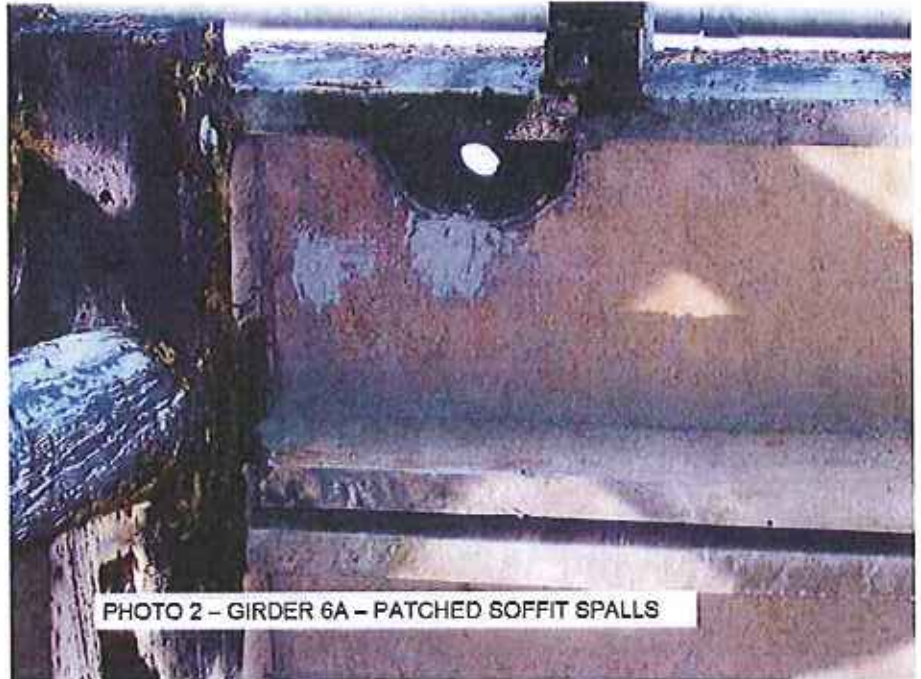
SI-3
2008
Photo Type: R - Repair
Orientation: UP
Dates: 9/9/2008
Repairs:
GIRDER 6A PATCHED SOFFIT
SPALLS

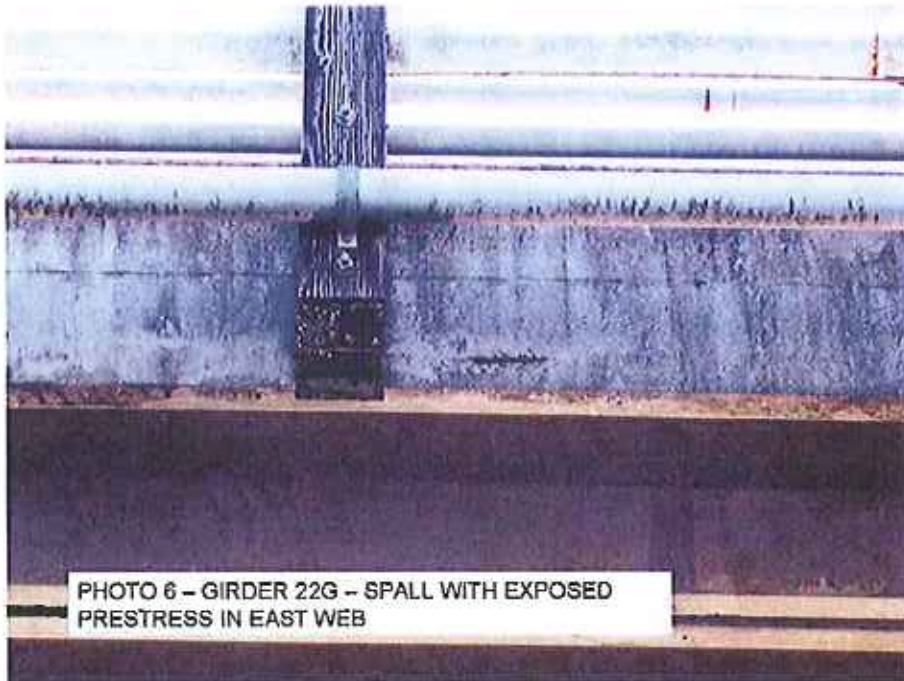
SI-5

GIRDER 22G EXPOSED

PRESTRESS STRANDS

PHOTO 6 - GIRDER 22G - SPALL WITH EXPOSED PRESTRESS IN EAST WEB

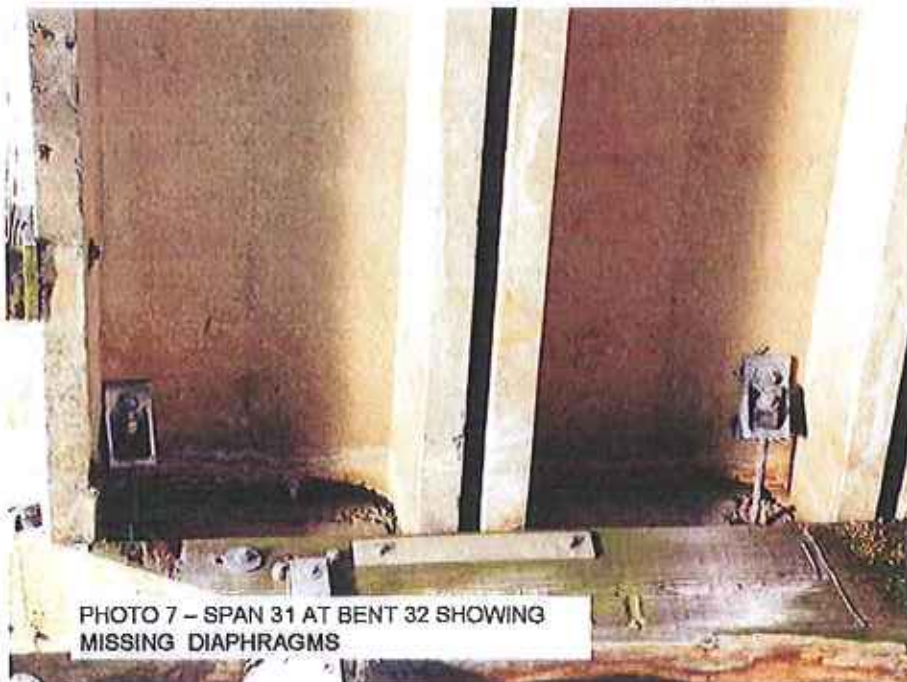
SI-6

DIAPHRAGMS BENT 32

PHOTO 7 - SPAN 31 AT BENT 32 SHOWING MISSING DIAPHRAGMS

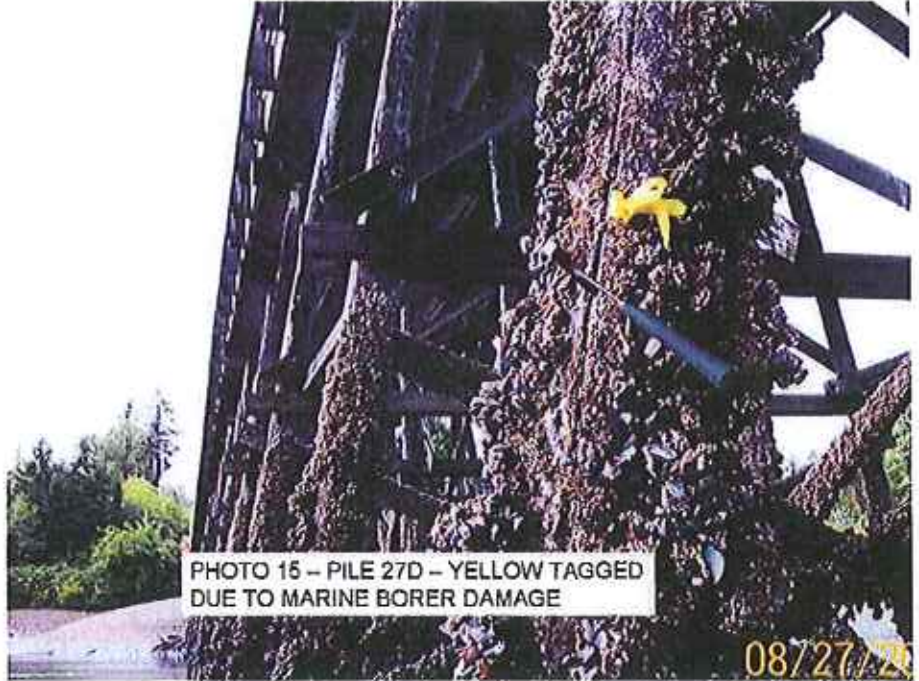
SI-7
2008
Photo Type: M - Monitor
Orientation: SW
Dates: 8/27/2008
Repairs:
PILE 27D MARINE BORER
DAMAGE

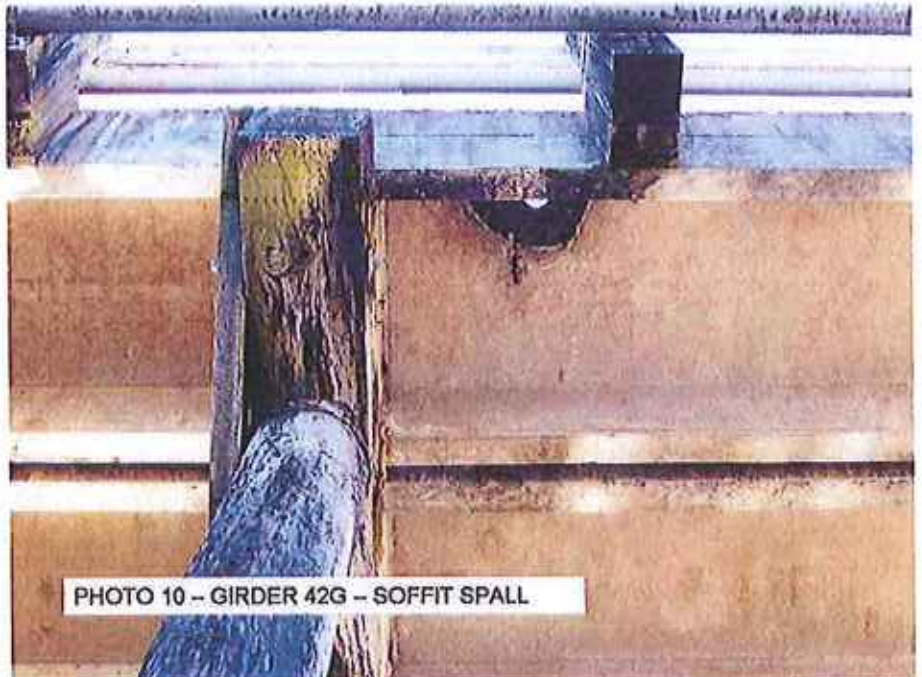
109 The following are girders with spalls and exposed rebar on the soffit: 16A, 29A, 36G and 42G. The spalls were typically 4" or less in diameter and less than 1" deep.
 Girder E east web has a 30" x 1" x 1/2" deep spall with exposed prestress strand. See photo SI-30. REPAIR 10010.
 The following girder had a crack that was significant: 13F had a 5' long soffit crack along centerline that was leaching and rust stained.
 64 girders had patches to the soffit or web.
 Girders 32A, 32G, 36A and 42A have been strengthened by the addition of steel girders below the soffit.

SI-10
2008
Photo Type: R - Repair
Orientation: UP
Dates: 9/9/2008
Repairs:
GIRDER 42G SOFFIT SPALL

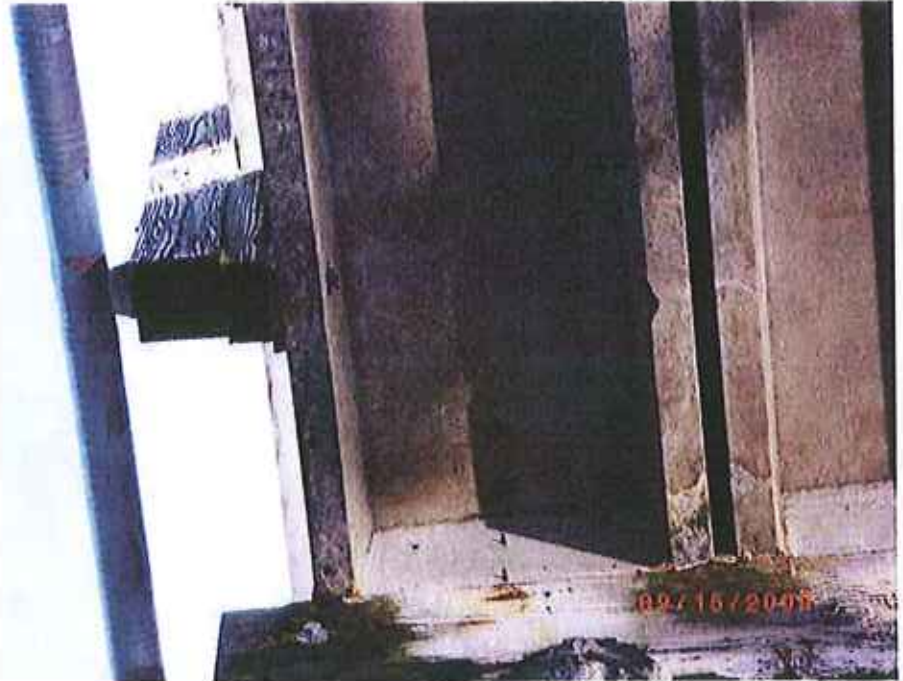
SI-11

Girder 16A soffit spalls

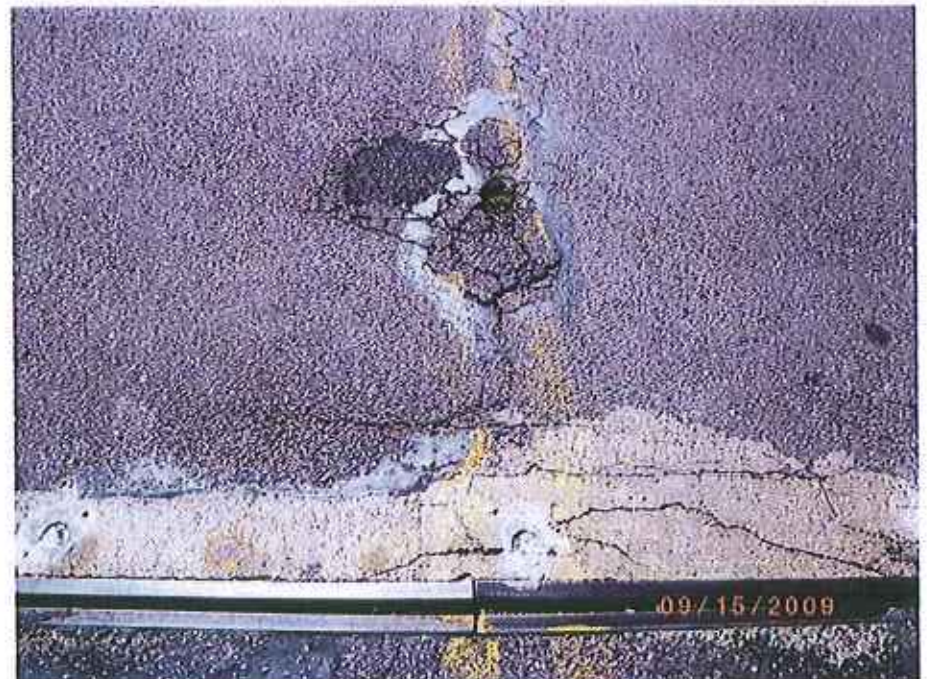
SI-28

Overlay pothole near Bent 32

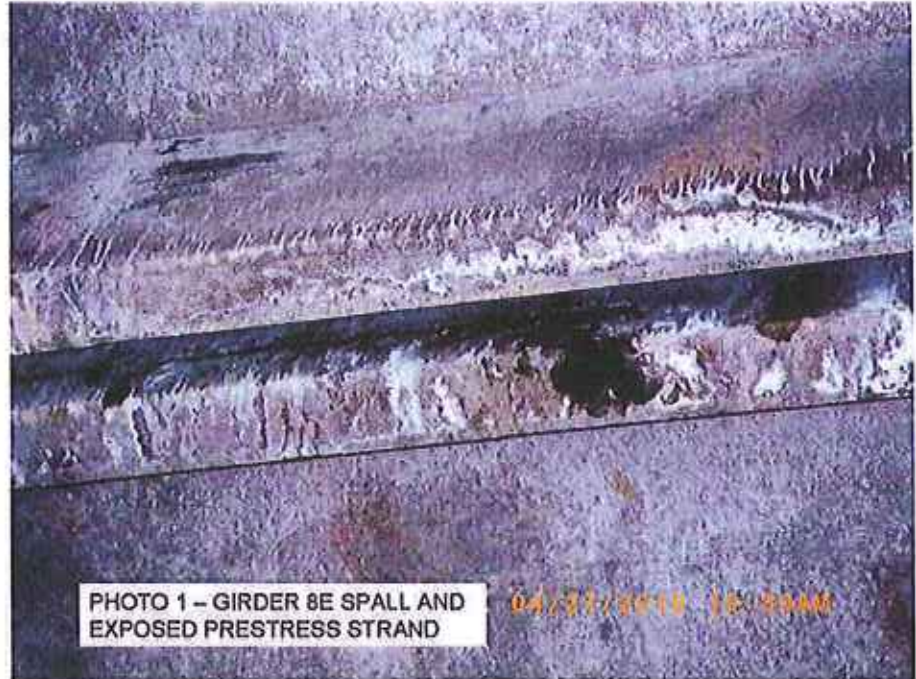
SI-30
2010
Photo Type: R - Repair
Orientation: UP
Dates: 4/27/2010
Repairs: 10010
Girder 8E spall

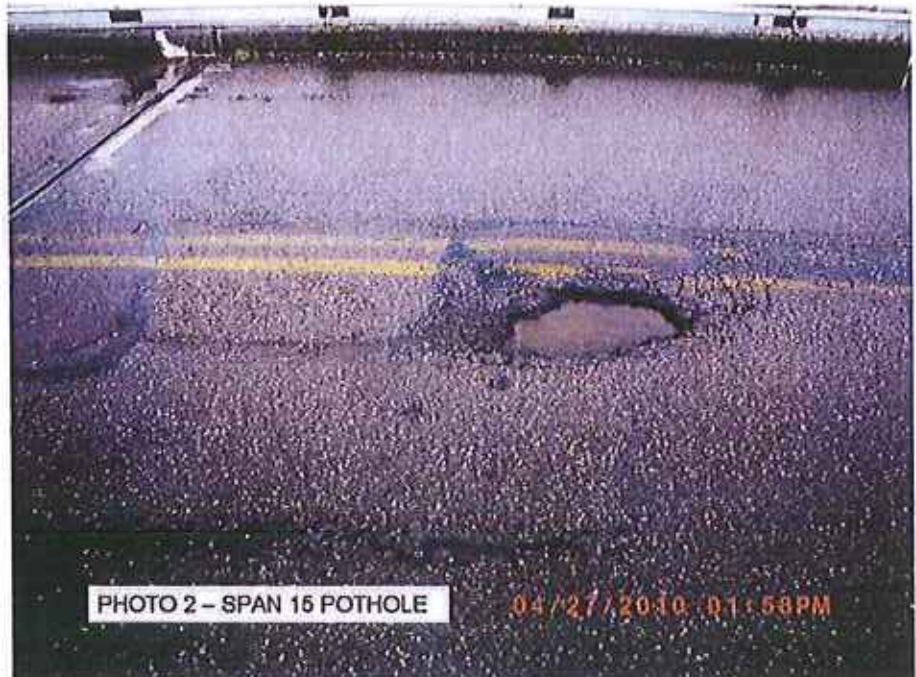
801 There is a 2" thick ACP overlay. There is patching and crack sealing along the centerline and at the expansion joints.
 In Span 15 there is a 15" x 12" x 2" deep pothole. See photo SI-31.
 At Bent 32 the overlay is delaminating along a 3' long strip. South of the joint there is a 24" x 12" x 2" deep pothole. See photo SI-32.
 REPAIR 10014.
 At the north abutment there is cracking full width with some smaller "D" cracking.

SI-31
2010
Photo Type: R - Repair
Orientation: E
Dates: 4/27/2010
Repairs: 10014
Span 15 pothole

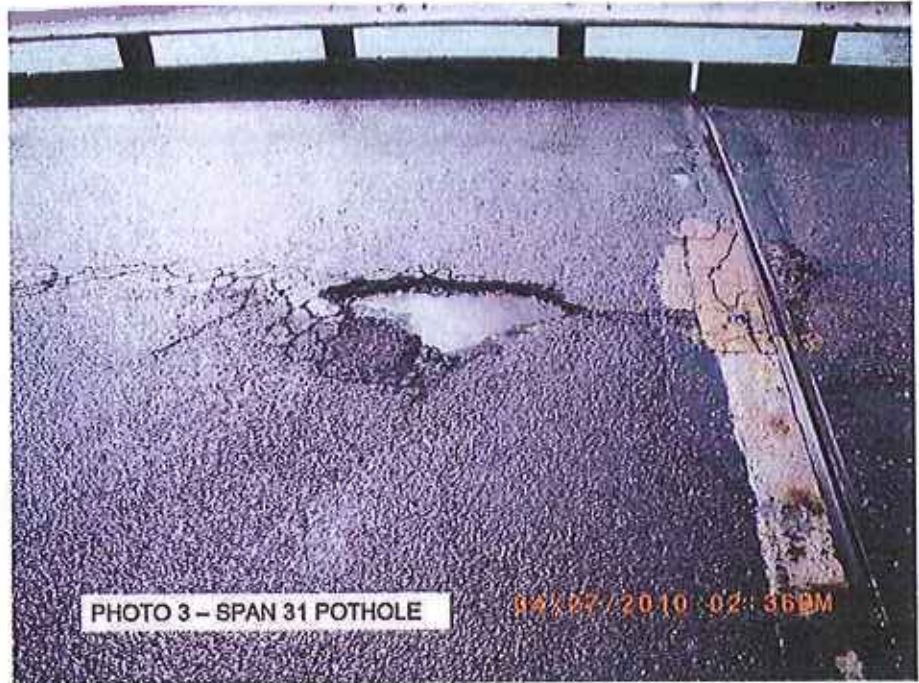
SI-32
2010
Photo Type: R - Repair
Orientation: W
Dates: 4/27/2010
Repairs: 10014
Span 31 pothole.

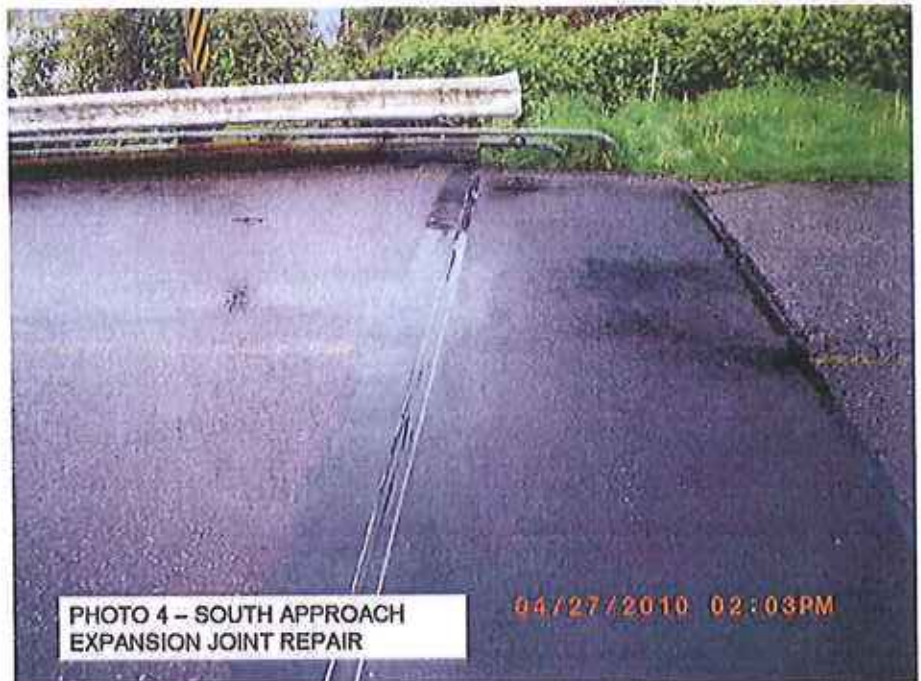
406 The compression seal header at the south abutment was repaired in 2009 with Lokcrete Elastomeric Concrete. Prior to installing the header the steel armour was attached with new anchor bolts. The surface is smooth and level. See photo SI-33. REPAIR 10006 is complete.

SI-33
2010
Photo Type: C - Completed
Orientation: E
Dates: 4/27/2010
Repairs:
South approach expansion joint
repair

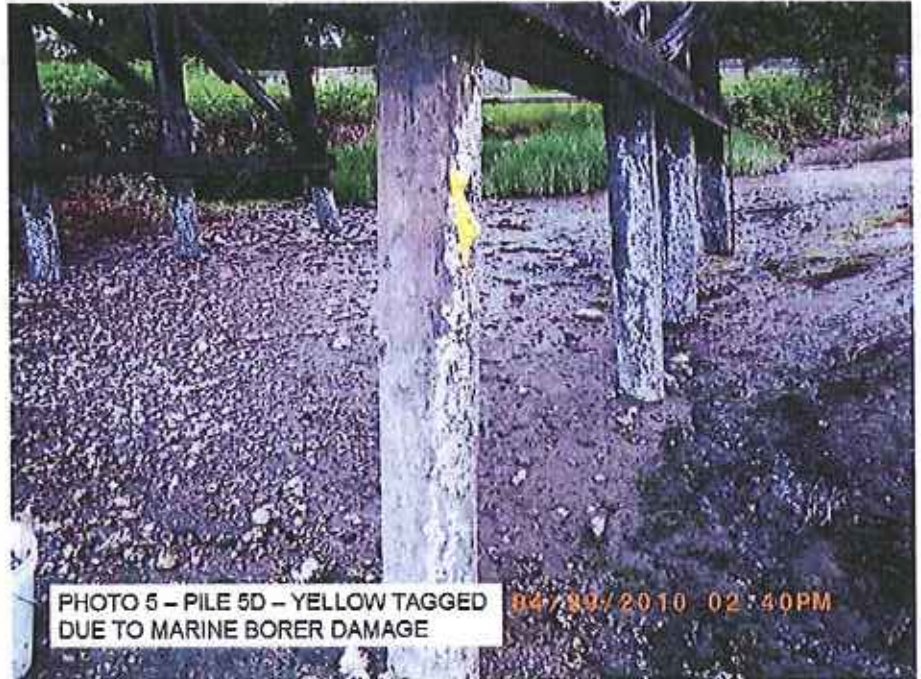
SI-34

228 Piles for Bents were sounded to a height of approximately 7' from the ground.
 Piles 5D, 8D, 15C, 16D, 19D, 21D, 22A, 27D, 29B, 30B, 31C, 37A, 37D, and 38D were YELLOW TAGGED due to marine borer damage. See photos SI-34, SI-36, SI-37, SI-38, SI-40, SI-41, SI-42 and SI-44. REPAIR 10013.
 Piles 13A, 22D, 35A, 38A and 39A were RED TAGGED due to marine borer damage and rot. See photos SI-35, SI-39, SI-43, SI-45 and SI-46. REPAIR 10008.
 Several of the piles had checks or splits that were up to 1/2" wide. At pile 37A there is a 1/2" wide split at midheight with center rot, 4" shell with 2" rot pocket. The pile was YELLOW TAGGED. REPAIR 10005.
 At Pile 44A there was a split 1/2" wide at the top that extended through the full diameter. The pile was repaired. See photo SI-60. REPAIR 10000 is complete.
 The following piles have been repaired by using a concrete filled splice at ground line and adding a new section of pile that has a metal strap connection to the cap: 11D, 20A, 20C, 21A, 23A, 25D, 28C, 30C, 32C, 34B, 36C, 39C, 40B, and 41B.

Pile 5D

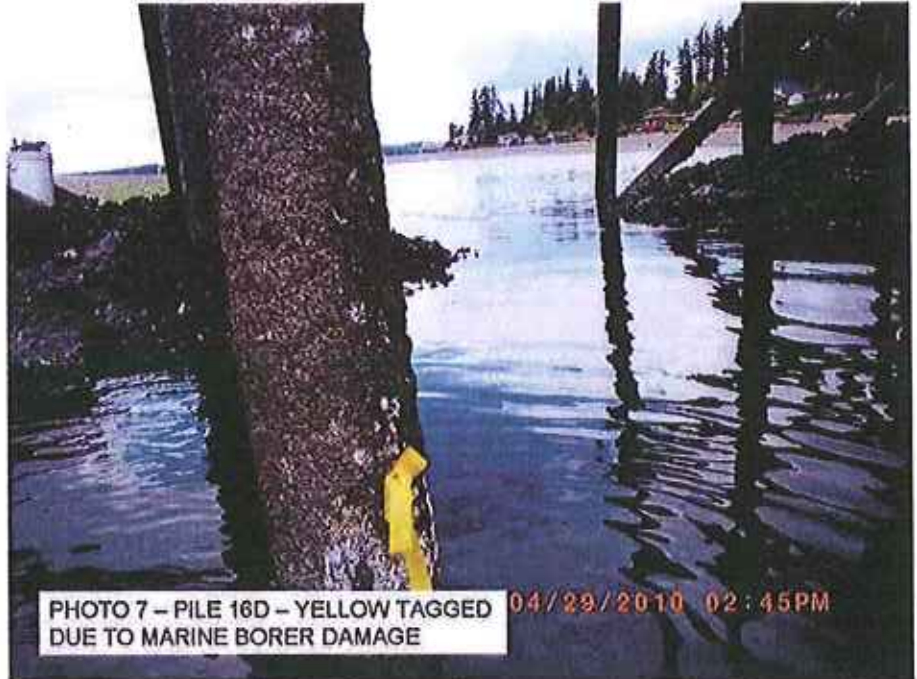
SI-36

Pile 16D

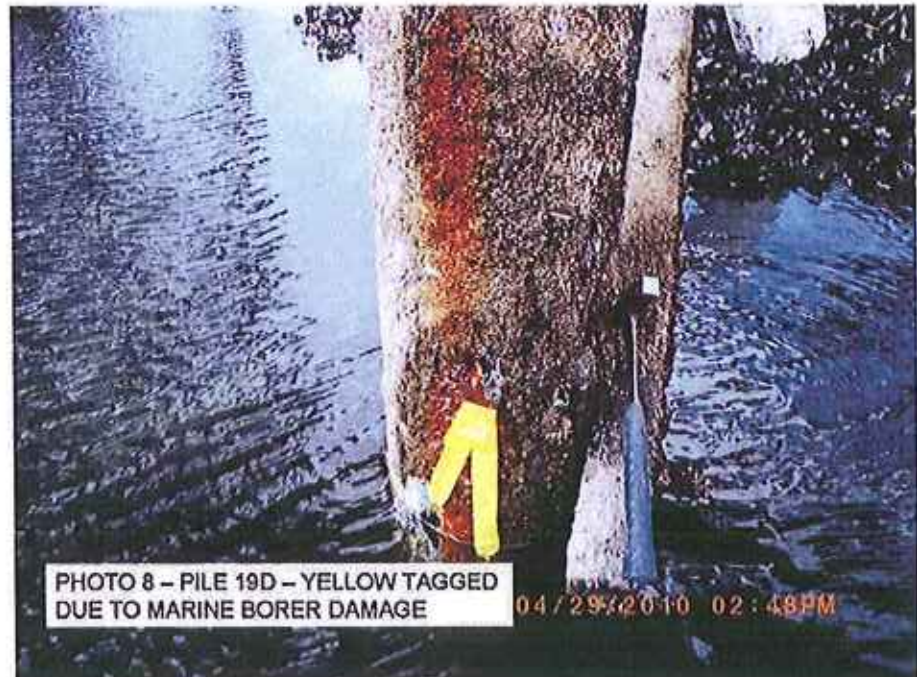
SI-37

Pile 19D

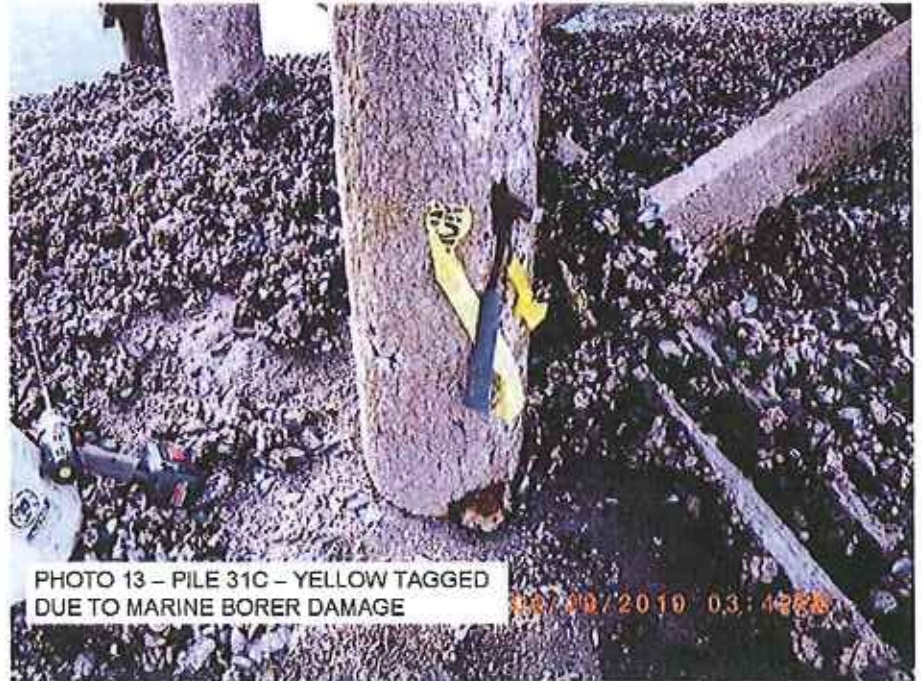
SI-42

Pile 31C

PHOTO 13 - PILE 31C - YELLOW TAGGED
DUE TO MARINE BORER DAMAGE

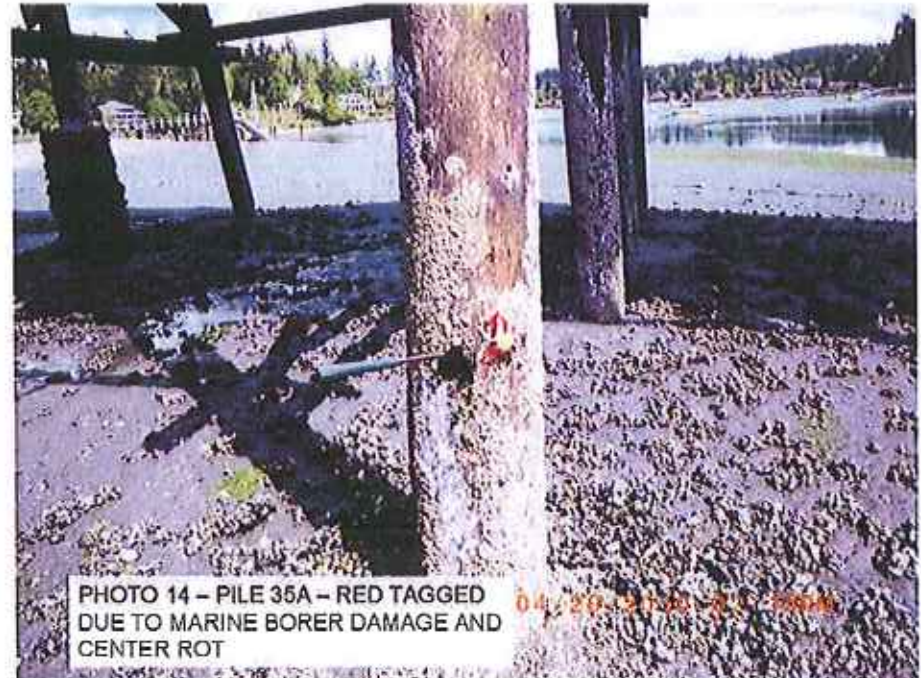
SI-43

Pile 35A

PHOTO 14 - PILE 35A - RED TAGGED
DUE TO MARINE BORER DAMAGE AND
CENTER ROT

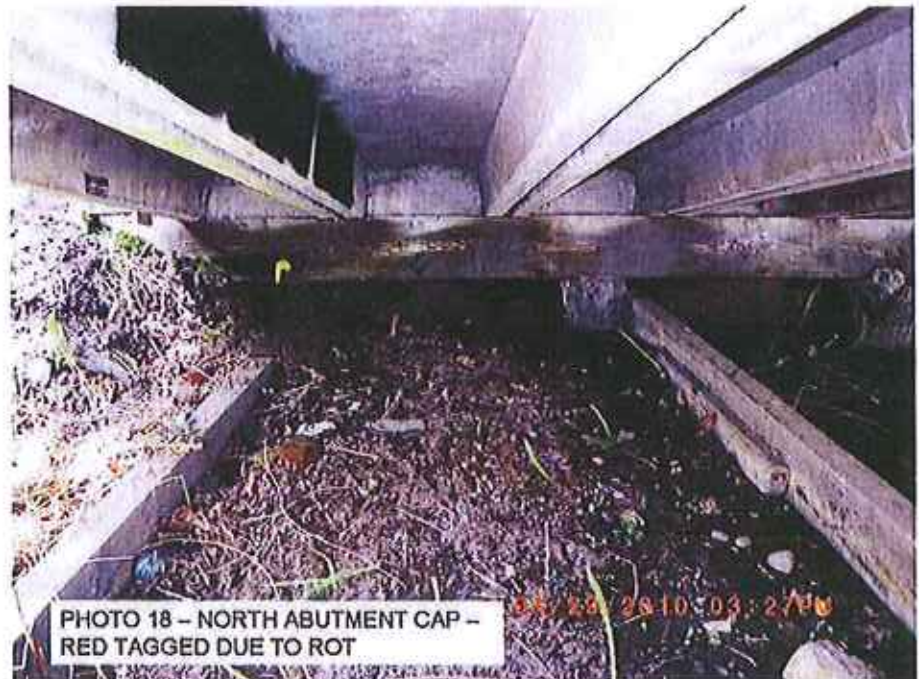
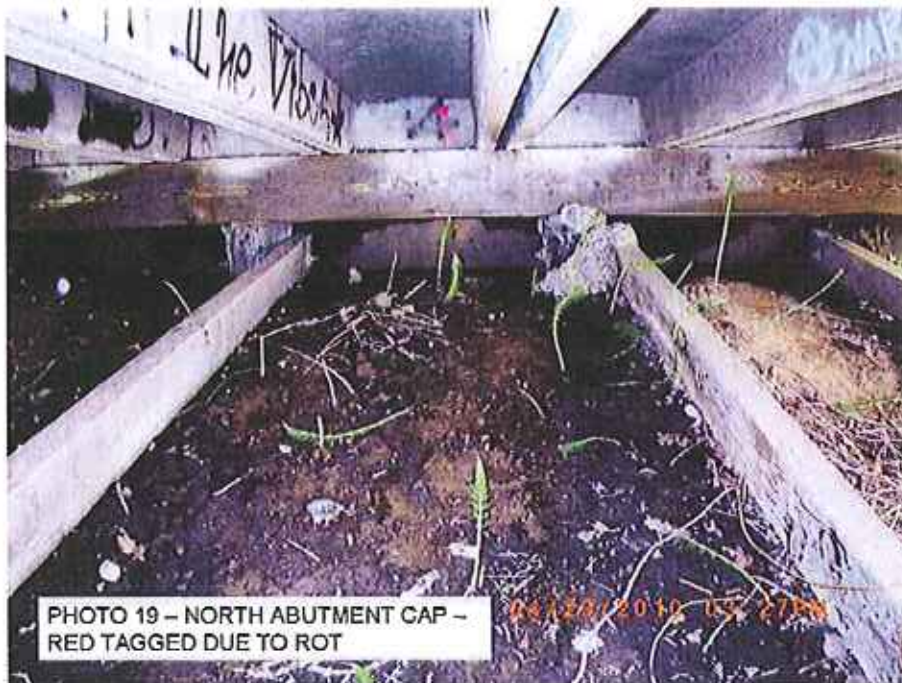
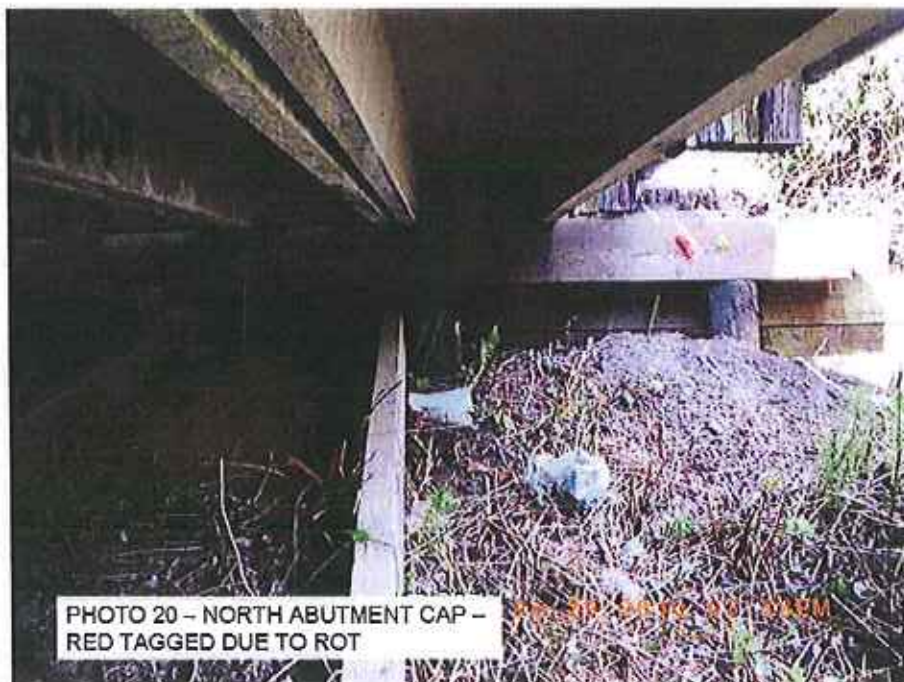
235 A few of the caps had checks but appear to be in good condition. The cap at Bent 9 had a full length check along the bottom. The cap at the north abutment has a 2" to 4" shell along the front face and rot through the remaining portion of the member. There is end rot at both ends. See photos SI-47, SI-48 and SI-49. The cap was RED TAGGED. REPAIR 10009.

North Abutment Cap

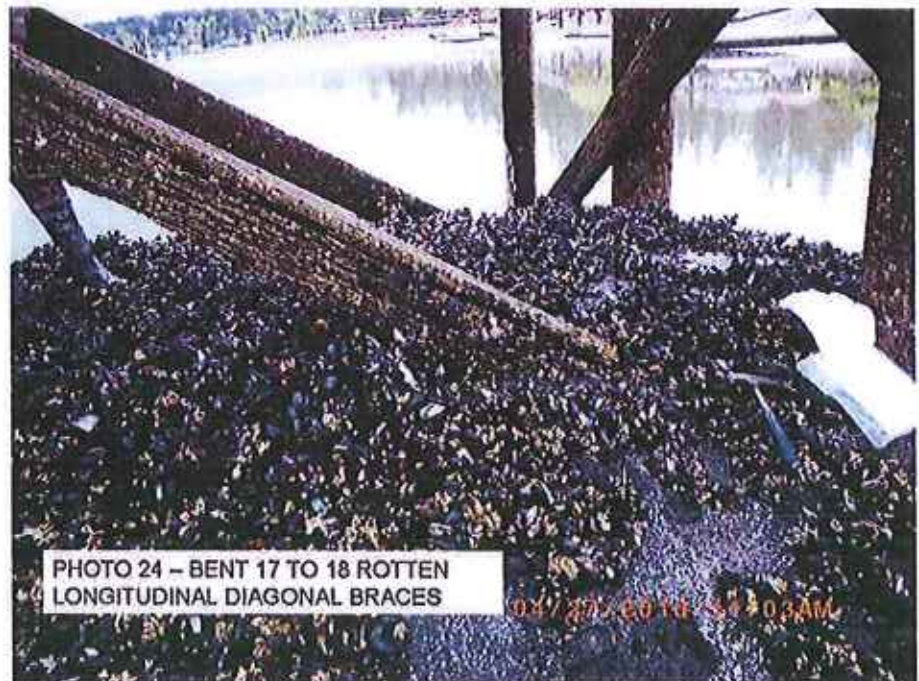
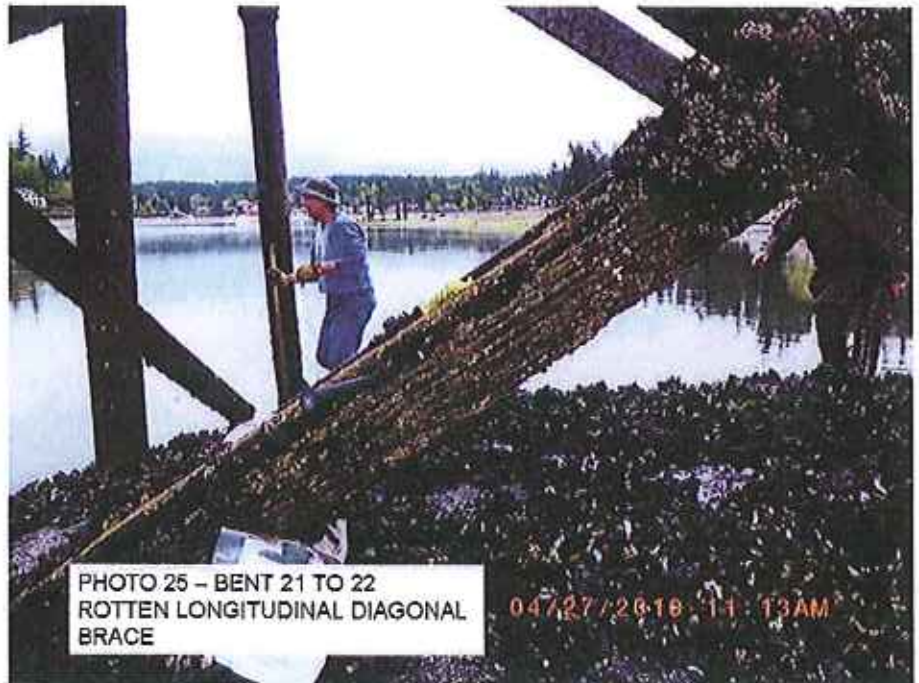
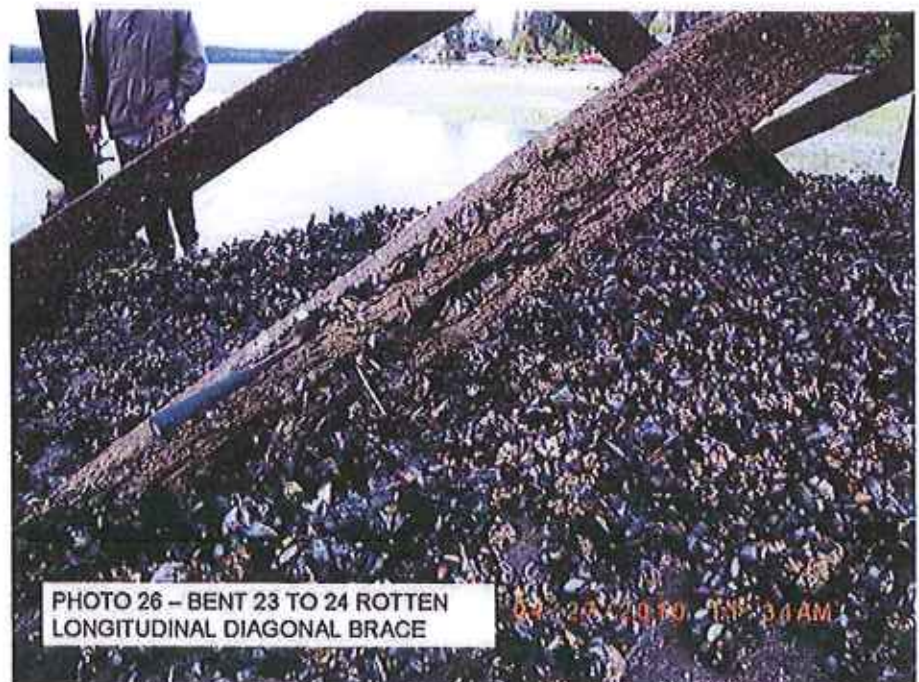
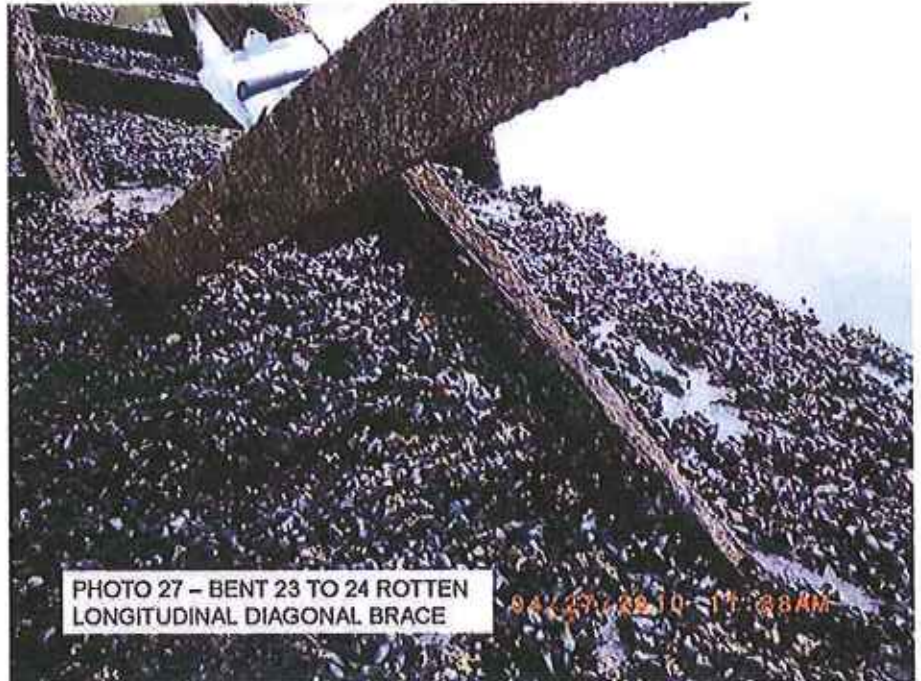
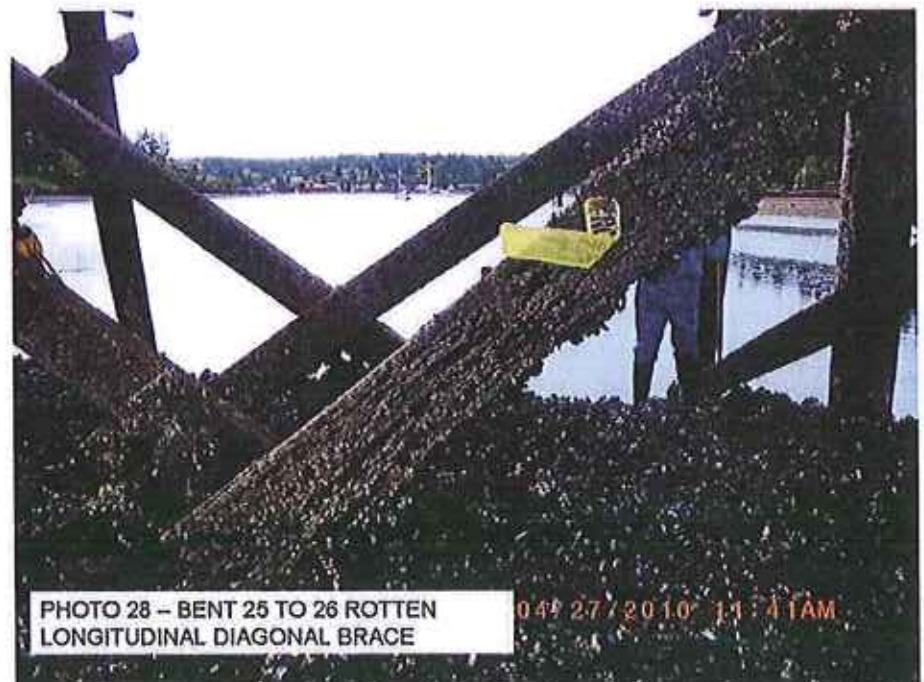
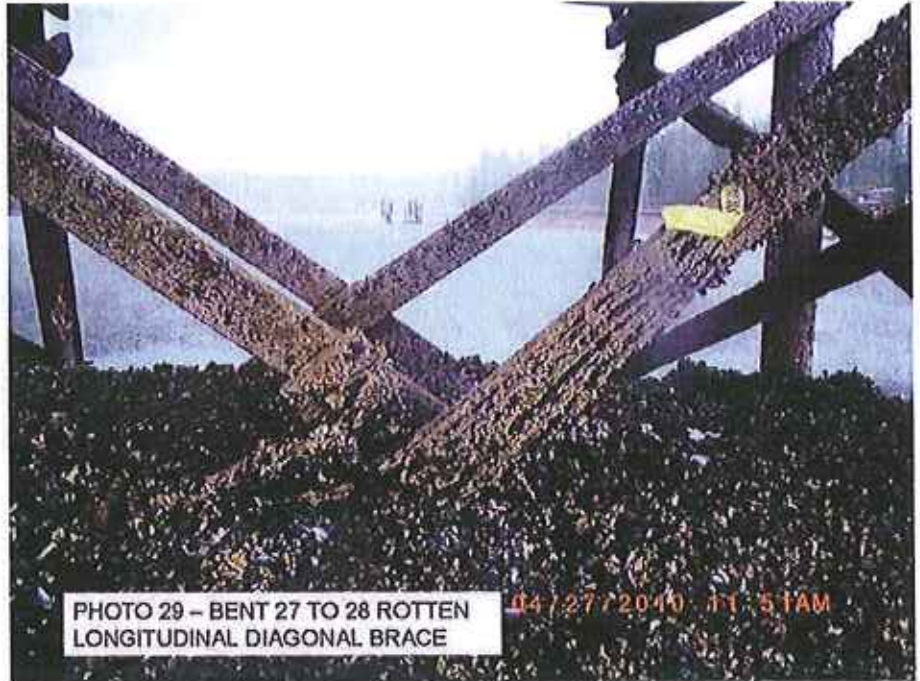
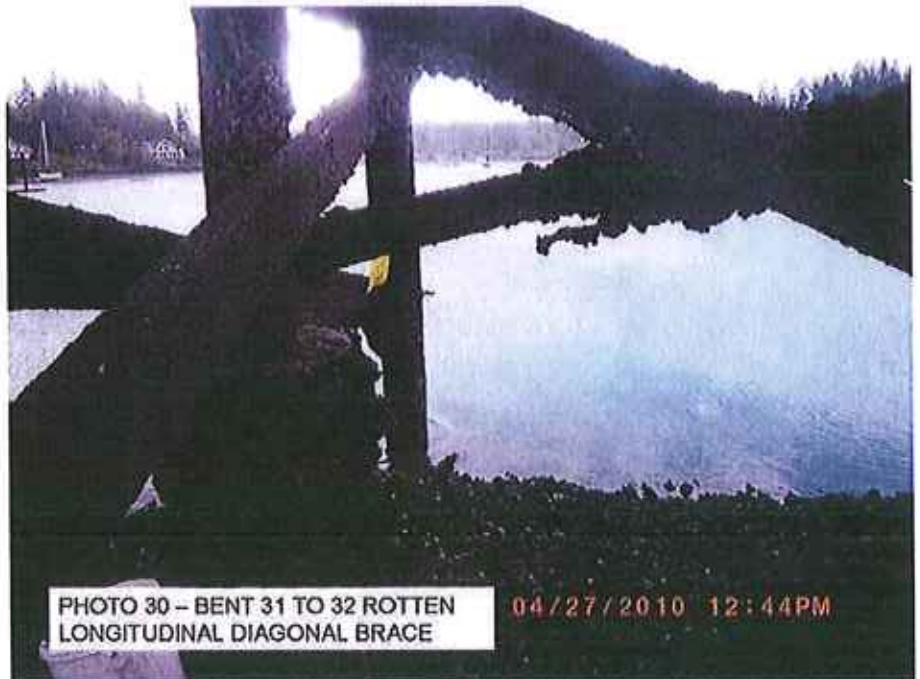
The following piles have been replaced as indicated by a metal strap connection at the cap: 13C, 16A (steel collar), 18C, 25B, 32A, 32B and 32D.
 Pile 31B has a fiberglass wrap at the ground line.
 The diagonal transverse bracing had end rot at top connection at many bents. The following braces require replacement due to rot or damage:
 Transverse diagonals at Bent 17, Bent 31 and Bent 32. See photos SI-50, SI-51 and SI-52. REPAIR 10011.
 Longitudinal diagonals Pile 17B to 18B, Pile 17C to 18C, Pile 21B to 22B, Pile 23B to 24B, Pile 23C to 24C, Pile 25B to 26B Pile 27B to 28B and Pile 31C to 32C. See photos SI-53, SI-54, SI-55, SI-56, SI-57, SI-58, and SI-59. REPAIR 10012.

Bent 17 to 18 Longitudinal Diagonal Brace
