Raft Island Improvement Association

2010 Bridge Inspection Report For Raft Island Bridge

Pierce County, Washington

May, 2010

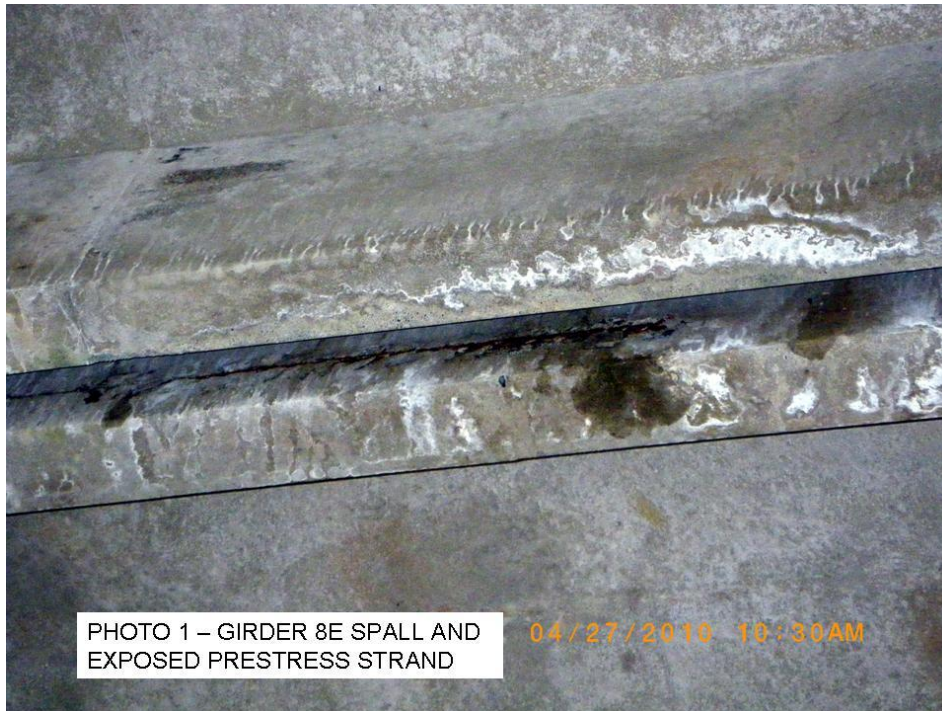
Description	Location
Spalled concrete on soffit with exposed steel reinforcement	Span 8: Girder E east web, 30" x 1" x 1/2" spall with exposed prestress strand. See photo 1. Span 16: Girder A soffit, three 3" diameter spalls with exposed rebar (2007). Span 29: Girder A has a 3" diameter spall with exposed rebar (2007). Span 36: Girder G has a 4" diameter spall with exposed rebar. Span 42: Girder G, spall with 5" exposed rebar.

8	Girder E east web has a 30" x 1" x 1/2" spall with exposed prestress strand. See photo 1. (2010)
8	Girder G has 3" diameter delamination near drain. Moisture and efflorescence present at various locations along the bottom edge of the webs. End diaphragm at north end of Girder B has 4" diameter spall.
9	Girder A and G have epoxy patches along soffit centerline. Moisture and some efflorescence is present along the bottom edge of the webs at various locations.
10	Girders A and G have epoxy patches along soffit centerline. Efflorescence present at various locations along the bottom edge of the webs.
11	Girders A and G have epoxy patches along soffit centerline. Girder A East web has 8" x 4" x 1" spall. Efflorescence present at various locations along the bottom edge of the webs.

Girder 8E has a 30" long spall in the web that is exposing a prestress strand. The strand should be cleaned and the spall patched with epoxy.

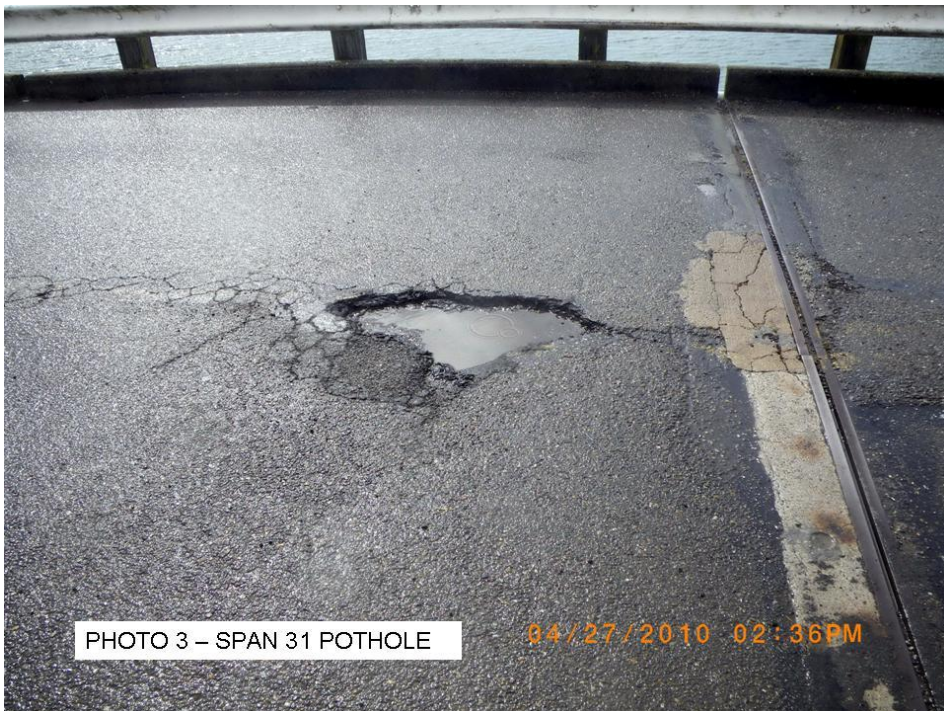
South of the expansion joint at Bent 32 there is a 24" x 12" x 2" deep pothole. See photo 3.

LOCATION	ITEM	DEFICIENCIES DESCRIPTION
South of the expansion joint at Bent 16	Asphalt overlay	15" x 12" x 2" deep pothole. See photo 2.
South of the expansion joint at Bent 32	Asphalt overlay	24" x 12" x 2" deep pothole. See photo 3.

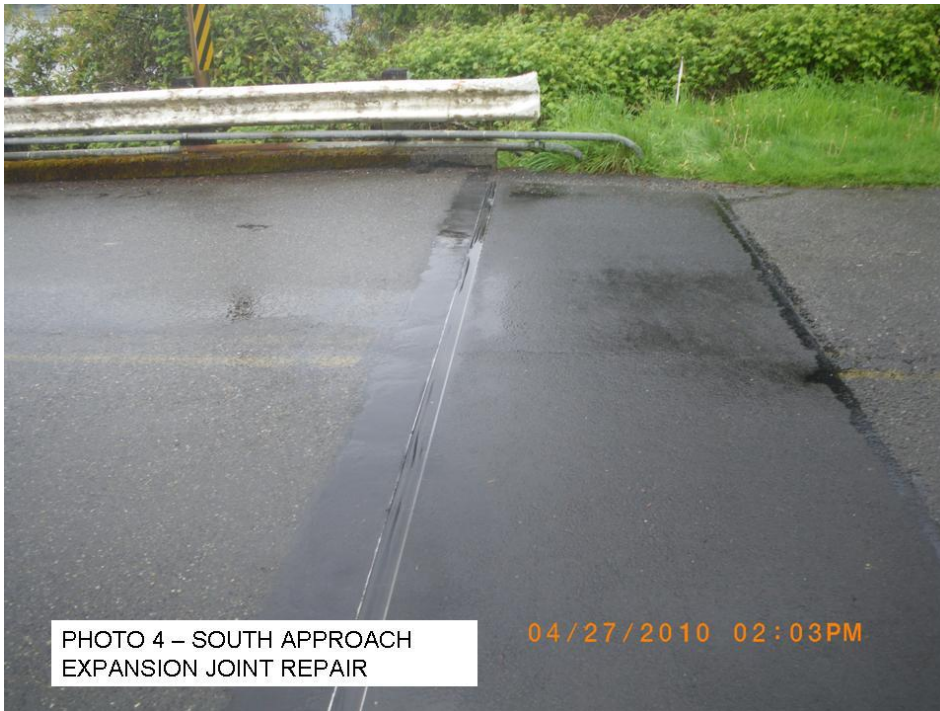
The expansion joint at the South Abutment is an armored compression seal. The joint was repaired in November 2009 using the material Lokcrete Elastomeric Concrete for the header. Prior to installing the header the steel armor was attached to new anchor bolts. The surface is smooth and level with no visible defects. See photo 4.

The South Approach is smooth due to the recent joint repair. See photo 4. The North Approach has several large patches and is approximately $\frac{3}{4}$ " higher than the bridge which is causing moderate impact to the bridge.

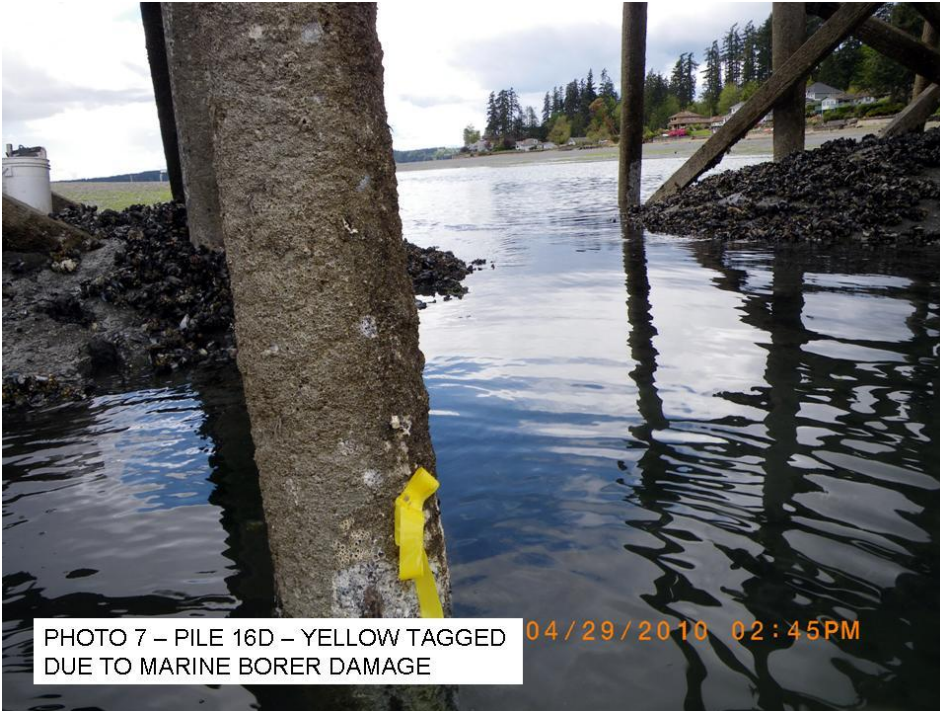
PHOTO 7 – PILE 16D – YELLOW TAGGED
DUE TO MARINE BORER DAMAGE

#16	Pile 16D Marine borer holes near ground. YELLOW TAGGED. See photo 7.
#17	Pile 17D has 1/4" wide split from ground 10' long. No rot found.
#17	Rotten Transverse Diagonal Brace Pile 17A to 17D (17D is low end). See photo 21.

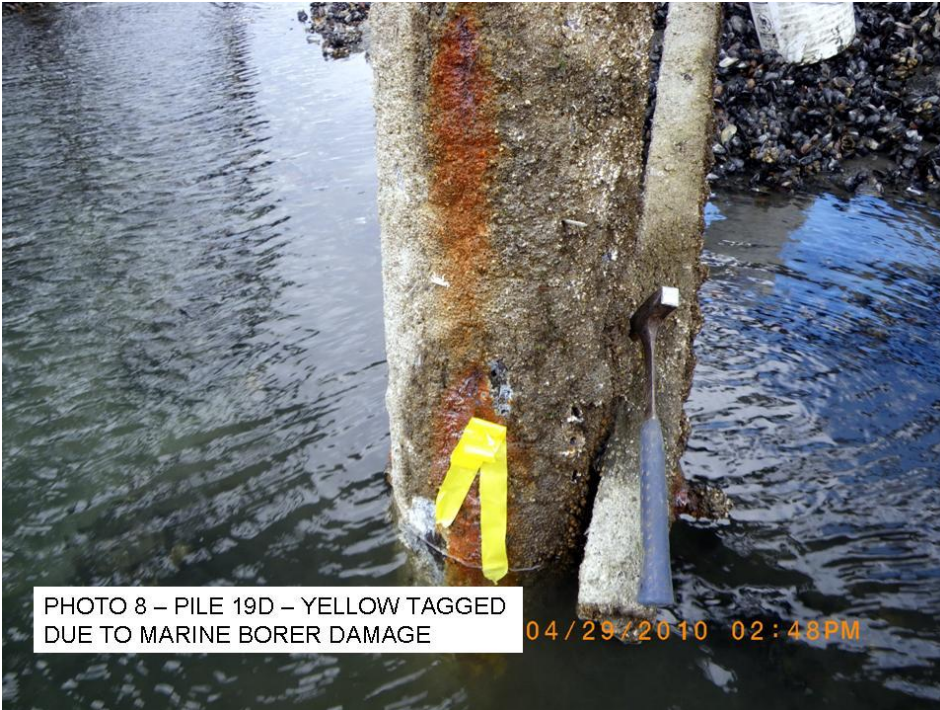
PHOTO 8 – PILE 19D – YELLOW TAGGED
DUE TO MARINE BORER DAMAGE

#18	Pile 18C has metal strap at cap indicating pile is a replacement.
#19	Pile 19D marine borer holes near ground. YELLOW TAGGED. See photo 8.
#20	Pile 20A has concrete filled splice at ground line with metal straps at cap.

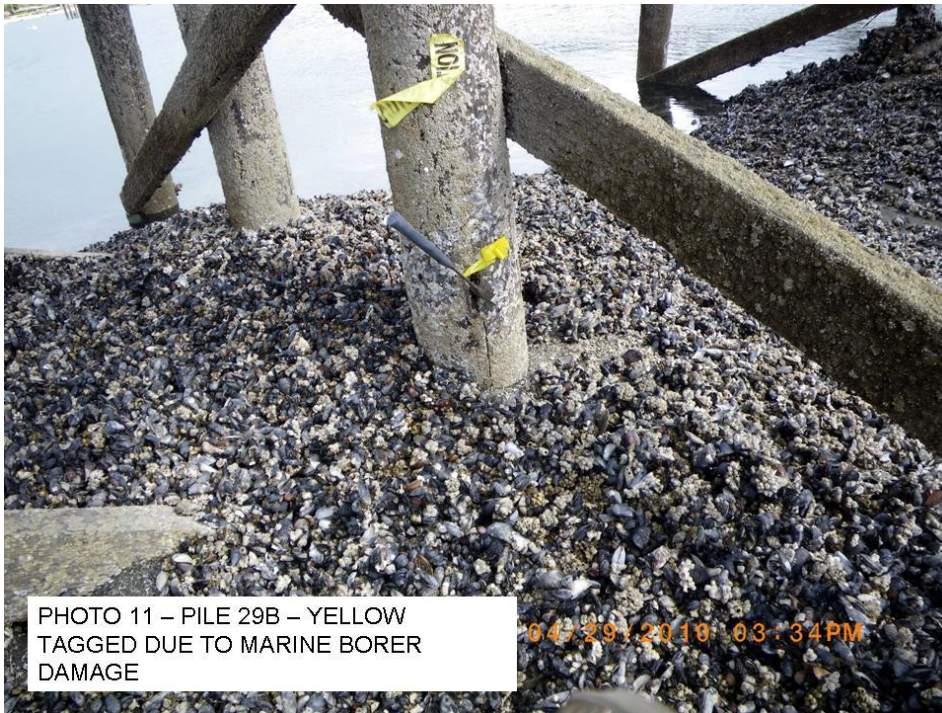
PHOTO 11 – PILE 29B – YELLOW TAGGED DUE TO MARINE BORER DAMAGE

#28	Diagonal brace at top west end has rot and is split at the lower connection to Pile 28D.
#29	Pile 29B marine borer hole near ground. 2" diameter. YELLOW TAGGED.

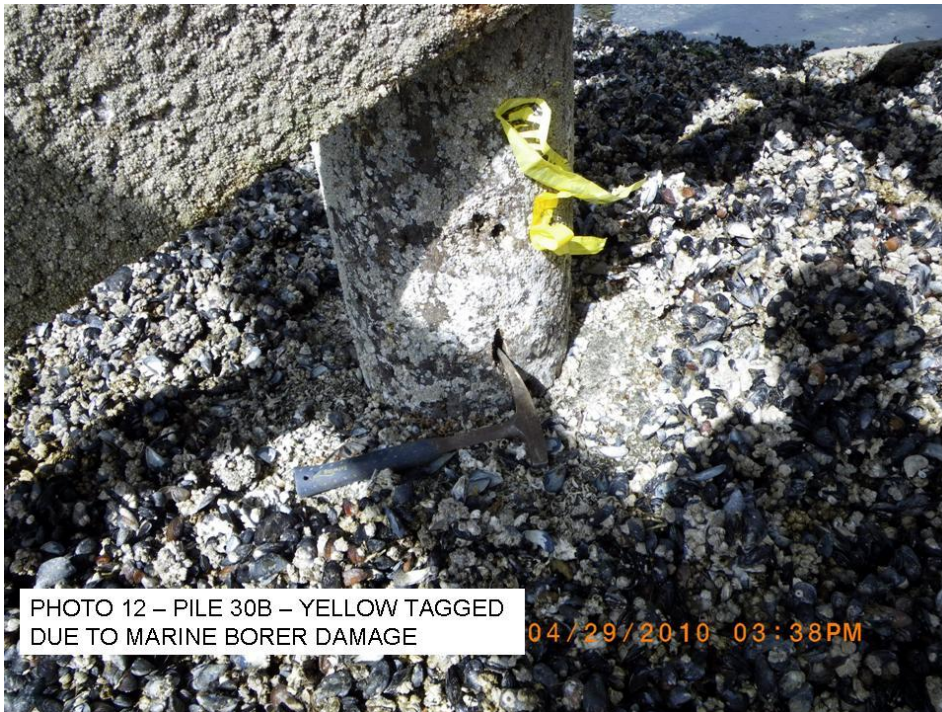
PHOTO 12 – PILE 30B – YELLOW TAGGED DUE TO MARINE BORER DAMAGE

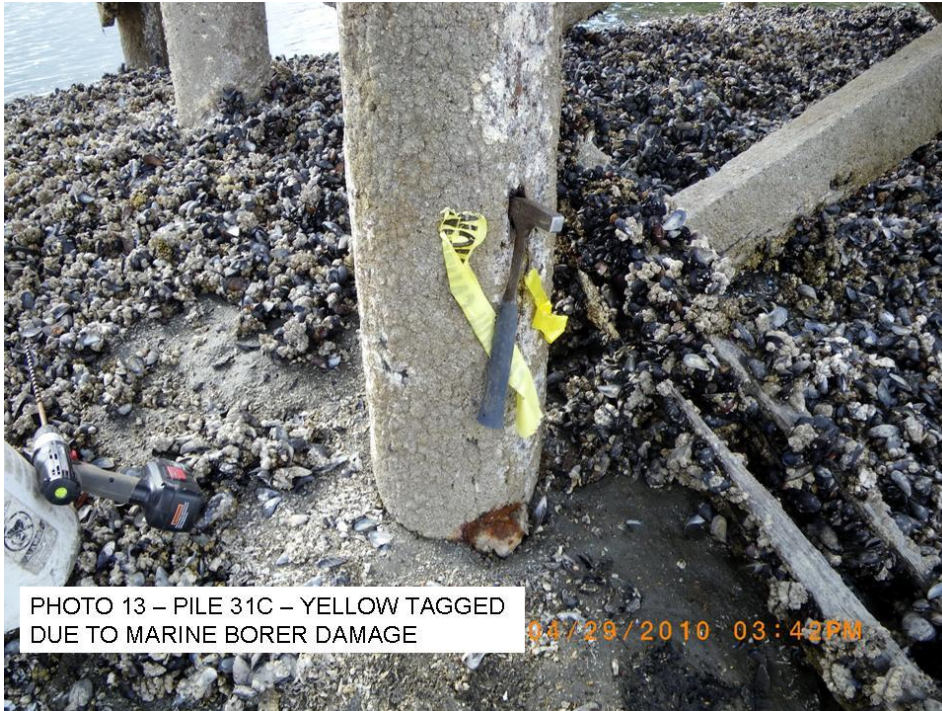
PHOTO 13 – PILE 31C – YELLOW TAGGED
DUE TO MARINE BORER DAMAGE

#31	Pile 31A has 3/16" wide split from ground 15' long. No rot found.
#31	Pile 31B has a fiberglass wrap at the groundline.
#31	Pile 31C marine borer hole near ground. 2" diameter hole 6" deep. YELLOW TAGGED. See photo 13.

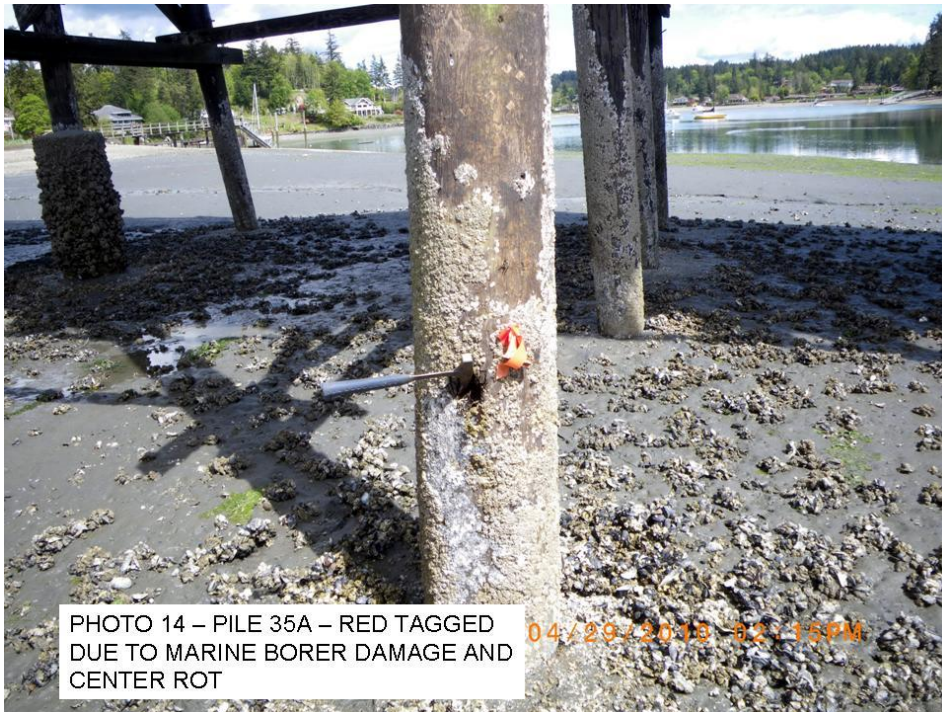
PHOTO 14 – PILE 35A – RED TAGGED
DUE TO MARINE BORER DAMAGE AND
CENTER ROT

#33	Pile 33B has 3/8" wide split near ground. No rot found.
#34	Pile 34B has concrete filled splice at ground line with metal straps at cap.
#35	Pile 35A has 4" diameter x 3" deep rot pocket 3' above ground. RED TAGGED (2009). REPAIR See photo 14.

In 2009 marine borer damage or rot damage was identified in eight piles and repairs were recommended to two of the piles. In 2010 a total of nineteen piles were identified with marine borer damage or rot damage and repairs are recommended to five piles. This includes 2 of the piles from the 2009 inspection. Repairs are required at this time to piles 13A, 22D, 35A, 38A and 39A.

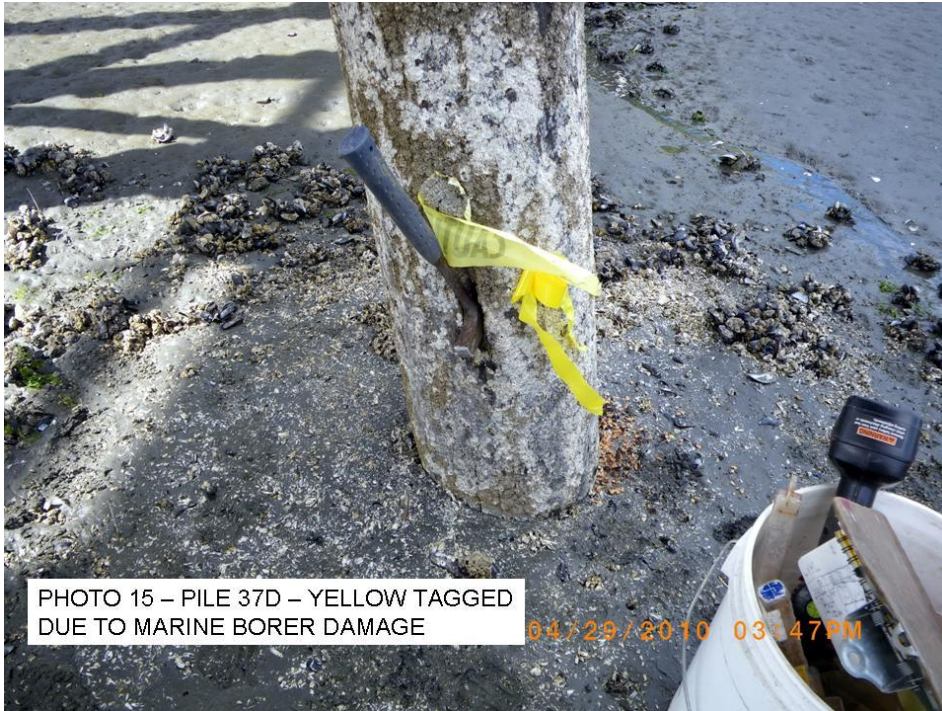
PHOTO 15 – PILE 37D – YELLOW TAGGED
DUE TO MARINE BORER DAMAGE

#37	Pile 37D 2" x 1" hole 4" deep near ground. YELLOW TAGGED. See photo 15.
#38	Pile 38A has marine borer damage at groundline. There is a 3" x 1" hole and there is center rot with a 4" shell. Pile was RED TAGGED (2010). REPAIR See photo 16.

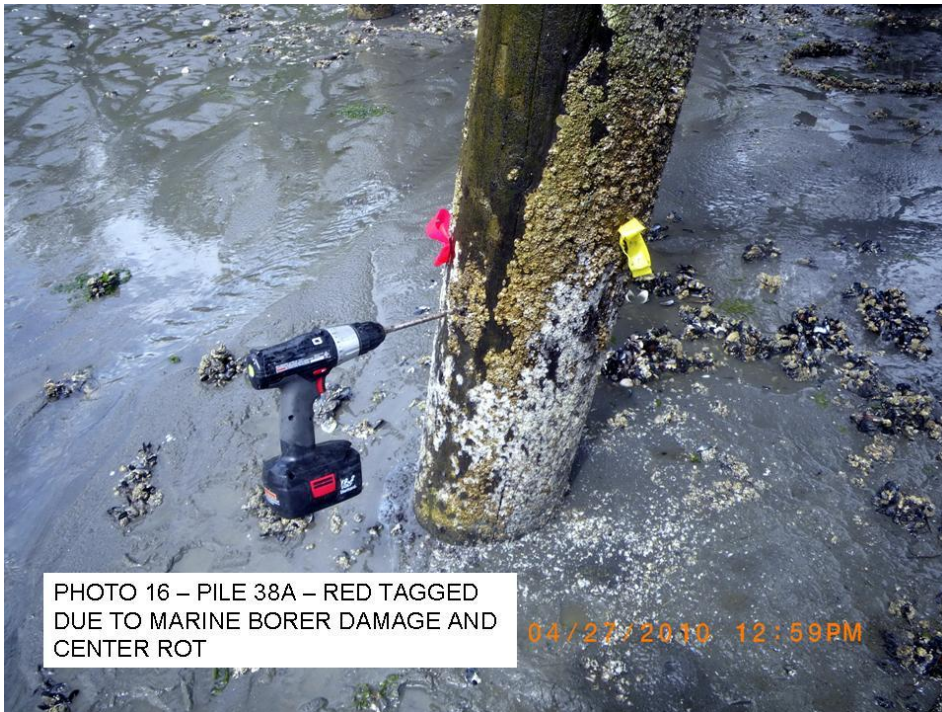
PHOTO 16 – PILE 38A – RED TAGGED
DUE TO MARINE BORER DAMAGE AND
CENTER ROT

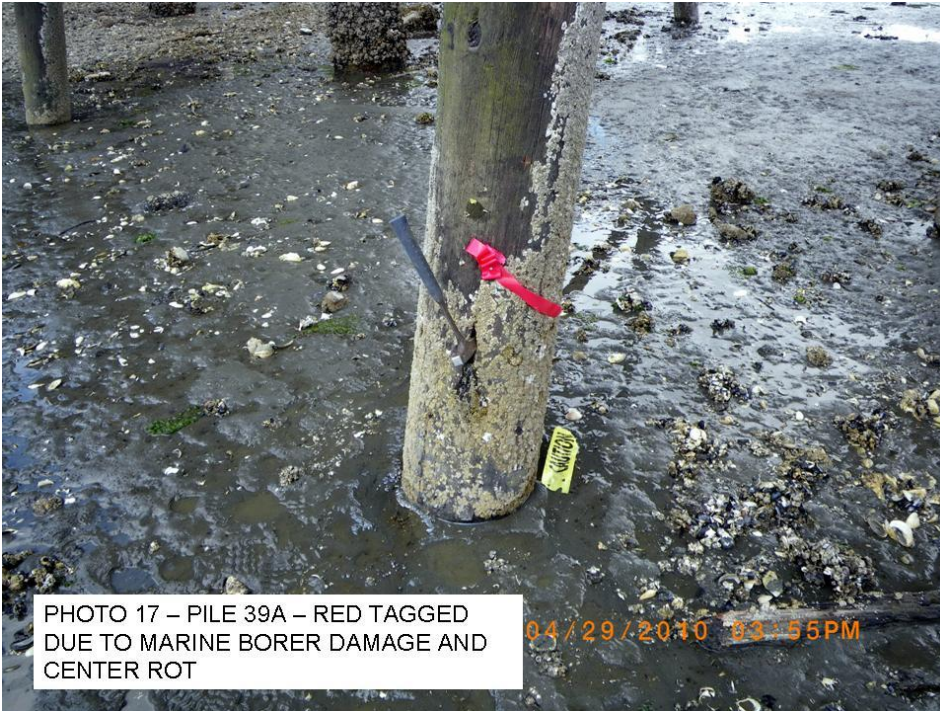
PHOTO 17 – PILE 39A – RED TAGGED
DUE TO MARINE BORER DAMAGE AND
CENTER ROT

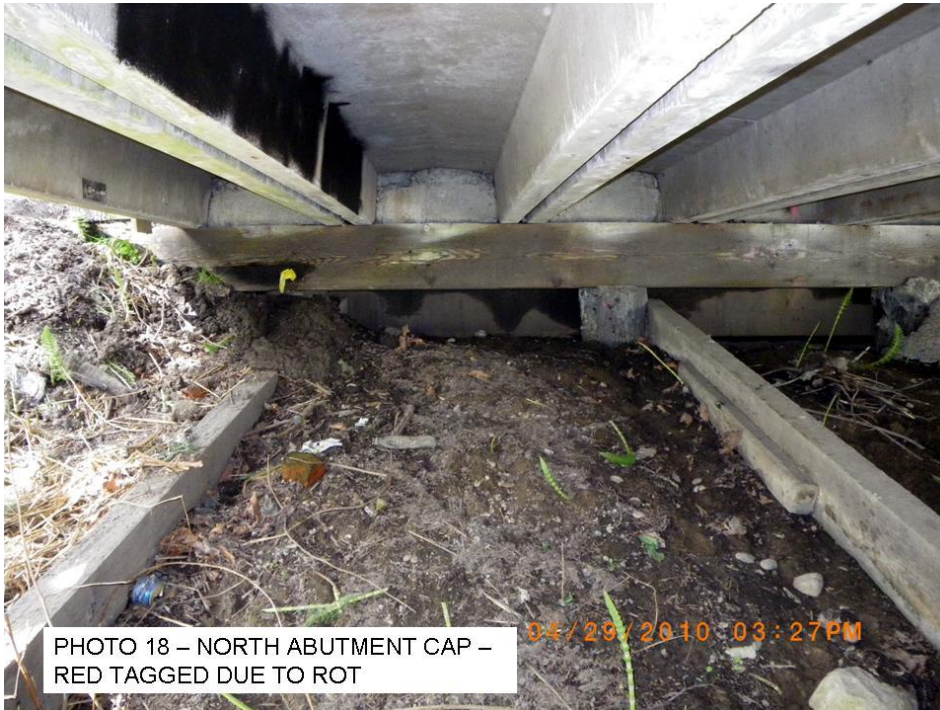
The North abutment cap has extensive rot. The front face has a 2" to 4" shell with rot through the remaining portion of the member. Fill was removed from above the west end and rot was found along the top. The backwall planks are also rotten. The cap was RED TAGGED for replacement. See photos 18, 19 and 20.

PHOTO 18 – NORTH ABUTMENT CAP –
RED TAGGED DUE TO ROT

North Abutment	Cap	The front face has a 2" to 4" shell with rot through the remaining portion of the member. West end has extensive rot along the top. The backwall planks are also rotten. The cap was RED TAGGED. See photos 18, 19 and 20.
Bent 17	Transverse Diagonal Brace	Extensive rot. See photo 21.
Bent 31	Transverse Diagonal Brace	Extensive rot and brace loose from piles. See photo 22.
Bent 32	Transverse Diagonal Brace	Extensive rot. See photo 23.
Bents 17 to 18 Piles 17B to 18B	Longitudinal Diagonal Brace	Extensive rot. See photo 24.
Bents 17 to 18 Piles 17C to 18C	Longitudinal Diagonal Brace	Extensive rot. See photo 24.
Bents 21 to 22 Piles 21B to 22B	Longitudinal Diagonal Brace	Extensive rot. See photo 25.
Bents 23 to 24 Piles 23B to 24B	Longitudinal Diagonal Brace	Extensive rot. See photo 26.
Bents 23 to 24 Piles 23C to 24C	Longitudinal Diagonal Brace	Extensive rot. See photo 27.
Bents 25 to 26 Piles 25B to 26B	Longitudinal Diagonal Brace	Extensive rot. See photo 28.

The timber cap and backwall at the north abutment have extensive rot. Temporary shoring to support the concrete girders should be added at this time. A more permanent repair will be required if bridge replacement is not planned within 5 years.

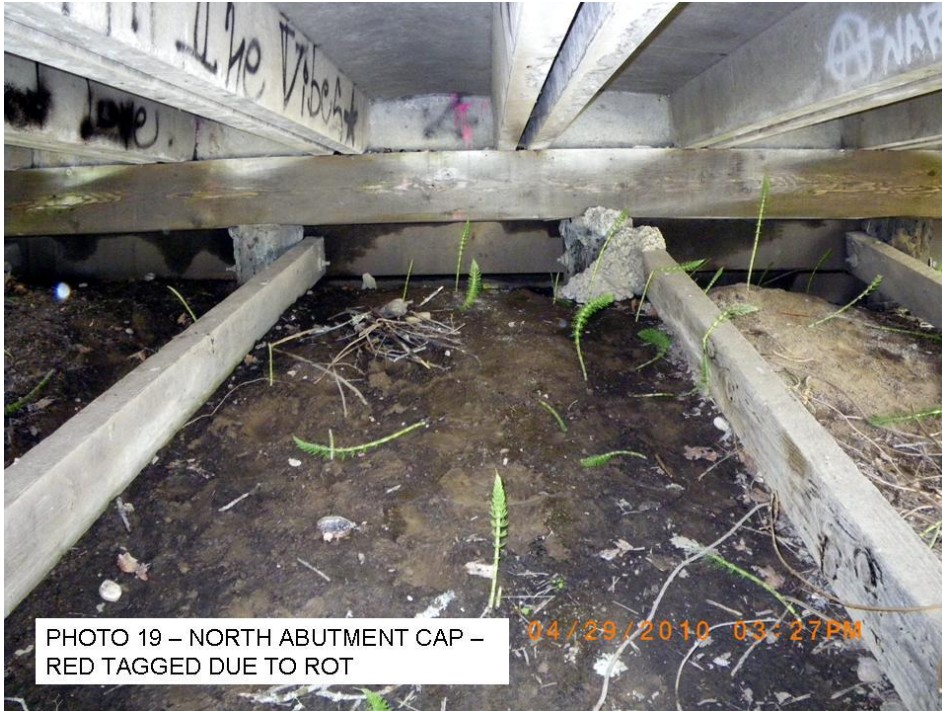
PHOTO 19 – NORTH ABUTMENT CAP –
RED TAGGED DUE TO ROT

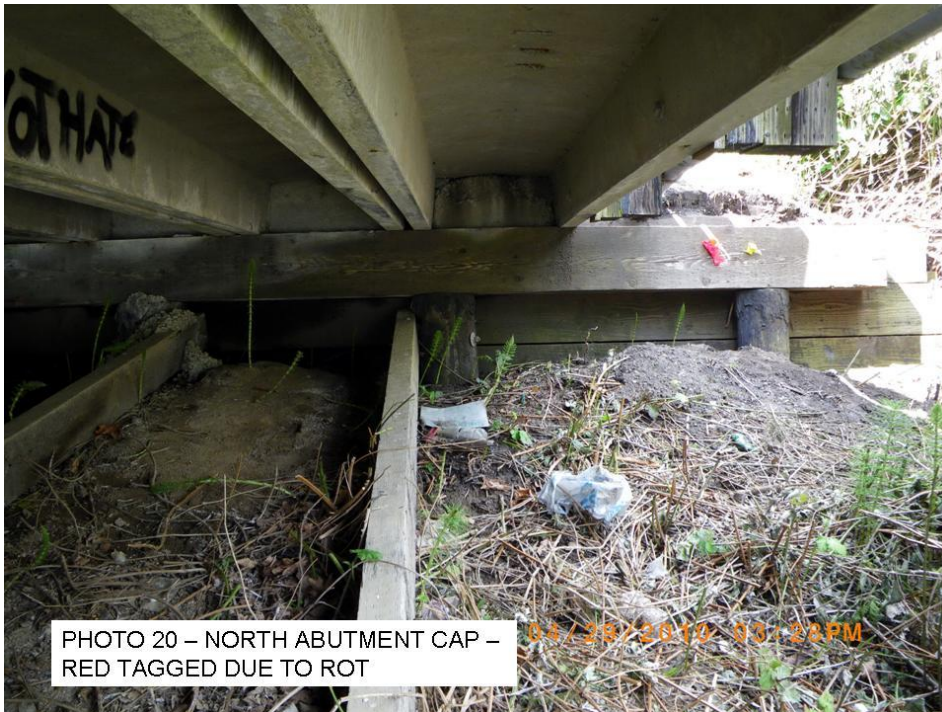
PHOTO 20 – NORTH ABUTMENT CAP –
RED TAGGED DUE TO ROT

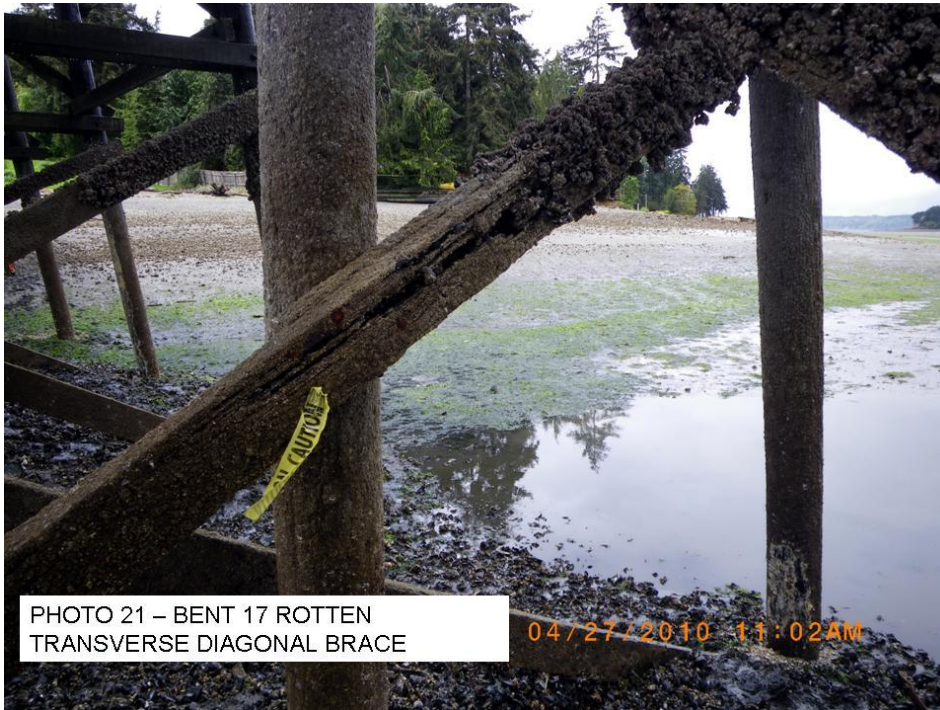
PHOTO 21 – BENT 17 ROTTEN
TRANSVERSE DIAGONAL BRACE

Transverse diagonal bracing at three locations and longitudinal diagonal bracing at eight locations requires replacement at this time.

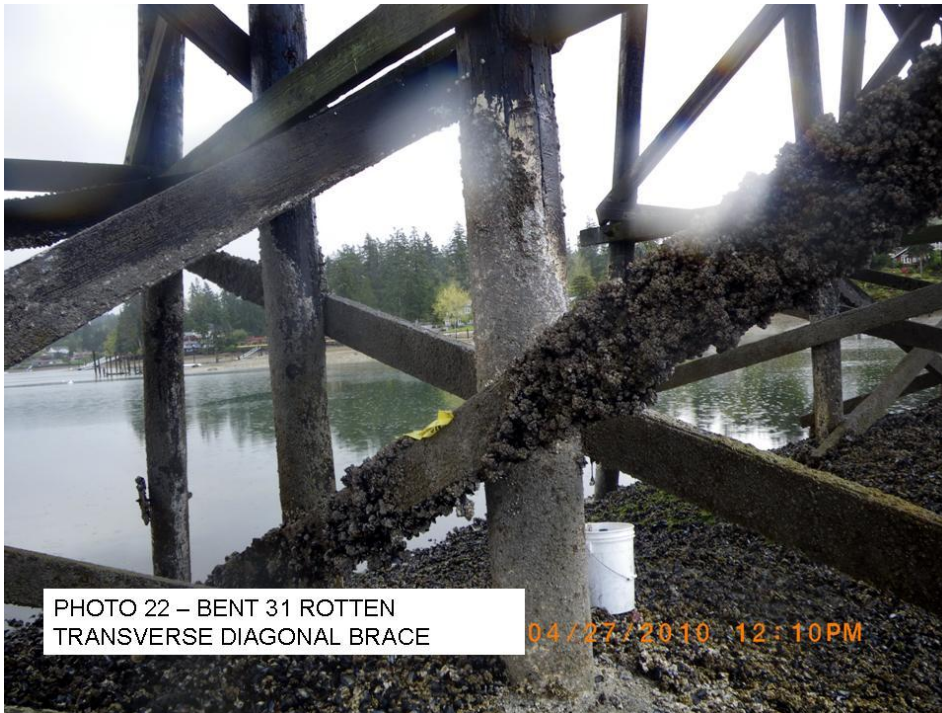
PHOTO 22 – BENT 31 ROTTEN
TRANSVERSE DIAGONAL BRACE

#31	Diagonal brace at top west end has rot.
#31	Rotten Transverse Diagonal Brace Pile 31A to 31D (31A is low end). See photo 22.
#31-#32	Rotten Longitudinal Diagonal Brace Pile 31C to Pile 32C (32C is low end). See photo 30.

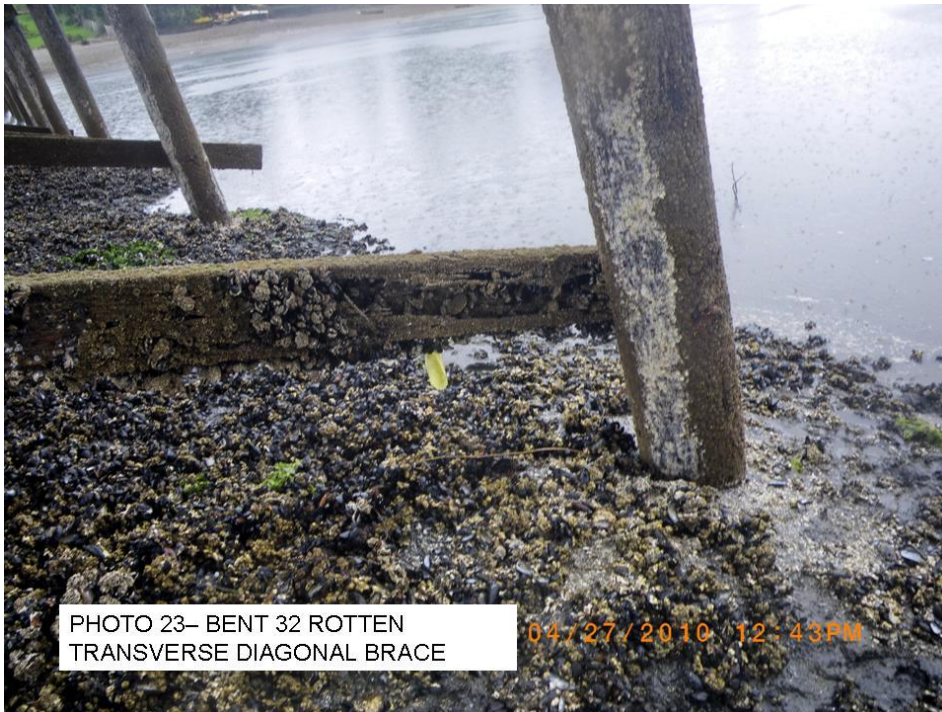
PHOTO 23– BENT 32 ROTTEN
TRANSVERSE DIAGONAL BRACE

#32	Pile 32D has metal strap at cap indicating pile is a replacement.
#32	Rotten Transverse Diagonal Brace Pile 32A to 32D (32D is low end). See photo 23.

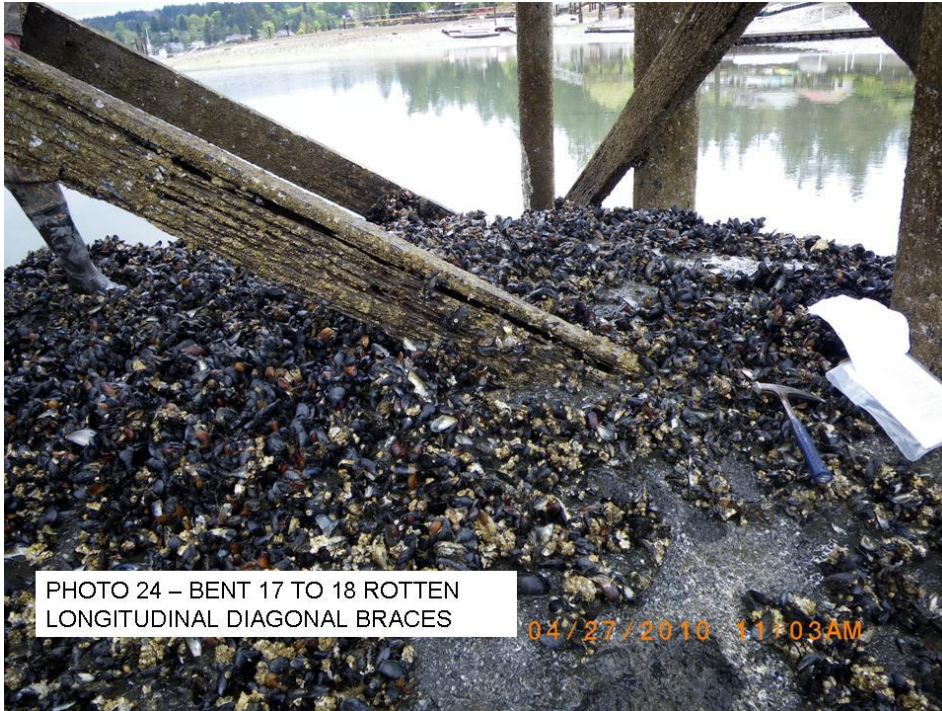
PHOTO 24 – BENT 17 TO 18 ROTTEN
LONGITUDINAL DIAGONAL BRACES

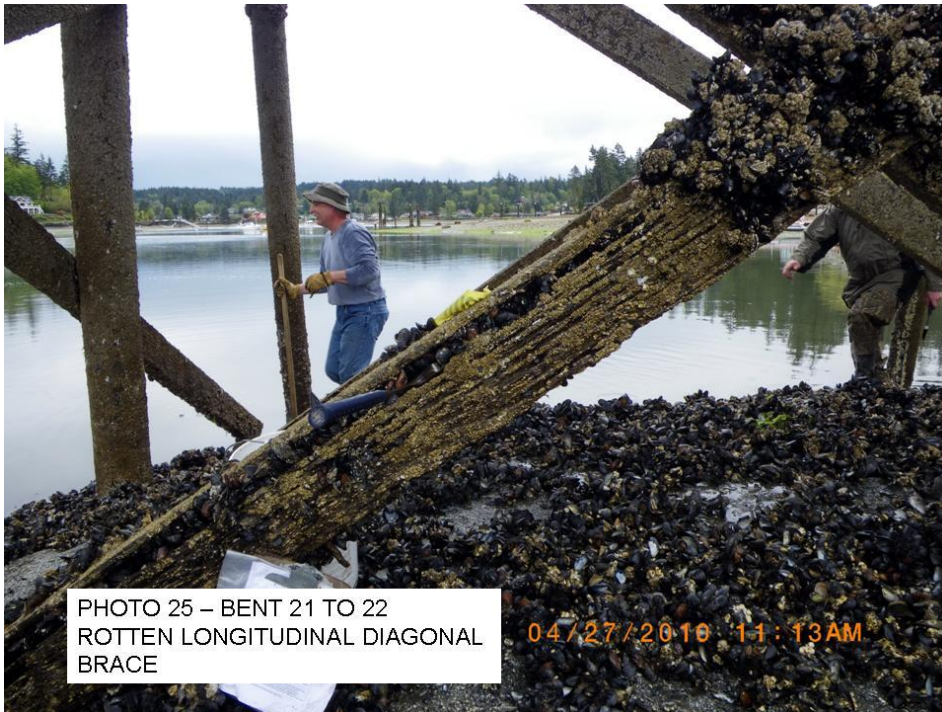
PHOTO 25 – BENT 21 TO 22
ROTTEN LONGITUDINAL DIAGONAL
BRACE

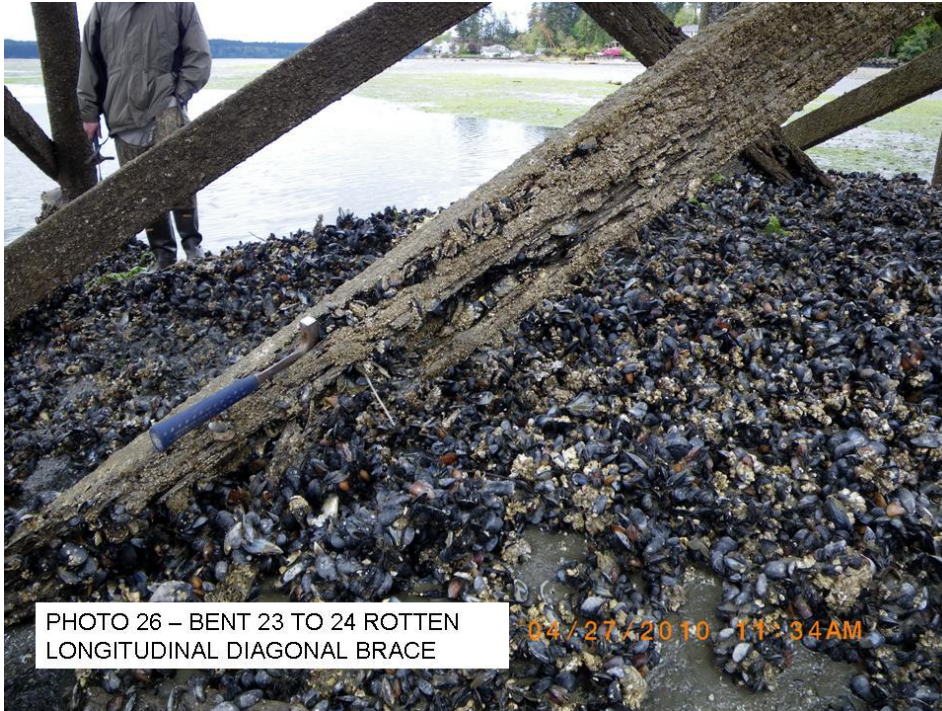
PHOTO 26 – BENT 23 TO 24 ROTTEN
LONGITUDINAL DIAGONAL BRACE

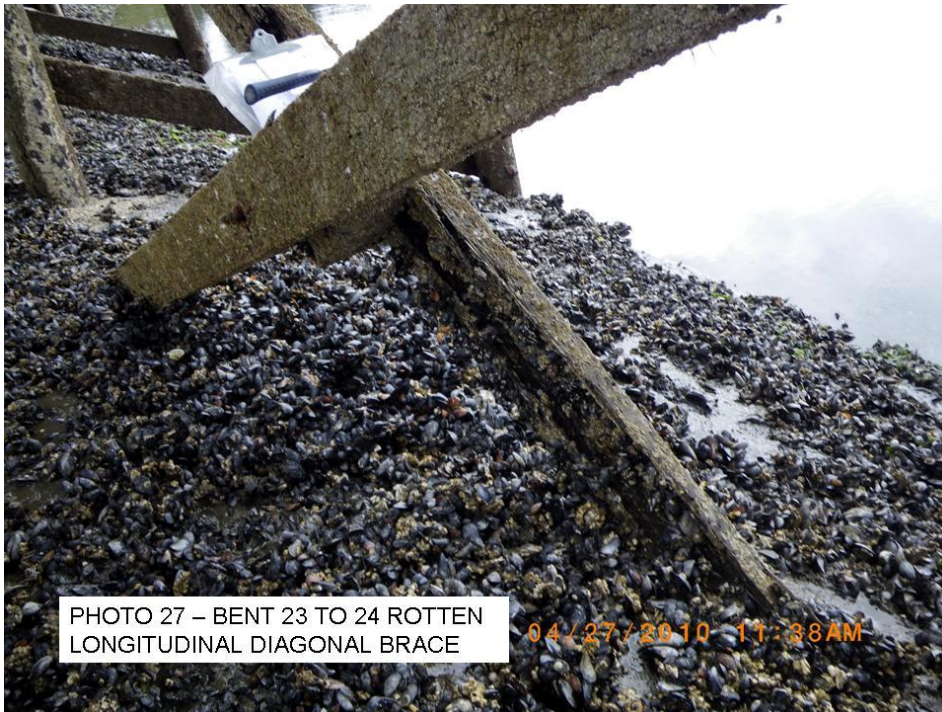
PHOTO 27 – BENT 23 TO 24 ROTTEN
LONGITUDINAL DIAGONAL BRACE

#23-#24	Rotten Longitudinal Diagonal Brace Pile 23C to Pile 24C (24C is low end). See photo 27
#24	Pile 24C has 3/16" wide split from ground 15' long. No rot found.

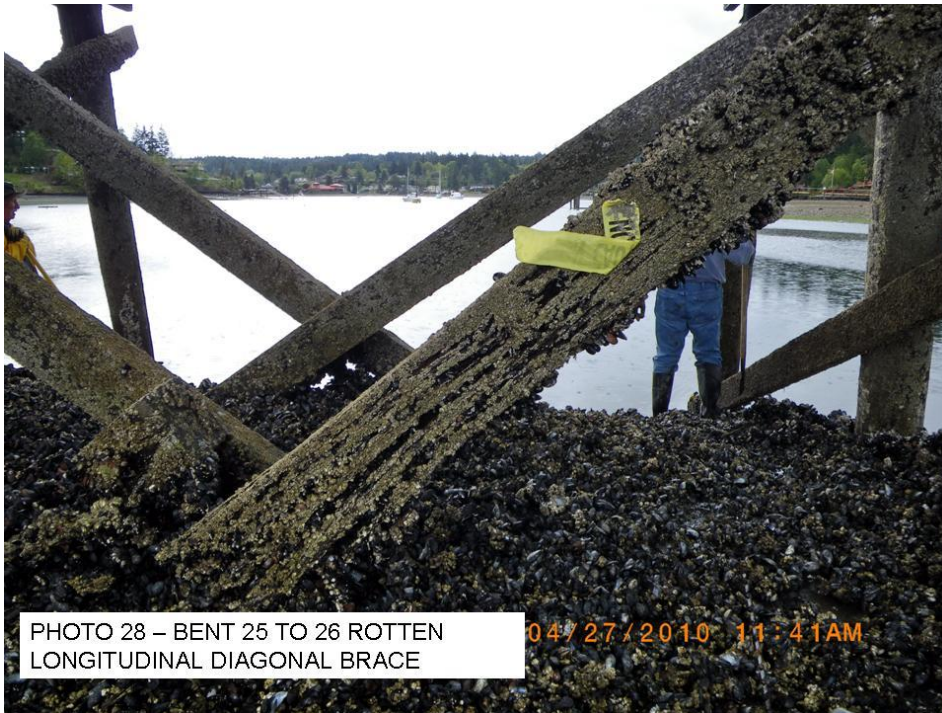
PHOTO 28 – BENT 25 TO 26 ROTTEN
LONGITUDINAL DIAGONAL BRACE

#25-#26	Rotten Longitudinal Diagonal Brace Pile 25B to Pile 26B (26B is low end). See photo 28.
#27	Pile 27B has 1/2" wide split from top 20' long.
#27	Pile 27D has full height 1/2" wide check. There is marine borer damage at groundline. Pile was YELLOW TAGGED (2007).

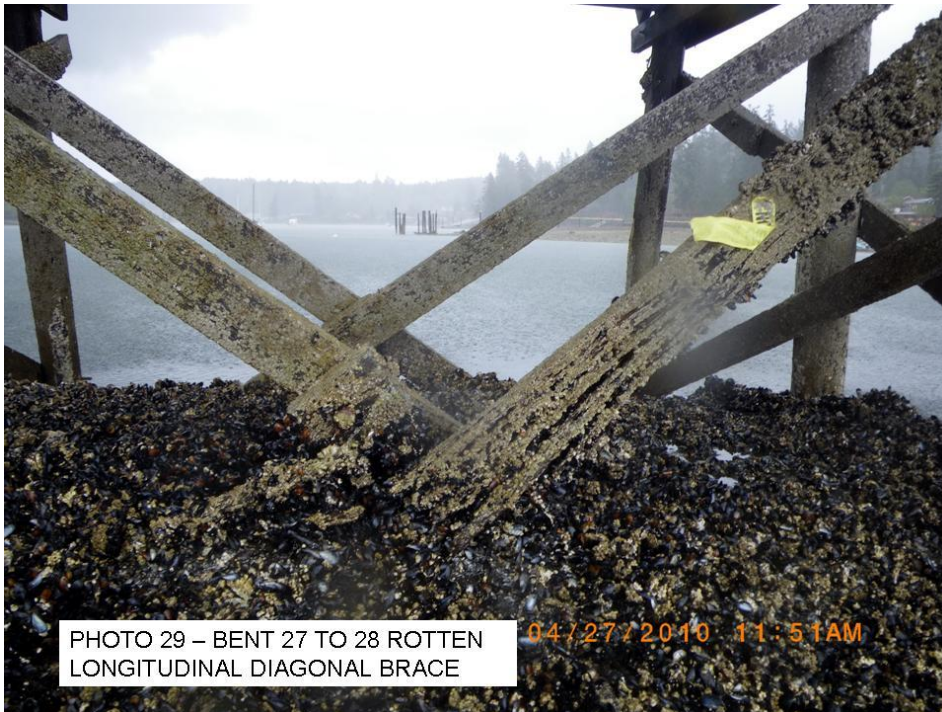
PHOTO 29 – BENT 27 TO 28 ROTTEN
LONGITUDINAL DIAGONAL BRACE

Bents 27 to 28 Piles 27B to 28B	Longitudinal Diagonal Brace	Extensive rot and broken off. See photo 29.
Bents 31 to 32 Piles 31C to 32C	Longitudinal Diagonal Brace	Extensive rot. See photo 30.

#27	Diagonal brace at top east end is split with rot.
#27-#28	Rotten Longitudinal Diagonal Brace Pile 27B to Pile 28B (28B is low end). See photo 29.
#28	Pile 28C has concrete filled splice at ground line with metal straps at cap.
