# **Raft Island Improvement Association**

## **2011 Bridge Inspection Report For Raft Island Bridge**

**Pierce County, Washington**

**July, 2011**

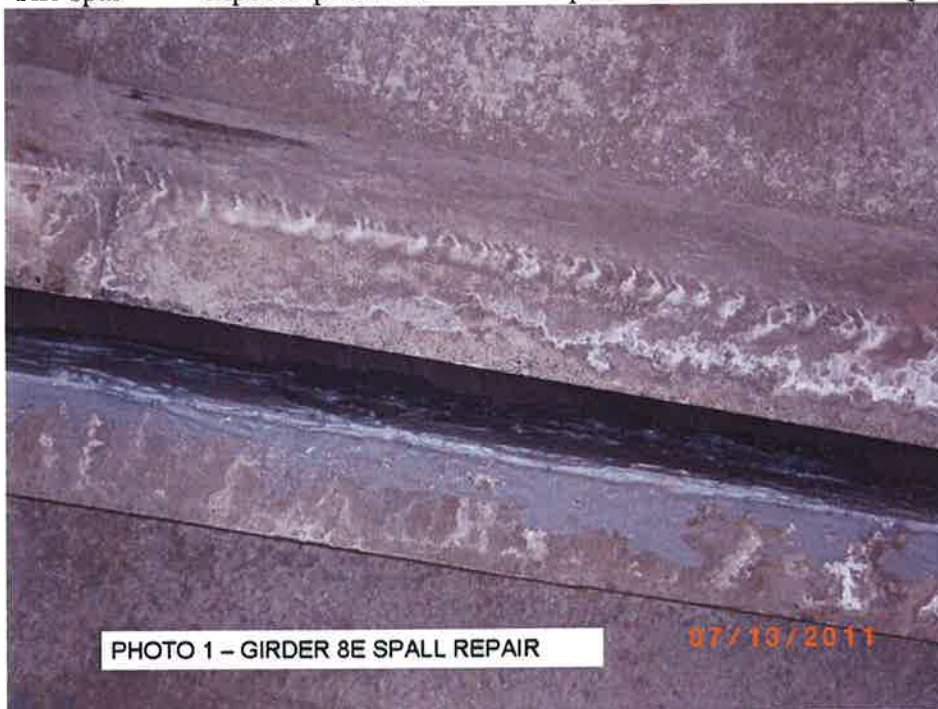
The spall with exposed prestress strand in Span 8 Girder E has been repaired. See photo 1.

PHOTO 1 – GIRDER 8E SPALL REPAIR

8	Girder E east web has a new repair patch. See photo 1. (2011)
8	Girder G has 3" diameter delamination near drain. Moisture and efflorescence present at various locations along the bottom edge of the webs. End diaphragm at north end of Girder B has 4" diameter spall.
9	Girder A and G have epoxy patches along soffit centerline. Moisture and some efflorescence is present along the bottom edge of the webs at various locations. Girder G has a 4" diameter spall with exposed rebar near the drain. (2011)
10	Girders A and G have epoxy patches along soffit centerline. Efflorescence present at various locations along the bottom edge of the webs.
11	Girders A and G have epoxy patches along soffit centerline. Girder A East web has 8" x 4" x 1" spall. Efflorescence present at various locations along the bottom edge of the webs.
12	Girders A, C and D have small spalls along bottom of webs. Girder

The repair to patch the concrete spall in Girder 8E was complete.

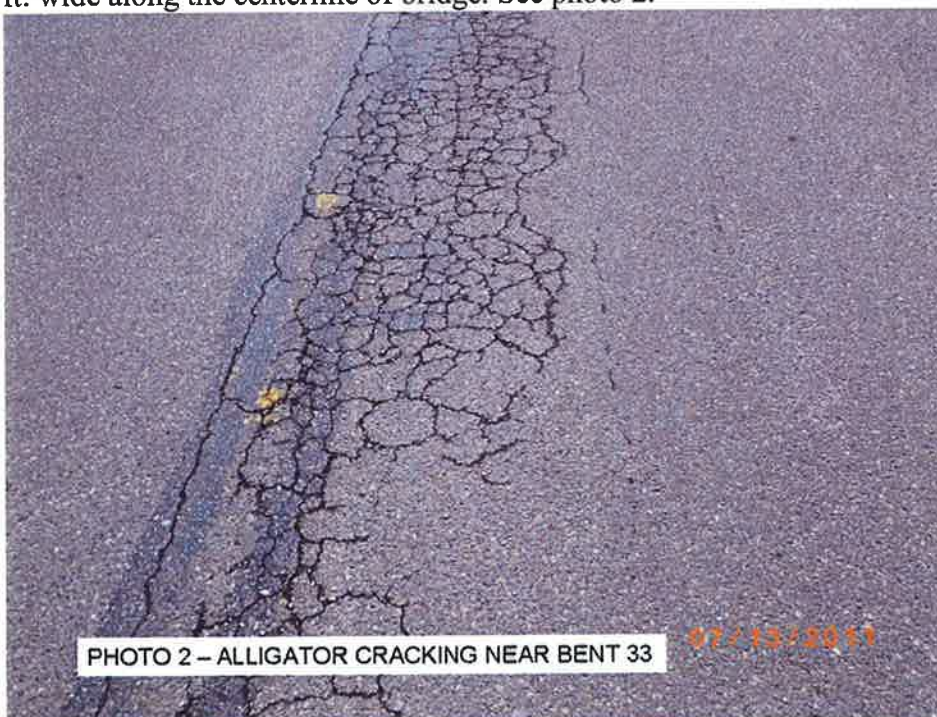
The asphalt depth is approximately 2”. The majority of the distresses were located near the expansion joints, which consists of alligator cracks and visible signs of deterioration of the existing asphalt patches. There is also alligator cracking in a strip that varies from 1 ft. to 2 ft. wide along the centerline of bridge. See photo 2.

PHOTO 2 – ALLIGATOR CRACKING NEAR BENT 33

LOCATION	ITEM	DEFICIENCIES DESCRIPTION
Dech Overlay	Asphalt	There is also alligator cracking in a strip that varies from 1 ft. to 2 ft. wide along the centerline of bridge. See photo 2.
Bent 5 Pile D	Pile	Marine borer damage at groundline. There is a 1" diameter hole. YELLOW TAGGED.
Bent 8 Pile D	Pile	3" of center rot with 4" shell near ground. YELLOW TAGGED.
Bent 16 Pile D	Pile	Marine borer holes near ground. YELLOW TAGGED.
Bent 19 Pile D	Pile	Marine borer holes near ground. YELLOW TAGGED.
Bent 27 Pile D	Pile	Full height 1/2" wide split. There is marine borer damage at groundline. YELLOW TAGGED
Bent 29 Pile B	Pile	Marine borer hole near ground. 2" diameter. YELLOW TAGGED.
Bent 30 Pile B	Pile	Marine borer hole near ground. 2 holes. YELLOW TAGGED.
Bent 31 Pile C	Pile	Marine borer hole near ground. 2" diameter hole 6" deep. YELLOW TAGGED.
Bent 33 Pile B	Pile	Rot pocket with 5" shell 7' above ground. YELLOW TAGGED.

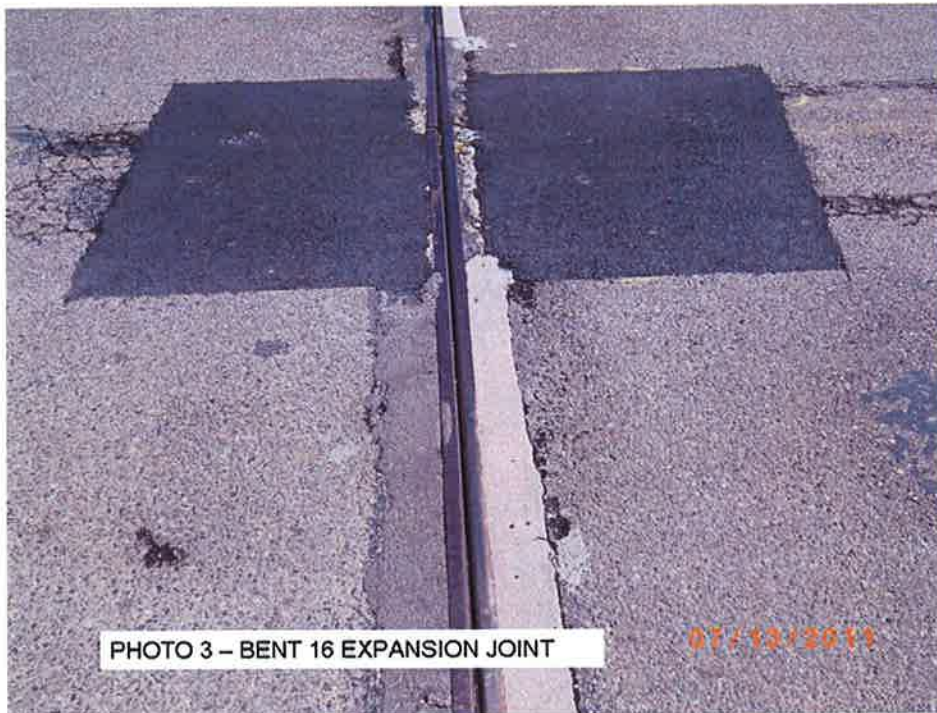
At Bent 16 expansion joint there are new asphalt patches on both sides of the joint. See photo 3.

The expansion joints at Bent 16 is a strip seal with a measured opening of approximately 3/4” between the steel extrusions. The joint was repaired in 2008 using the material Set 45 as a new header on the south side of the joint. There are seven 2” diameter patches where ports were created to pour the new diaphragms. The old header on the north side of the joint is cracked and spalled. See photo 3.

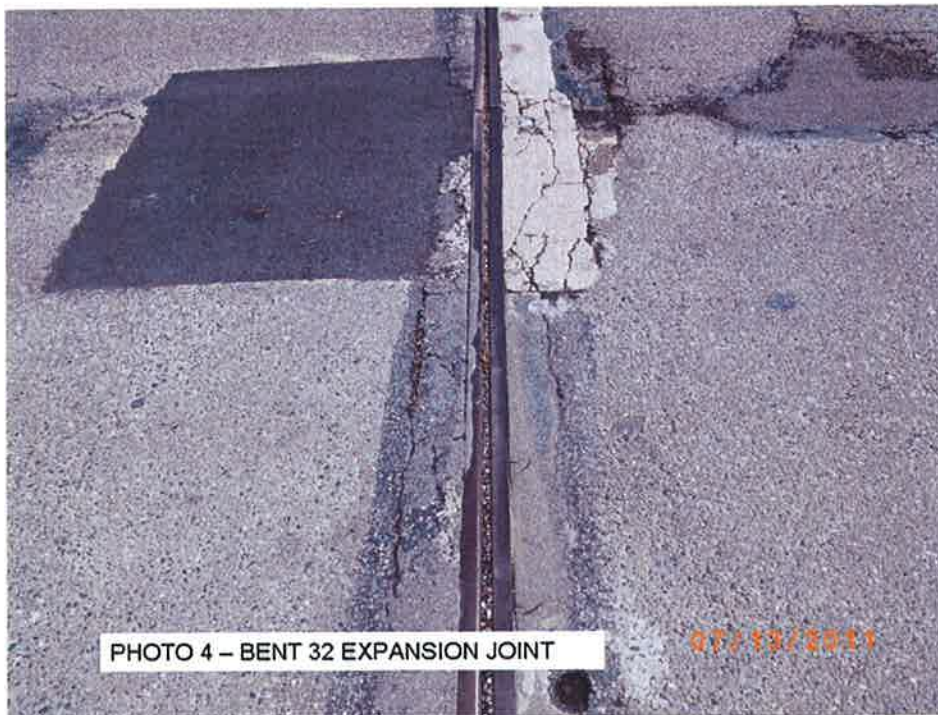
At Bent 32 expansion joint there are new asphalt patches on both sides of the joint. The old patch along the north side of the joint is breaking up. See photo 4.

The expansion joint at Bent 32 is a strip seal with a measured opening of approximately 3/4” between the steel extrusions. There is an old concrete patch at centerline that is cracked and starting to break up. There are seven 2” diameter patches where ports were created to pour the new diaphragms. The old header on the north side of the joint is cracked and breaking up. See photo 4.

LOCATION	ITEM	DEFICIENCIES DESCRIPTION
North of the expansion joint at Bent 32	Header	The header on the north side of the joint is cracked and breaking up. See photo 4.

The header on the north side of the joint at bent 32 is cracked and breaking up. It should be rebuilt with new anchors and header material.

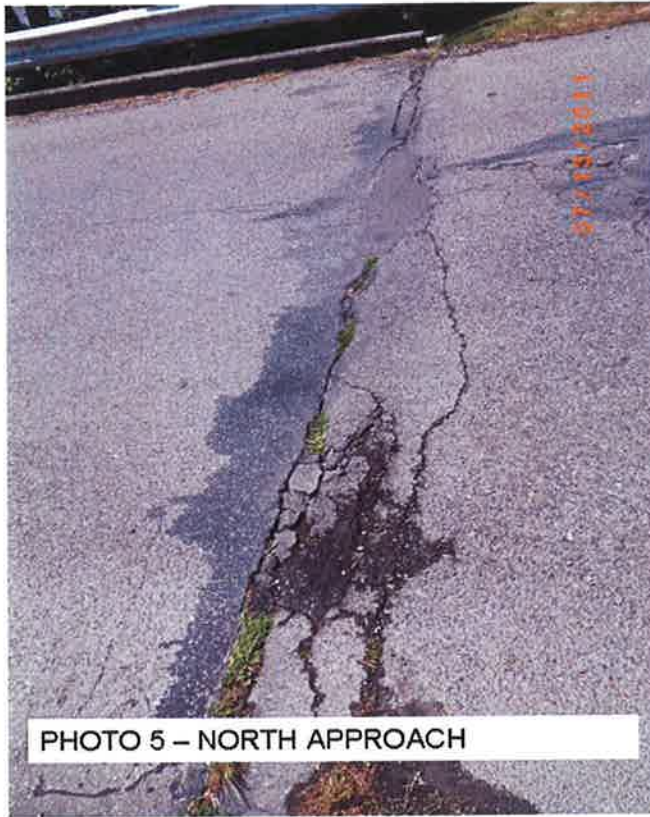
At the north abutment there is cracking full width with some “D” cracking. In the northbound lane the asphalt is breaking up. It is anticipated that this cracking will worsen as the rotten timber cap deteriorates. See photo 5.

The South Approach is smooth due to the joint repair in 2009. See photo 4. The North Approach has several large patches and is approximately  $\frac{3}{4}$ " higher than the bridge which is causing moderate impact to the bridge. See photo 5.

The North abutment cap has extensive rot. The front face has a 2" to 4" shell with rot through the remaining portion of the member. Fill was removed from above the west end and rot was found along the top. The backwall planks are also rotten. The cap was RED TAGGED for replacement. A repair to add temporary shoring is in the current contract. The fill from in front of the wall has been excavated down approx. 3 ft. below the cap and a minimum of 12" out from the front of the cap.

The timber cap and backwall at the north abutment have extensive rot. Temporary shoring to support the concrete girders is in the current contract.. A more permanent repair will be required if bridge replacement is not planned within 5 years.

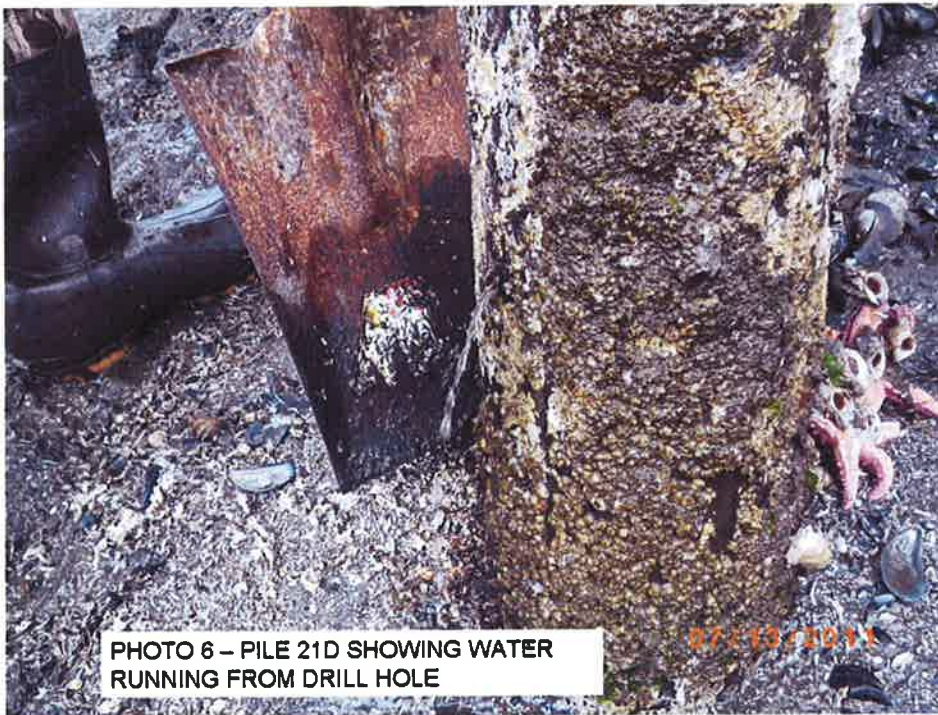
The sounding results indicated some audible signs of rot and/or marine borer damage. In 2009 nine piles were found to have damage. In 2010 nineteen piles were found to have damage. In 2011 5 piles were being repaired by adding fiberwrap jackets filled with grout. There were 14 piles remaining that were found to have damage with one deleted from the 2010 list and one new addition. Piles 5D, 8D, 16D, 19D, 21D, 22A, 27D, 29B, 30B, 31C, 33B (new in 2011), 37D and 33D have damage from marine borers near the ground line. Pile 37A had a ½" wide split at mid height with center rot, 4" shell with 2" rot pocket. See photos 6 and 7.

PHOTO 6 – PILE 21D SHOWING WATER  
RUNNING FROM DRILL HOLE

<b>LOCATION</b>	<b>ITEM</b>	<b>DEFICIENCIES DESCRIPTION</b>
Bent 21 Pile D	Pile	Marine borer damage at groundline. 2" diameter hole. 2" shell with 6" center rot. Water poured from drill hole. RED TAGGED. See photo 6.
Bent 22 Pile A	Pile	Marine borer damage at groundline. 2" diameter hole. 2" shell with 6" center rot. RED TAGGED. See photo 7.
North Abutment	Cap	The front face has a 2" to 4" shell with rot through the remaining portion of the member. West end has extensive rot along the top. The backwall planks are also rotten. The cap was RED TAGGED. A repair to add temporary shoring is in the current contract.
Bent 17	Transverse Diagonal Brace	Extensive rot. A repair to replace the bracing is in the current contract.
Bent 31	Transverse Diagonal Brace	Extensive rot and brace loose from piles. A repair to replace the bracing is in the current contract.
Bent 32	Transverse Diagonal Brace	Extensive rot. A repair to replace the bracing is in the current contract.

#21	Pile 21D. Marine borer damage at groundline. 2" diameter hole. 2" shell with 6" center rot. Water poured from drill hole. RED TAGGED. See photo 6. This was added to the current repair contract.

Repairs are required at this time to piles 21D and 22A.

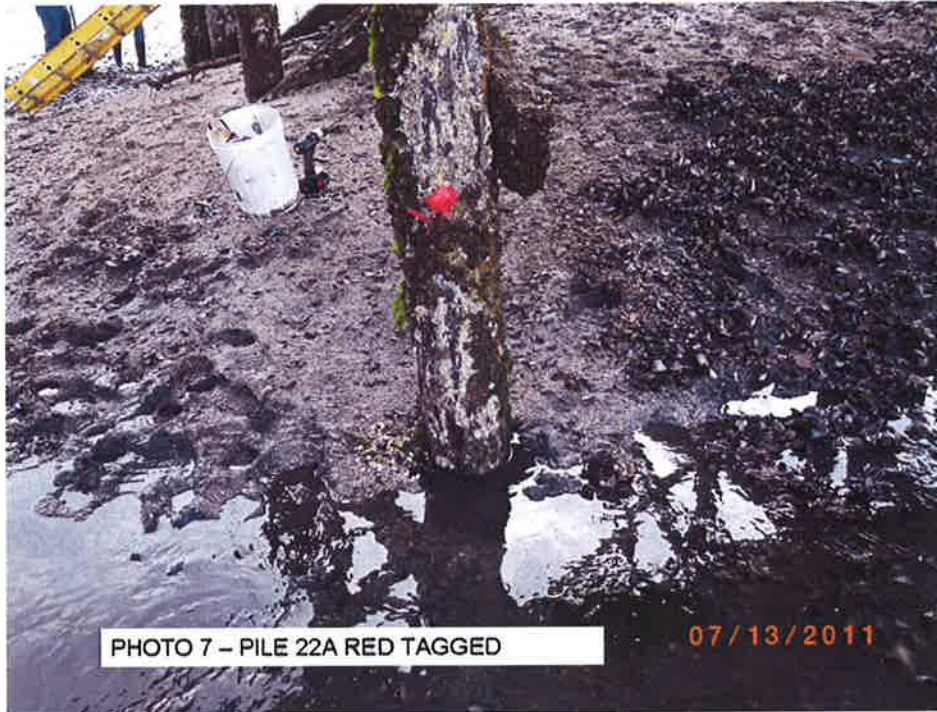
#22	Pile 22A. Marine borer damage at groundline. 2" diameter hole. 2" shell with 6" center rot. RED TAGGED. See photo 7. This was added to the current repair contract.

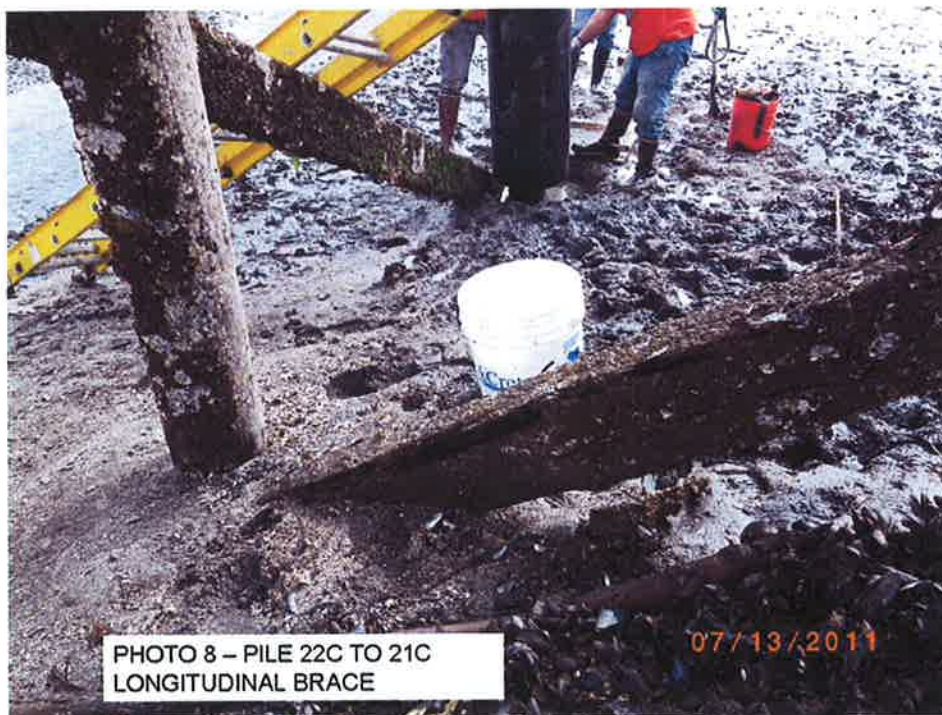
In addition to the timber pile repairs, some lateral bracing had been replaced over the years. Most of the bracing members are in fair condition but three transverse diagonals and eight longitudinal diagonals have extensive rot or are broken and were TAGGED for replacement in 2010. An additional longitudinal brace between piles 22C and 21C was added in 2011. See photo 8.

Transverse diagonal bracing at three locations and longitudinal diagonal bracing at eight locations is in the current contract. One additional longitudinal brace should be added to that repair.

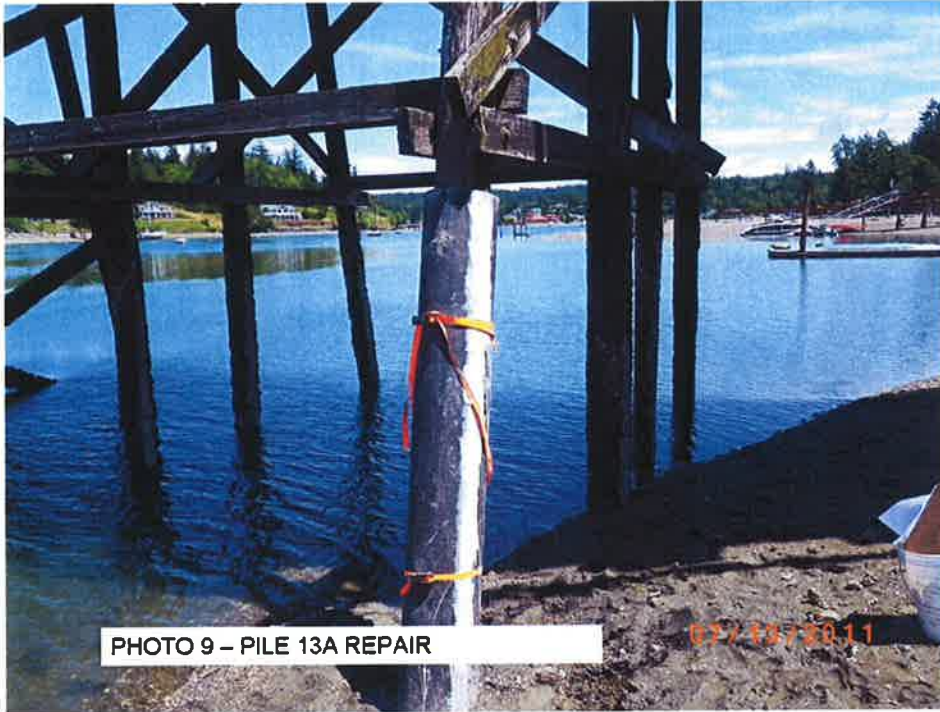
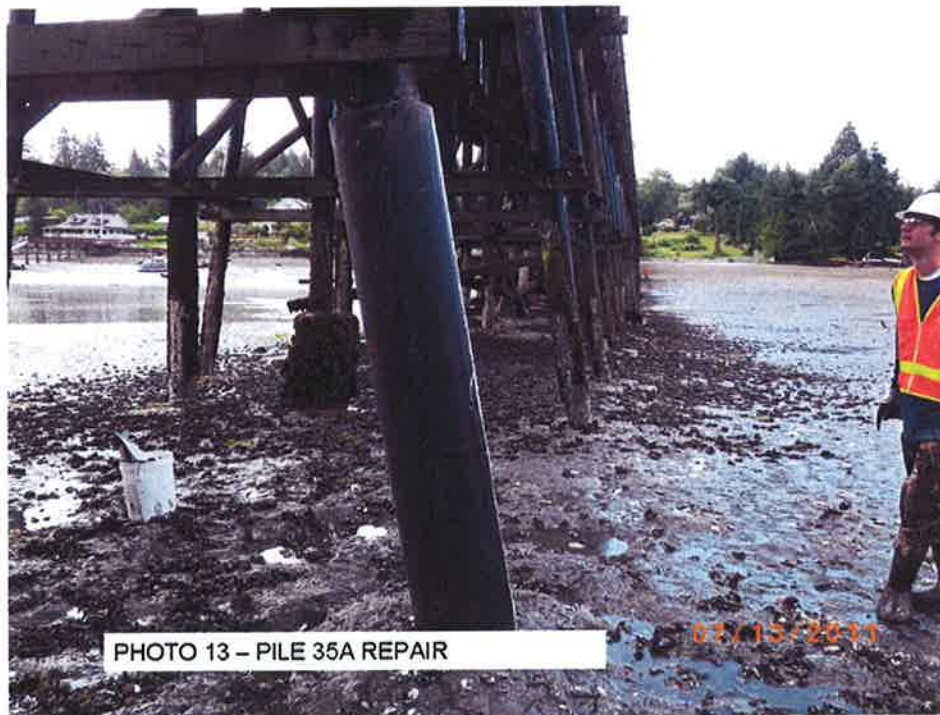
Repairs to piles 13A, 35A, 38A and 39A were complete.

#12	Cap has split along bottom on west end open to 1/4".
#13	Pile 13A has been repaired with a fiberwrap jacket and concrete grout. See photo 9.
#13	Pile 13C has concrete filled splice at ground line with metal straps at cap. Several worm holes 7' from ground.

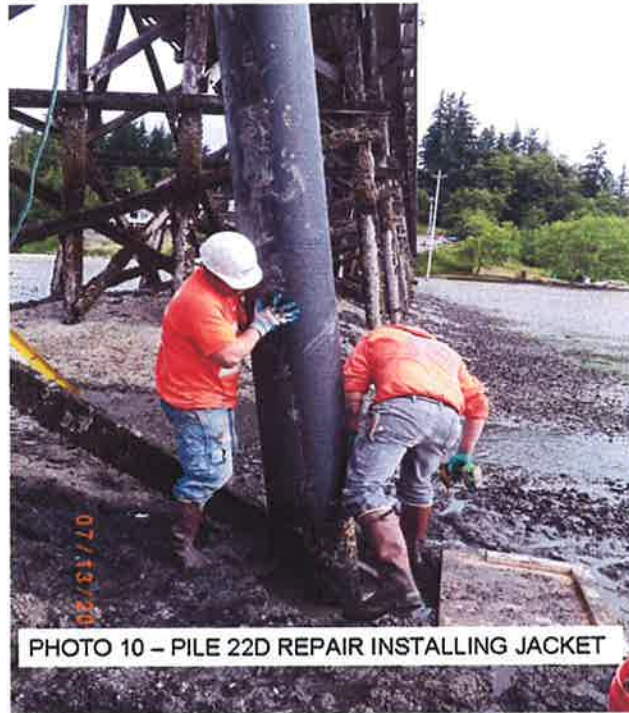
The fiberwrap jacket was installed for Pile 22D and 1 ft. of grout. The repair was scheduled for completion on the following day.

#22	Pile 22D has been repaired with a fiberwrap jacket and concrete grout. See photo 10.
#22	Cap has full length split along bottom.
#23	Pile 23A has concrete filled splice at ground line with metal straps at cap.
