**STRUCTURAL ENGINEERING STUDY OF
RAFT ISLAND BRIDGE, APRIL 2012**

**STRUCTURAL ENGINEERING STUDY OF RAFT ISLAND BRIDGE
INDEX**

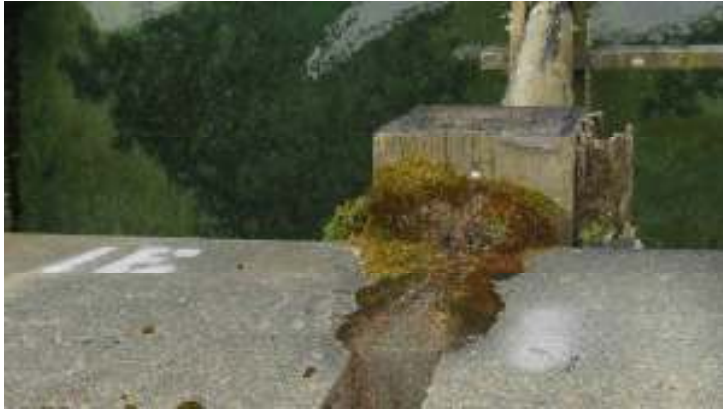
The creosote treatment higher on the piles is still quite visible. Also, the X-bracing serves as a useful reference point in the way in which the wood may deteriorate. The field survey noted that many braces were in generally good condition, hollowed out at their tops, due to wind driven rain, especially from the west. See the photo below, from bent 3 as an illustration.

Note top of X-Brace rotting

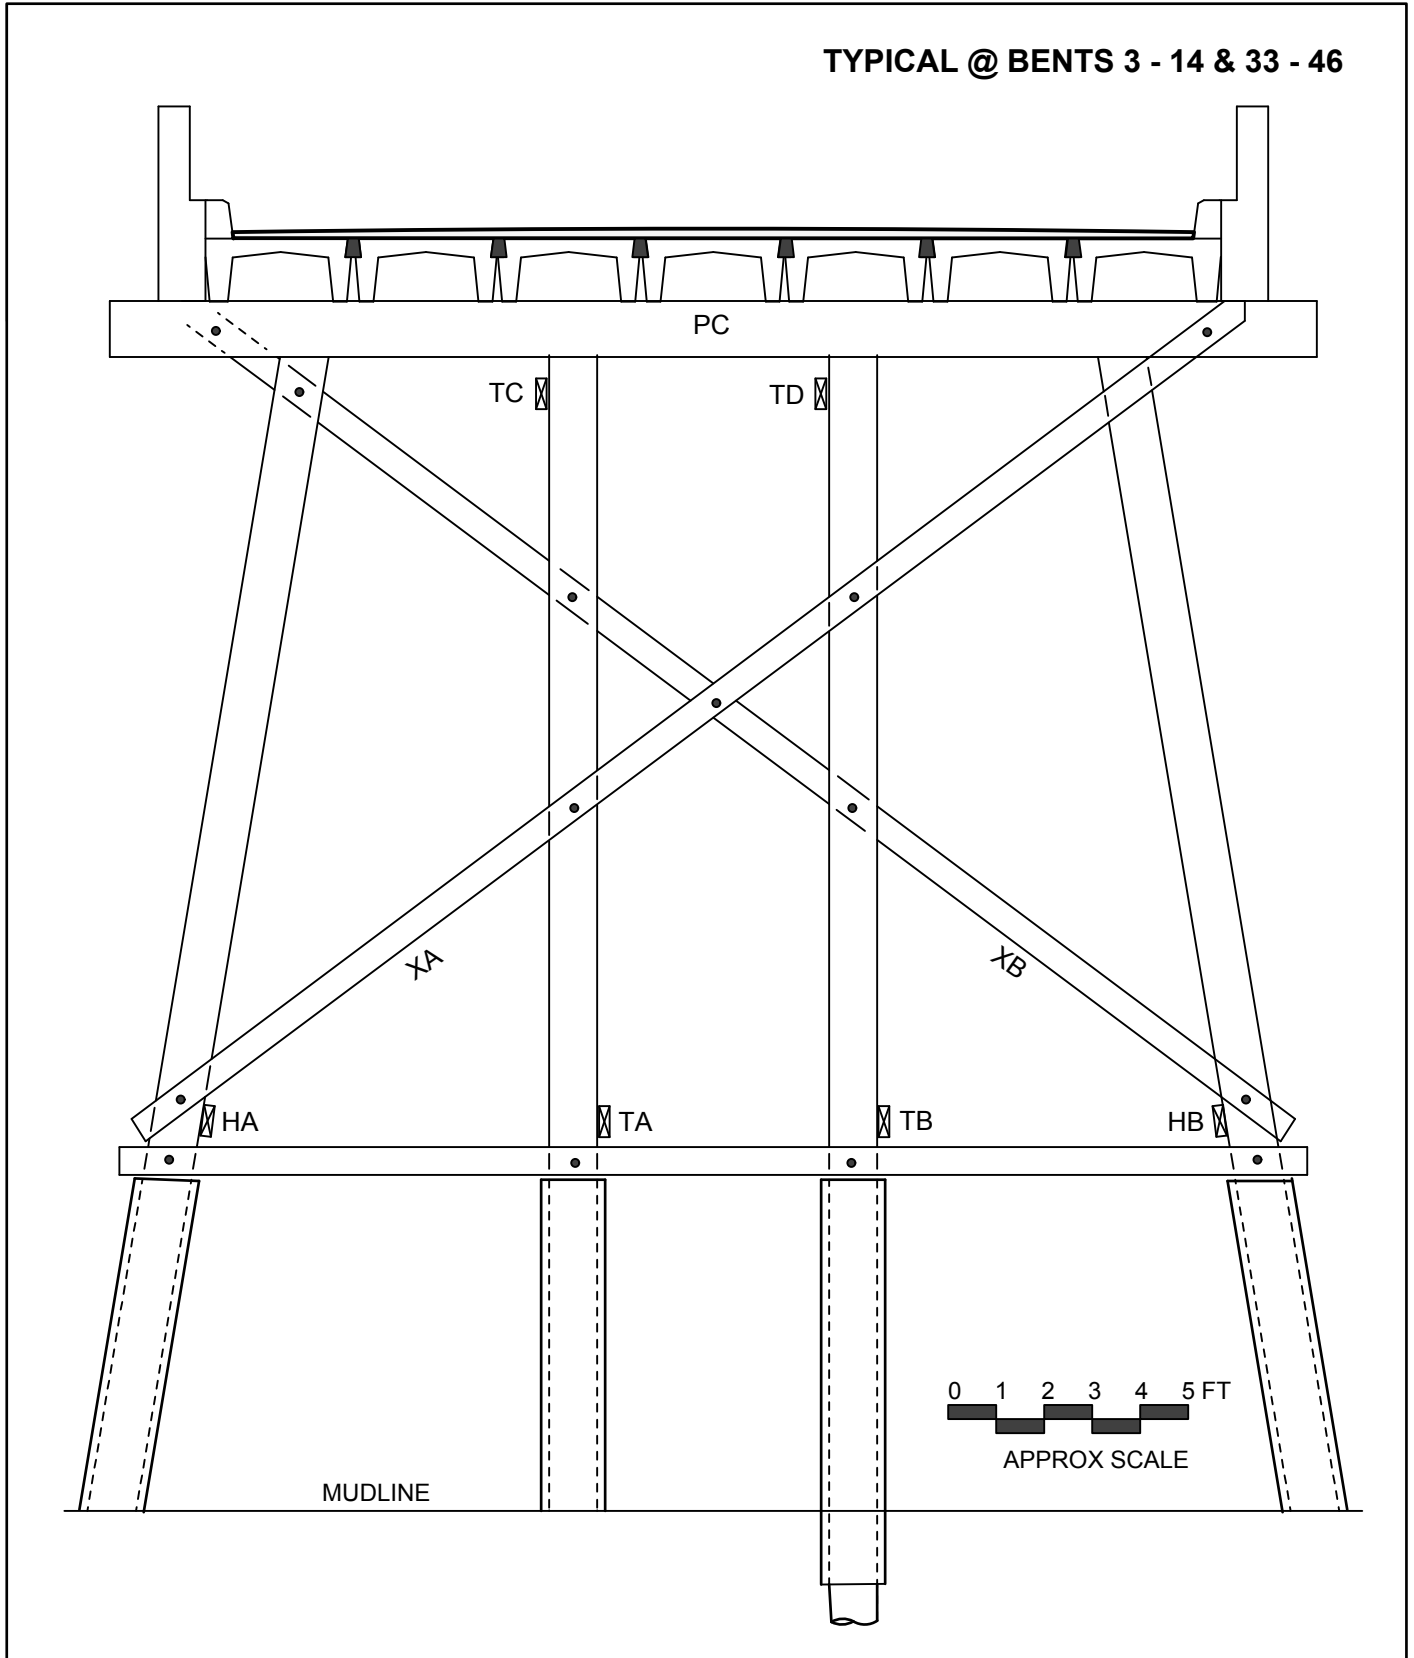
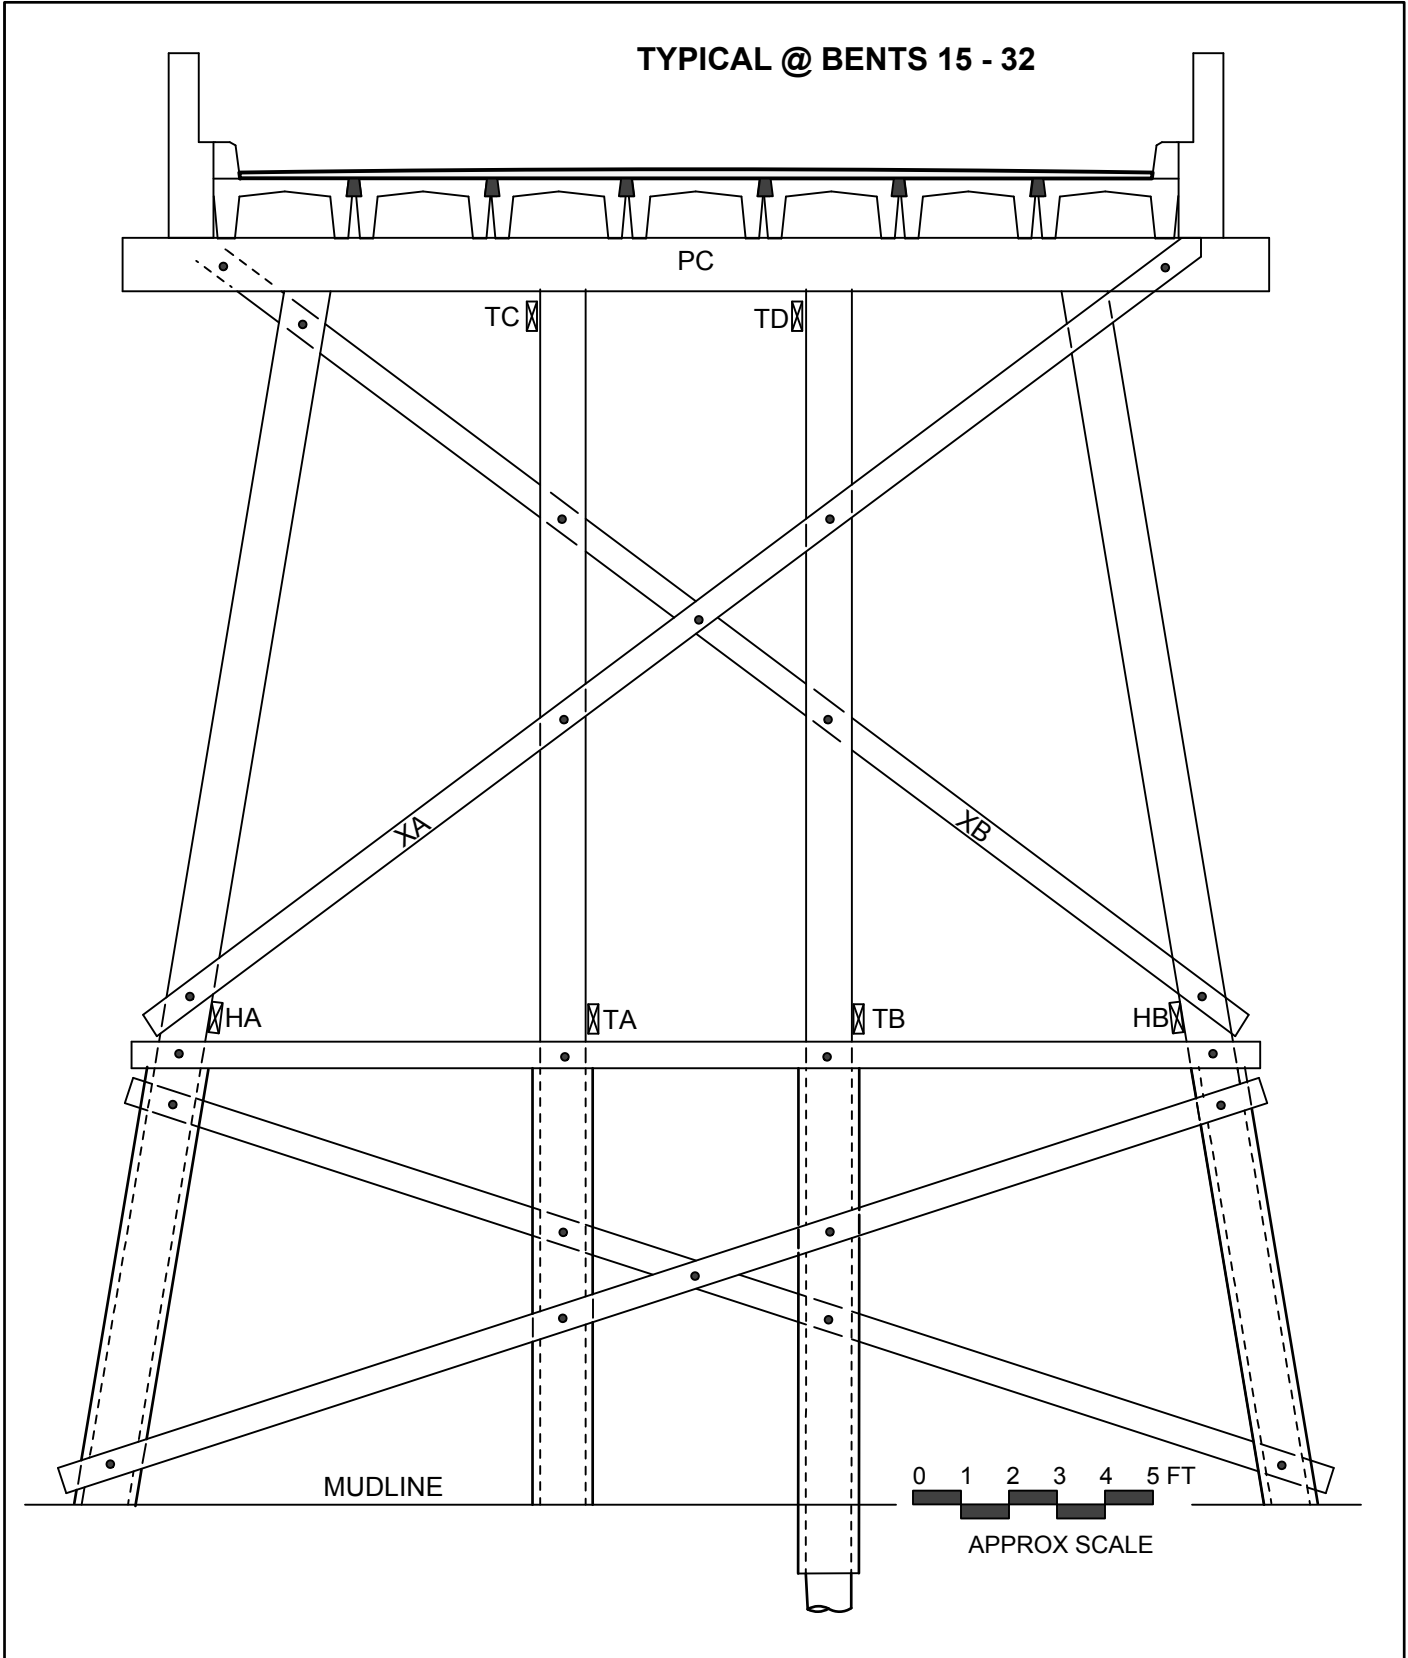
Results are summarized in Tables 1 and 2. Those members that were sampled were noted with "xx" in the tables. Those members which are judged to be in need of repair are noted as "RIK" for "Replace in Kind." Note that in cases where pilecaps are noted "RIK" pressure injection of epoxy resin is also an acceptable repair method.

1. Replace wood members as noted "RIK" in the Tables.
2. Replace wood members as noted "RIK" in the Tables.
3. Wrap all piles from bents 3 through 46 in fiberglass jackets (made to desired color) and grout them from 2' below mudline to 10.5' elevation, according to the datum established by Aspen Land Survey. The piles would first be cleaned of sea life, reinforcing steel applied around the pile, and the fiberglass jackets zippered into place. Grout would be tremied into the jacket forms. Where bracings intersect piles at a jacket, the bracing would be bolted through the jacket, which would be "tailored" for this purpose.
