# PROFESSIONAL RESERVE STUDY

## Raft Island Homeowners Association

Raft Island, Gig Harbor, WA 98335

**April 4, 2019**

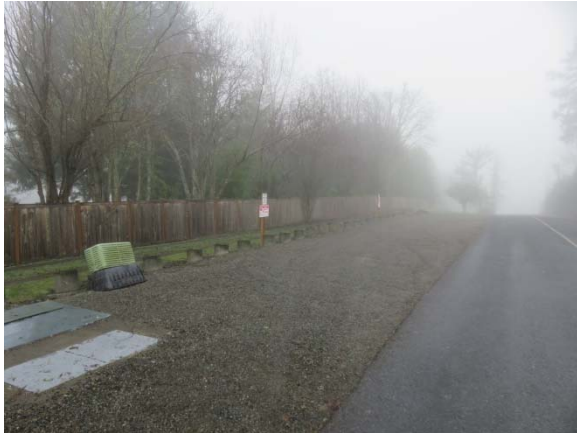
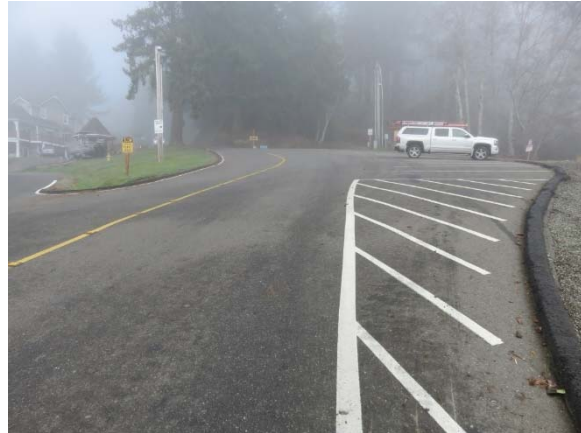
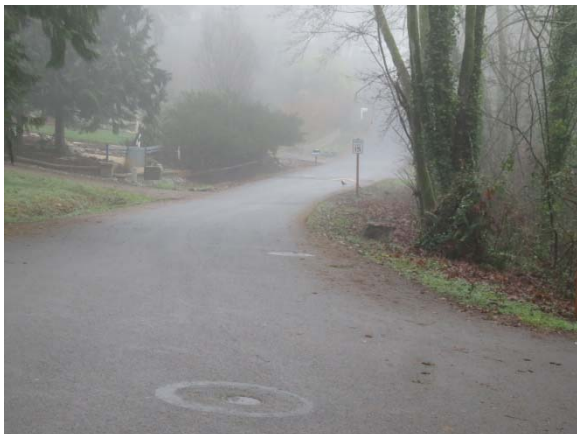
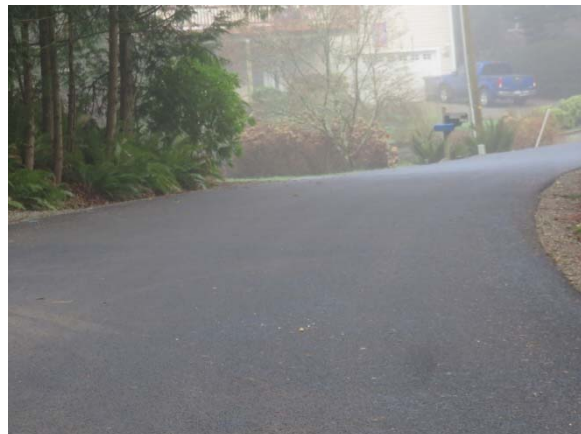
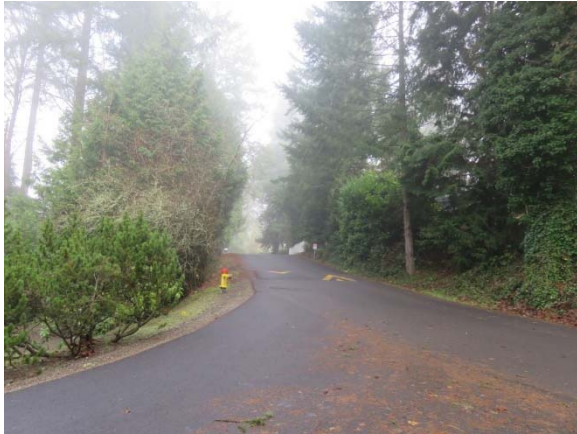
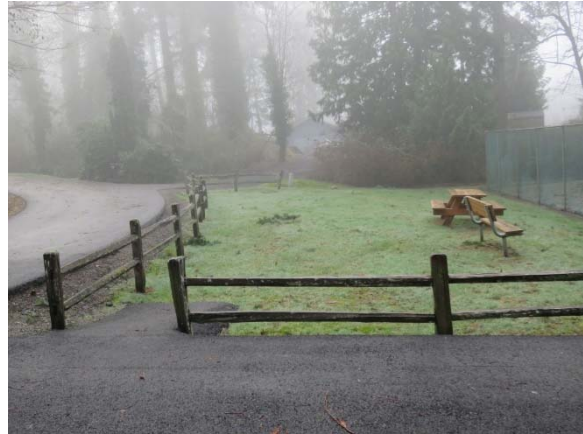
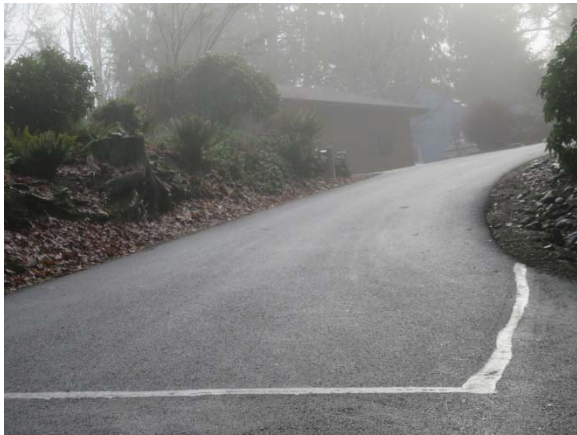
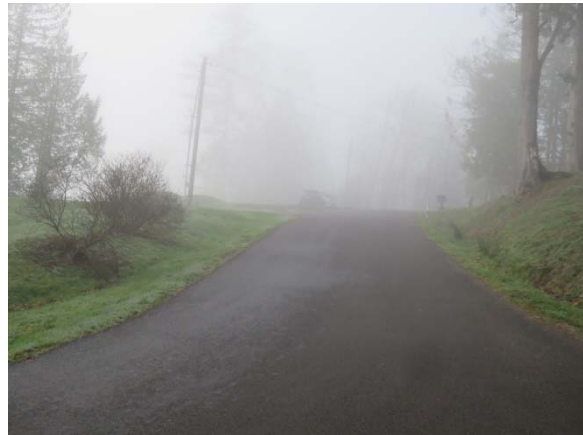
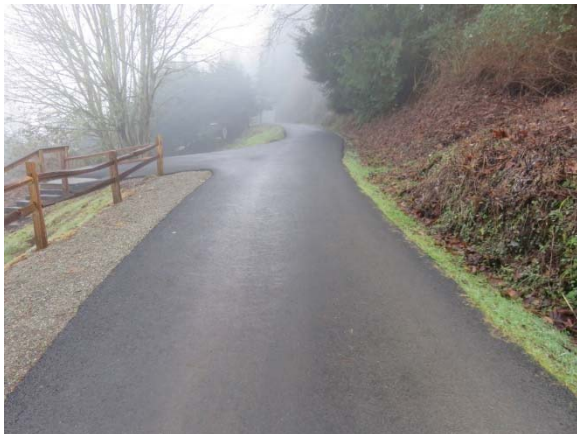
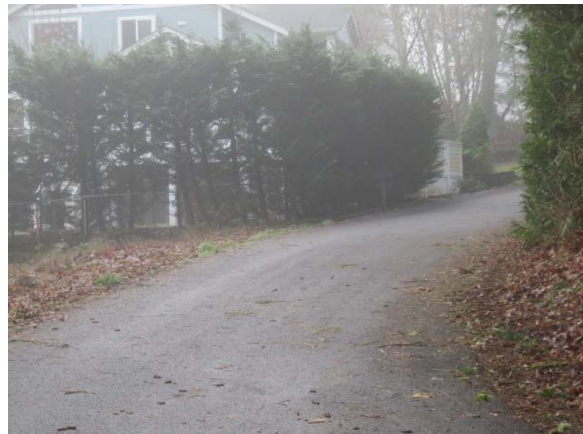
These roads should not have to be completely replaced (as they were in 2017) within the 30-year duration of this study; however, we do anticipate that a 2-inch asphalt overlay will be necessary 30 years after these roads were installed, in 2047.

We have budgeted for emulsion seal coating to occur in 2021 and every 5 years thereafter. Following emulsion seal coating, the asphalt and curbing should be painted with any appropriate fire lane markings that are recommended.

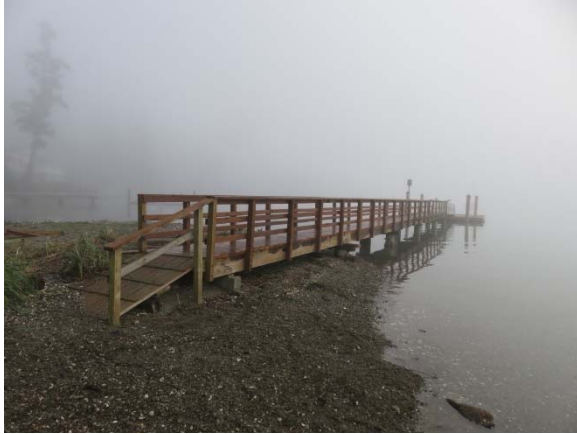
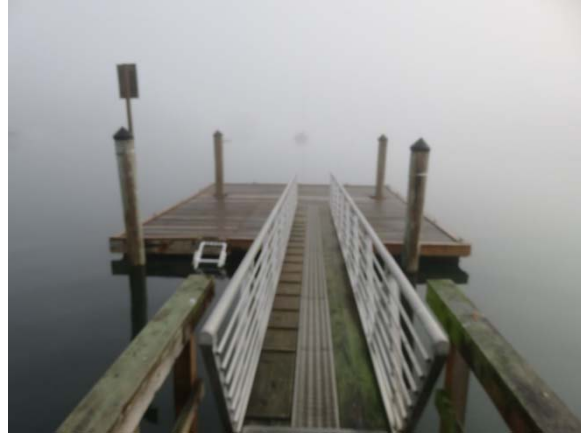
Community Dock

There is a community dock on in this development. We understand that new pilings were installed in 2002 and new floats were installed in 1988. We have assumed a total lifespan of 50 years for this dock starting in 1988. The decking, however, will be replaced in 2019 at a budgetary cost of \$10,000. We recommend that the current decking will be replaced with synthetic decking as it is a much more durable material.

Component	Cost	Urgency	Section
Resurface dock decking with synthetic decking	\$10,000	2019	3.2
Playground equipment replacement	\$25,000	2019	3.2

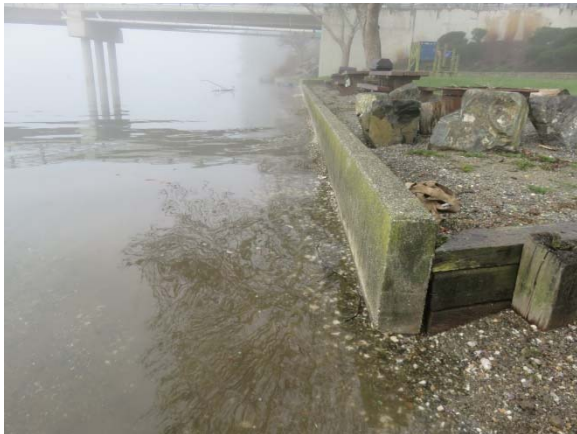
South Concrete Bulkhead

There is a concrete bulkhead at both of the community beaches. The south bulkhead is very short and does not appear to take much punishment. Therefore, we have not budgeted for replacement of the south bulkhead. We actually believe that both of these concrete bulkheads should have a lifespan well beyond the duration of this study. However, we understand that the north bulkhead had a design life of 50 years when it was installed in 1993. We believe that this is a bit conservative; however, we have budgeted for replacement of this bulkhead on this schedule. The original cost to install this bulkhead was \$25,000. Typically, these types of 8-foot bulkheads are installed at a cost of \$280 per linear foot. Therefore, we have budgeted for a replacement cost in today's dollar values at \$61,600.

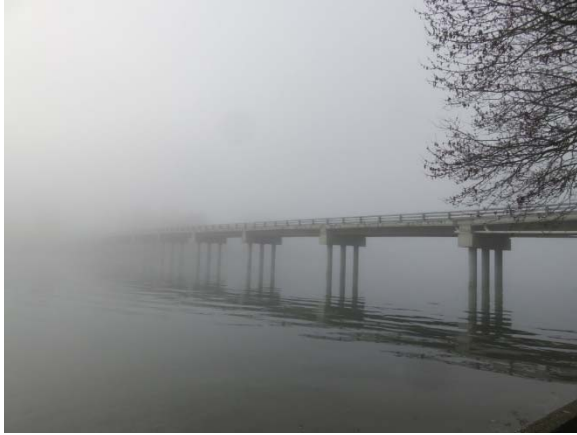
New Bridge

The bridge leading to Raft Island was recently constructed in 2014/2015. The Association deposits funds for future bridge repairs in a separate "Bridge Reserve Fund" that is not factored into this study.

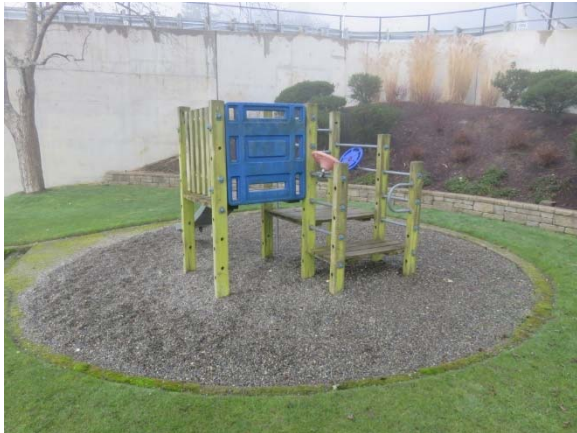
Playground Equipment at South Beach

There is playground equipment at the south beach. We understand that the Board plans on replacing this playground equipment with a new larger playground assembly in 2019. We were provided 5 different options for play equipment that the Board is considering that vary widely in cost. Therefore, at this point, we have simply budgeted for \$25,000 for this equipment.

Generally, playground equipment should have a total lifespan of 25 years if maintained. The level of funding that can be spent on new playground equipment can vary widely.

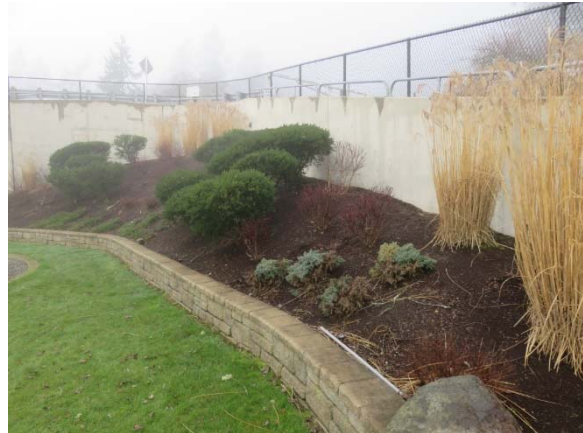
Landscaping Surrounding South Playground Area

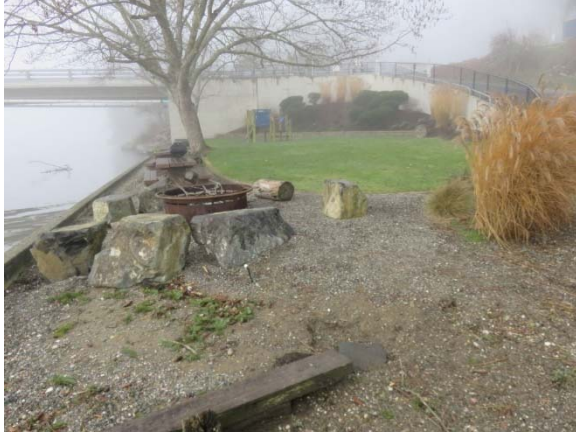
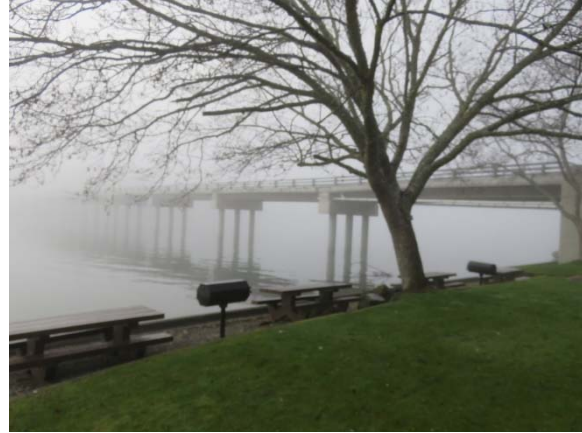
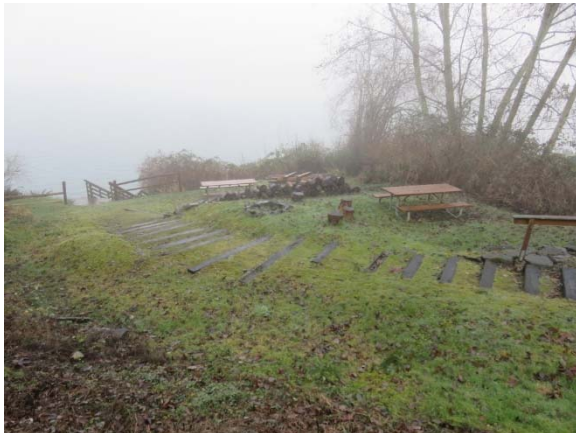
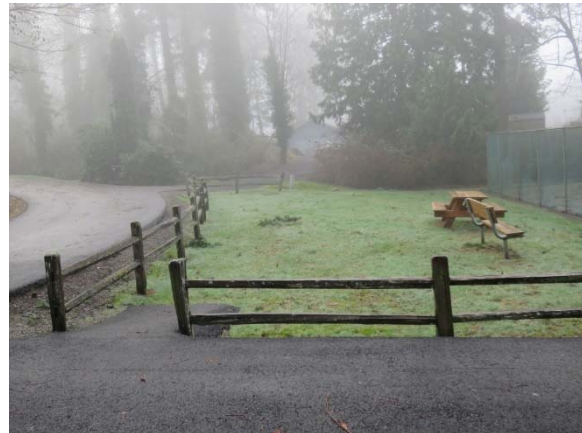
There are barbecues, picnic tables, a fire pit, and benches at the two community beaches and the community tennis court. The cost to replace these items is very small in comparison to the large collective expenses on this property in the future. However, we have included a small line item in the Reserve Study as a lump sum picnic assets replacement allotment every 5 years.

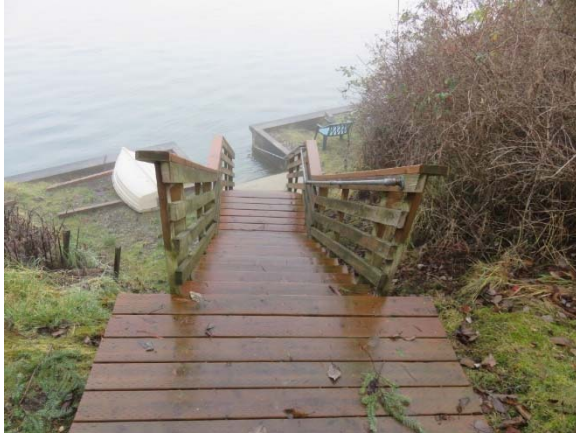
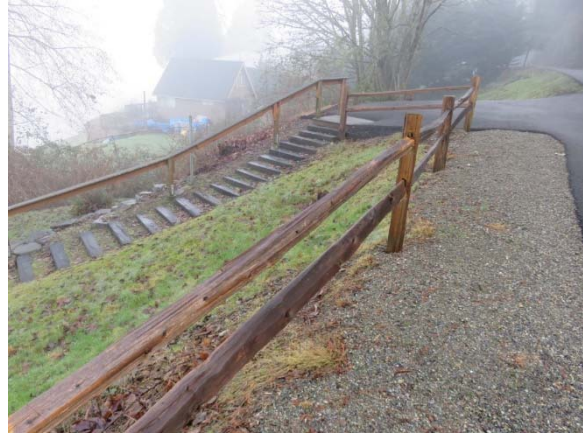
Stairs to North Beach

There are wood stairs at the north community beach. These stairs were rebuilt in 2016 at a cost of \$6,785. We have assumed that these stairs will have a total lifespan of 25 years.

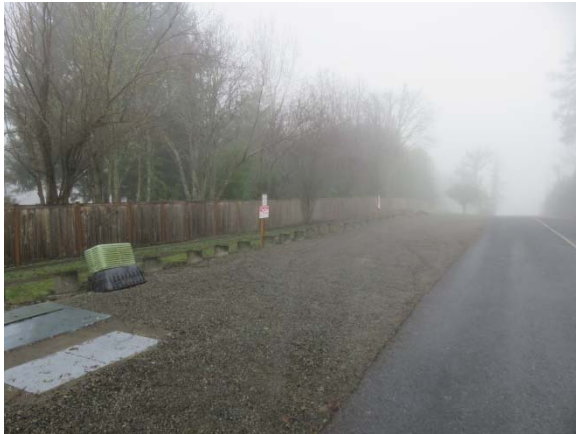
There are wood fences on both sides of the road that accesses the bridge leading to the island. However, we understand that these fences are not the property of the Homeowners Association. We understand that there are no solid fences that are the responsibility of the HOA.

Wood Fence along Entrance

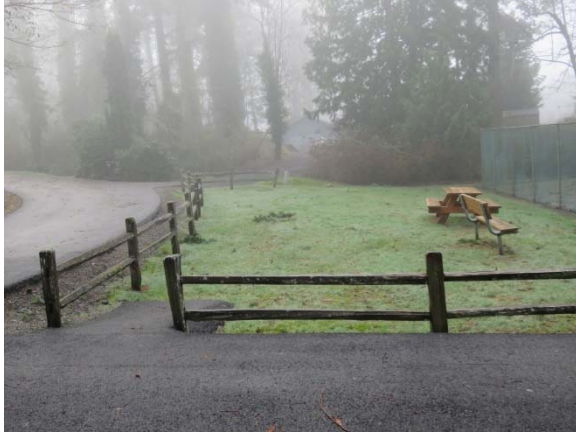
Split Rail Fence adjacent Tennis Court

There is a split rail fence that is in the vicinity of the tennis court. This fence is the responsibility of the HOA; however, this fence is very simple and can easily be replaced by members of the community as needed. Therefore we have not budgeted for replacement of this fence in the Reserve Study.

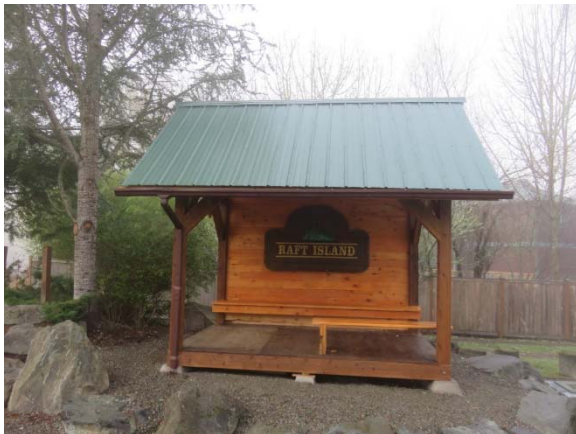
Existing Front Sign and Bus Shelter

There is a bus-stop shelter and community entrance sign at entrance to Raft Island Road off of Kopachuck Drive NW that was installed in 2018 at a cost of \$6,869. We assume that this structure will have a total lifespan of 30 years.

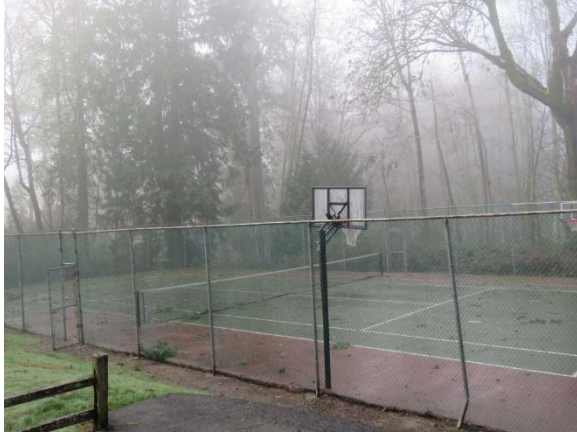
Tennis Court

There is a community tennis court on this property. We understand that this tennis court was last resurfaced in the year 2000 for a cost of \$6,527. We have budgeted for this same level of surfacing every 25 years.

The chain link fence surrounding this tennis court is currently in good condition and should have a service life well beyond the duration of this study. Therefore, no funding has been allocated to replacement of this chain link fence.

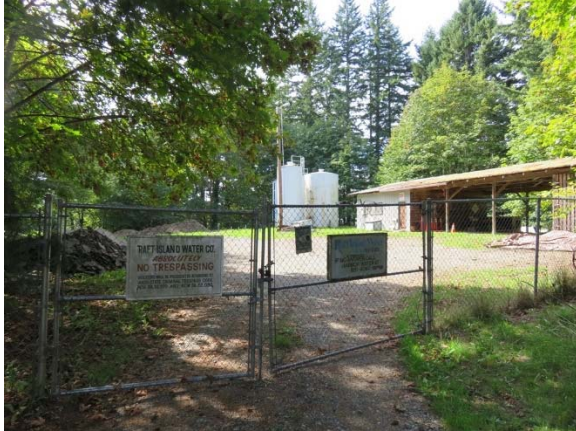
A private utility owns and maintains the water distribution system on this island. We understand that the community water distribution system is currently being replaced though out this community. However, this is being done via the private utility at their cost and does not affect the Reserve Fund.

Private Water Distribution System
