2007 Annual Bridge Inspection Report for Raft Island Bridge

July 2007

**Raft Island Improvement Association
Pierce County, Washington**

Exeltech Consulting, Inc.
2590 Willamette Drive NE, Suite 101
Lacey, Washington 98516

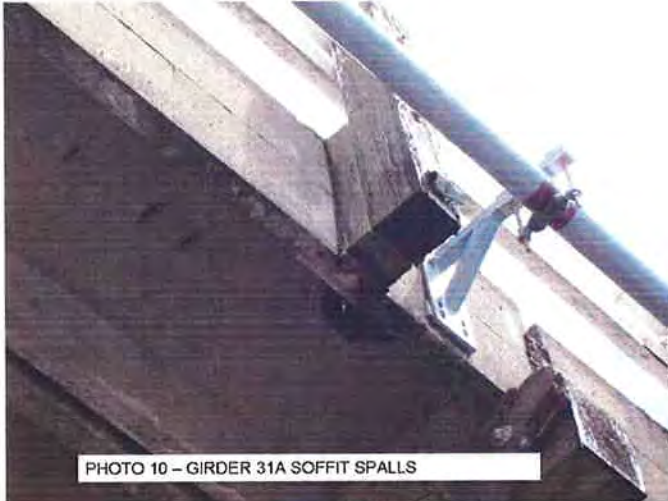
Description	Location
Spalled concrete on girder soffit with exposed steel reinforcement	Span 6: Girder G – two 4" diameter shallow spalls
	Span 16: Girder A – three 3" diameter shallow spalls
	Span 24: Girder A – one 3" diameter shallow spall
	Span 26: Girder A – one 3" diameter shallow spall
	Span 28: Girder A – one 3" diameter shallow spall and two small delaminations
	Span 29: Girder A – one 3" diameter shallow spall
Spalled concrete on girder web with exposed prestress strand	Span 31: Girder A – three 3" to 4" diameter shallow spalls – see Photo 10
	Span 44: Girder A – one 3" diameter shallow spall
	Span 22: Girder G – east web has two shallow spalls 8" long and 6" long – see Photos 8 and 9
Concrete crack formation (non-superficial surface cracking)	Span 13: Girder F – soffit has 5' long leaching rust stained crack along centerline – see Photo 5
	Span 16: Girder G – east web has 12" diagonal crack with delaminating concrete – see Photo 7

PHOTO 5 - GIRDER 13F - LONGITUDINAL SOFFIT CRACKING AT CENTER
