Raft Island Improvement Association

**2008 ANNUAL BRIDGE INSPECTION
REPORT
FOR RAFT ISLAND BRIDGE**

Pierce County, Washington

September 2008

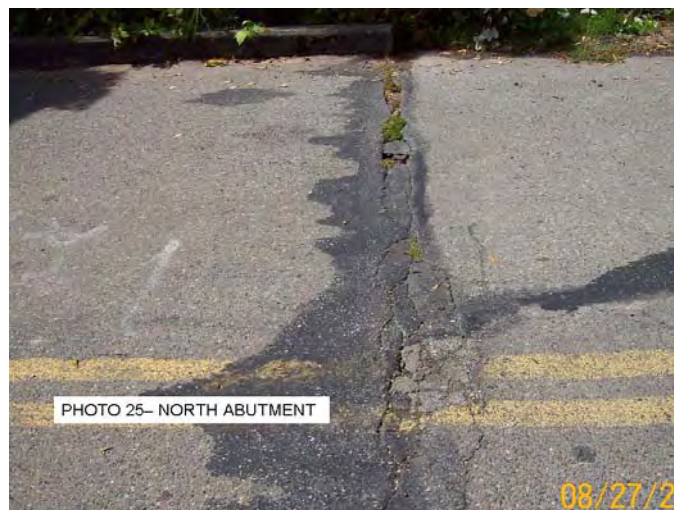
At the north abutment there is cracking full width with some smaller “D” cracking. **See photo 25 below.** It is anticipated that this cracking will worsen as the rotten timber cap deteriorates.

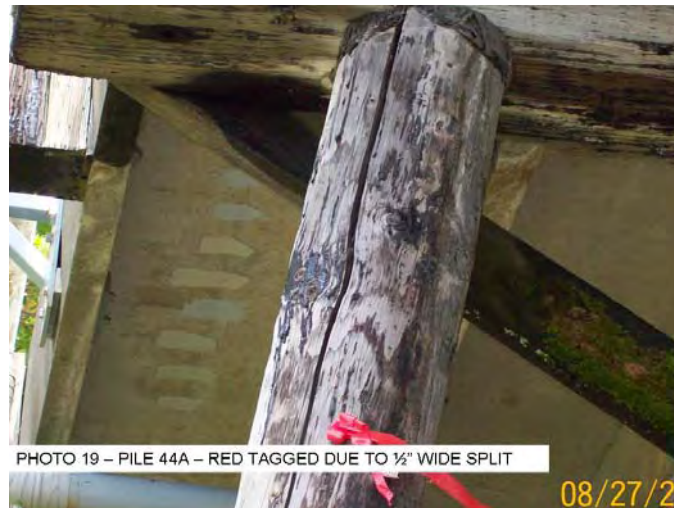
At several bent locations, there were checks, also referred to as “splits,” present that typically extends from the top of the timber pile to around mid-length of the timber pile. The checks were approximately $\frac{1}{2}$ ” wide at the maximum width and tapers down to 0”. At pile 44A the split is $\frac{1}{2}$ ” wide at the top of the pile and extends through the full diameter. **See photo 19 below.** The pile was RED TAGGED with flagging indicating that it should be repaired. No rot was found at the checks.
